## FINAL INVESTIGATION REPORT

**ACCIDENT OF ETIHAD AIRWAYS FLIGHT ETD-72K,  
B787-900 AIRCRAFT, REG. NO. A6-BLF AT ALLAMA  
IQBAL INTERNATIONAL AIRPORT, LAHORE ON  
27 MAY, 2022**

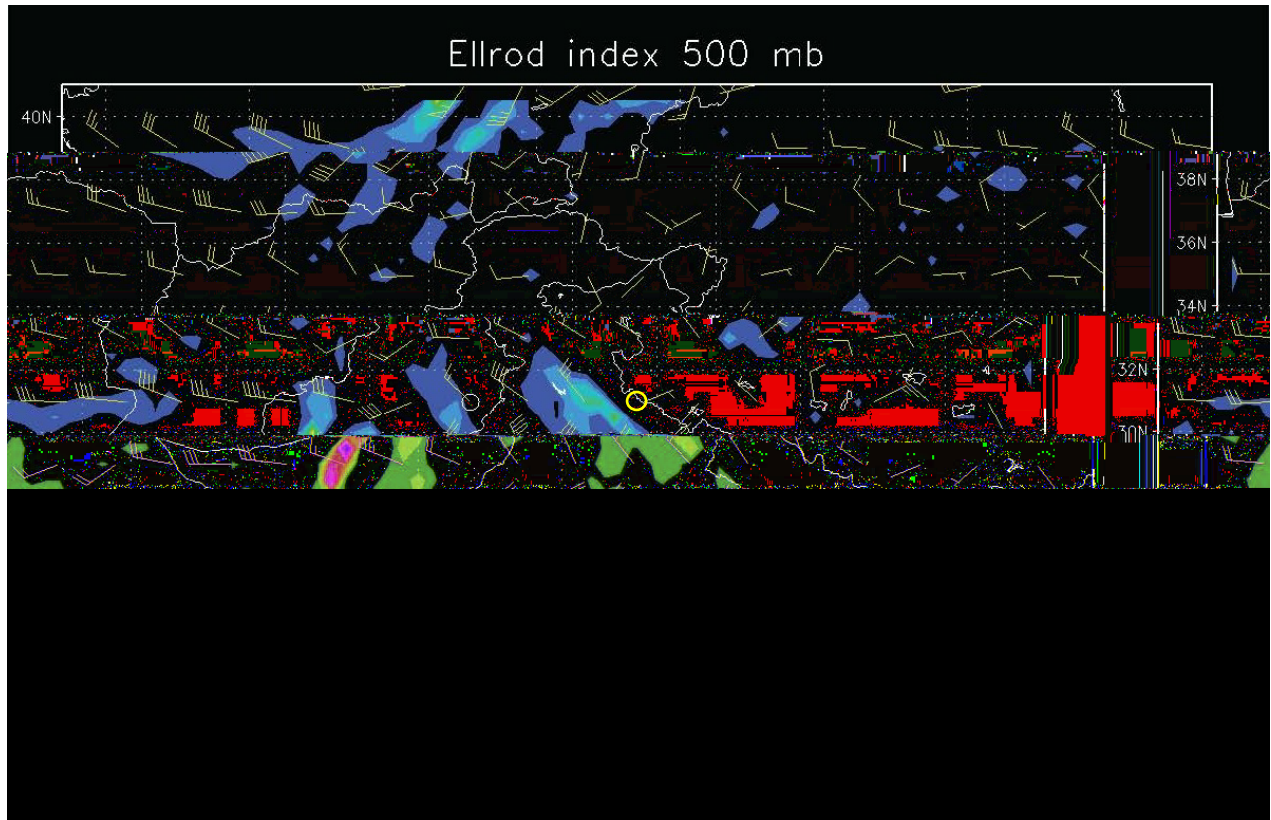
Figure 7 Atmospheric Physics

2.4.6. This is a short-range computer model forecast that depicts wind direction at speed at their incident time and altitude (the yellow wind barbs). Plotted in coloured blobs is a technique used to diagnose large scale turbulence. Large scale turbulence potential was not high, but this model cannot resolve thunderstorm-scale turbulence. Incident position is marked at the centre of the map with a small yellow circle. (Note: they were downwind of the thunderstorm cell.)
