**PAKISTAN CIVIL AVIATION AUTHORITY**  
**(SAFETY INVESTIGATION BOARD)**

**FINAL REPORT**

**SERIOUS INCIDENT OF M/S SAI FLIGHT NL-122**  
**BOEING 737-400 AIRCRAFT, REG # AP-BJN ON**  
**22<sup>ND</sup> APRIL, 2012 AT JIAP, KARACHI**

### INVESTIGATION INTO SERIOUS INCIDENT OF M/S SHAHEEN AIR INTERNATIONAL FLIGHT NL – 122, BOEING 737-400 AIRCRAFT, REG # AP-BJN, (SECTOR ISB – KHI) AT JIAP, KARACHI ON 22<sup>ND</sup> APRIL, 2012

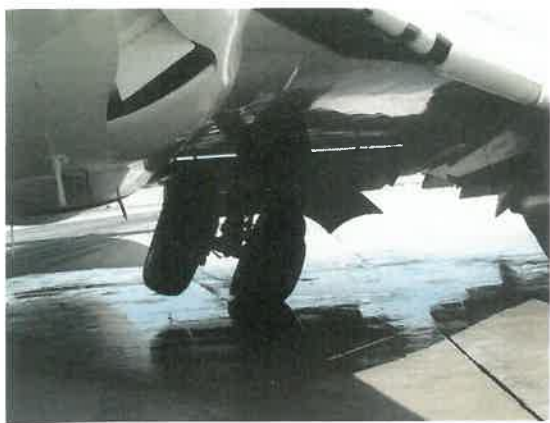
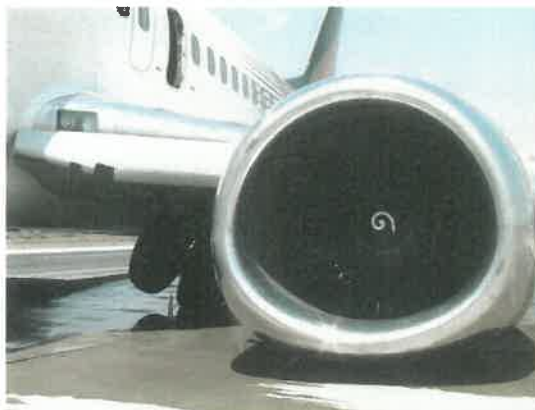
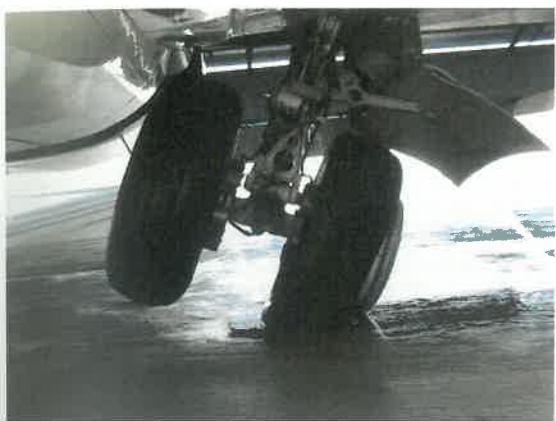
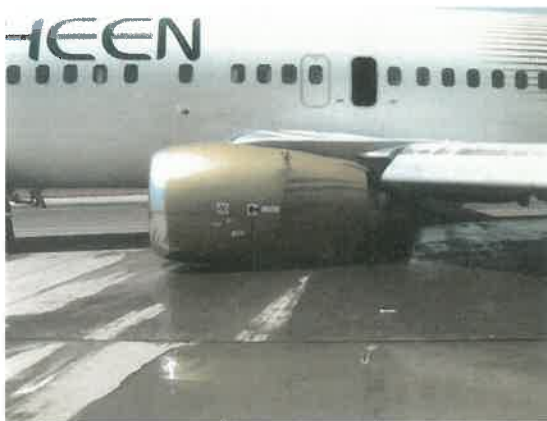
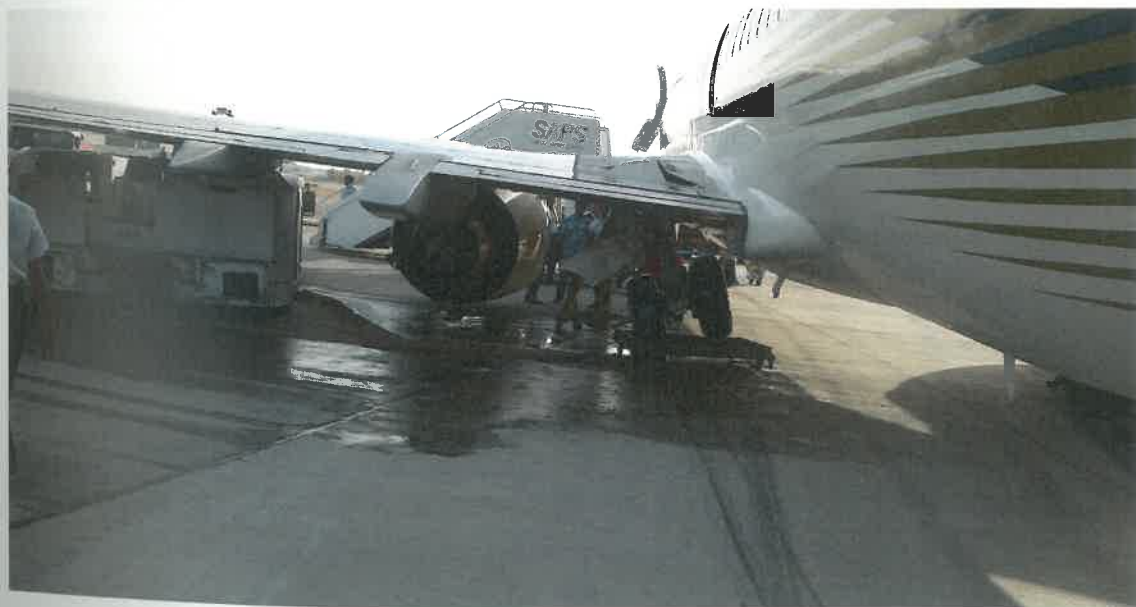
**Collapsed LHS Main Landing and Engine No 1 resting on runway surface**

- 2.2.4 The onsite inspection of aircraft revealed that the LHS MLG had collapsed damaging severely the MLG sub parts and wing structure resulting into heavy fuel leakage from the damaged wing structure. However, no visible signs of any FOD or animal strike were observed. After collection and preservation of all the available evidences, the aircraft was moved to Shaheen Air Maintenance Hangar.

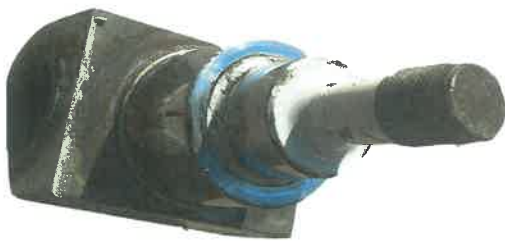
- 2.2.5 Subsequent inspection revealed that T-Bolt Part No 65-46140-9 Serial No 58060-0015 was broken into two pieces and the broken top end of the bolt had been still hanging with the T-Bolt. The broken parts of T-Bolt were preserved for failure mode analysis.

**Broken T-Bolt**

2.2.8.1.1.1 The T-bolt failed due to inter-granular fracture initiating from surface at thread root, which later propagated across the bolt diameter under high load.

2.2.8.1.1.3 Inter-granular fracture in the crack initiation zone could have resulted either from Stress Corrosion Cracking or Hydrogen Embrittlement. However, the available evidences were more supportive to 'Hydrogen Embrittlement' due to Cadmium plating.

- 3.2.7 The LHS MLG collapsed due to fracture of T-Bolt Part No 65-46140-9 Serial No 58060-0015 due to inter-granular cracking as a result of weakened grain boundaries.

- 3.2.8 Once the crack traversed to a certain depth, the remaining cross-section of the bolt suffered instantaneous fracture due to overload.
- 3.2.9 The most probable cause of T-Bolt failure is hydrogen embrittlement due to inadequate heat treatment of the T-Bolt at manufacturing or reworking stage.

- 6.7 All operators in Pakistan operating Boeing 737 series aircraft are to carry out one time inspection of T-Bolts of all aircraft through appropriate NDT (Non Destructive Testing) for crack detection. The bolts with positive indications of crack(s) are to be removed from service.

- 6.10.3 All bolts in this lot should be inspected by a non-destructive method for crack detection. The bolts with positive indications of crack(s) are to be removed from service.

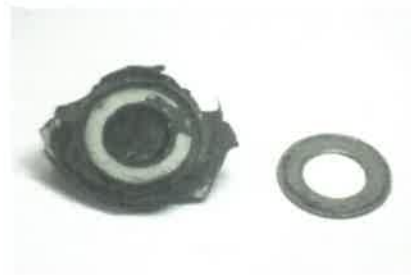
**Nut with Top side of Broken T-bolt still inside**

- 2.2.7.1.6 T-Bolt found broken and threads of nut found sheared-off.
- 2.2.7.1.7 LHS upper drag brace crushed into two pieces b/w shock strut and wing rear spar.

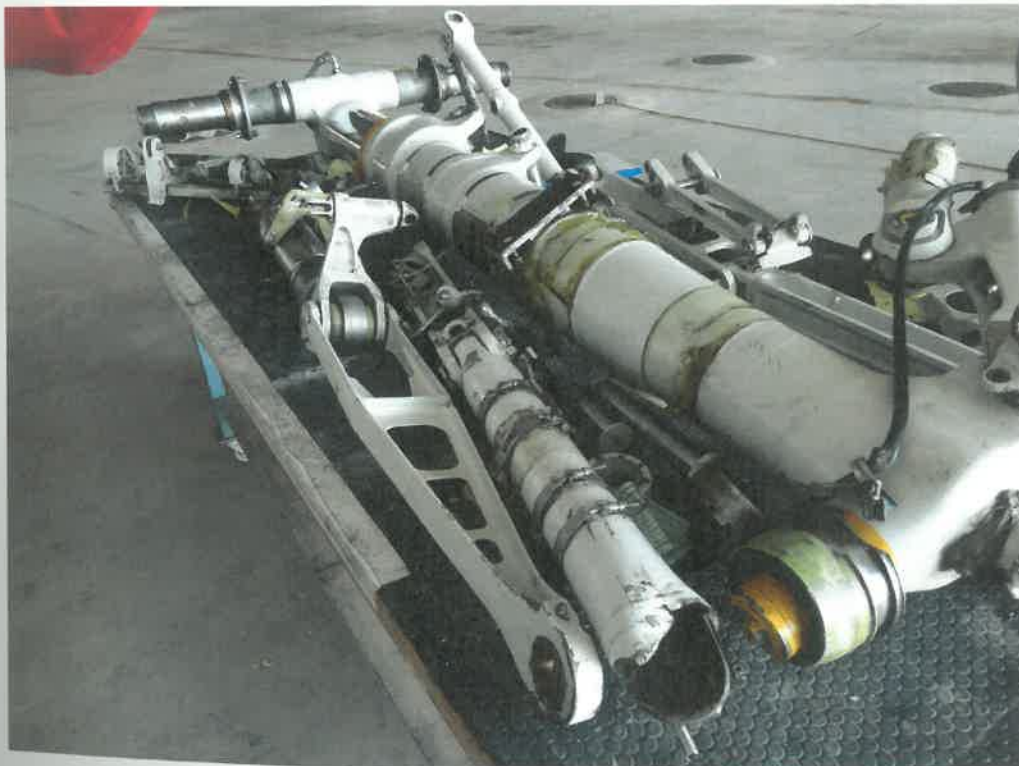
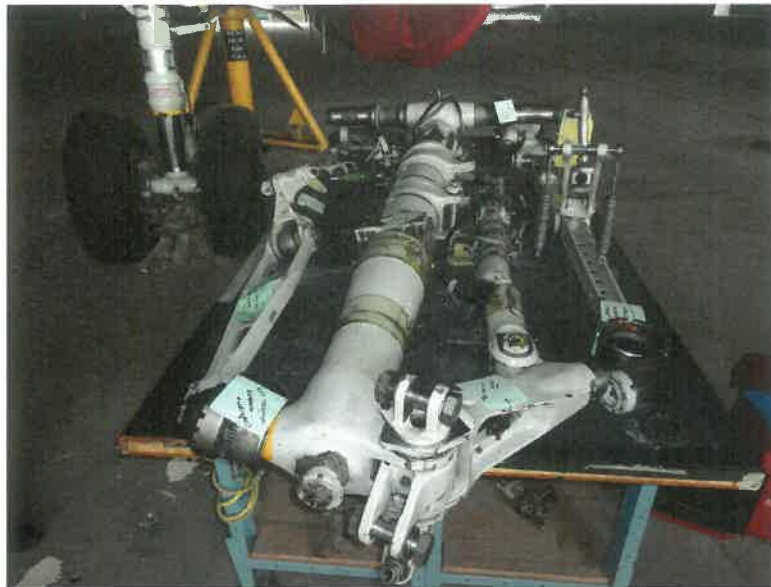
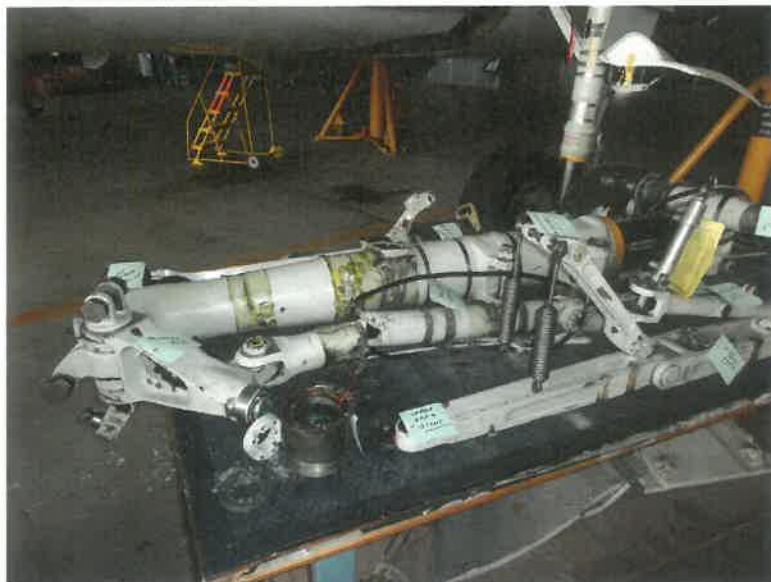
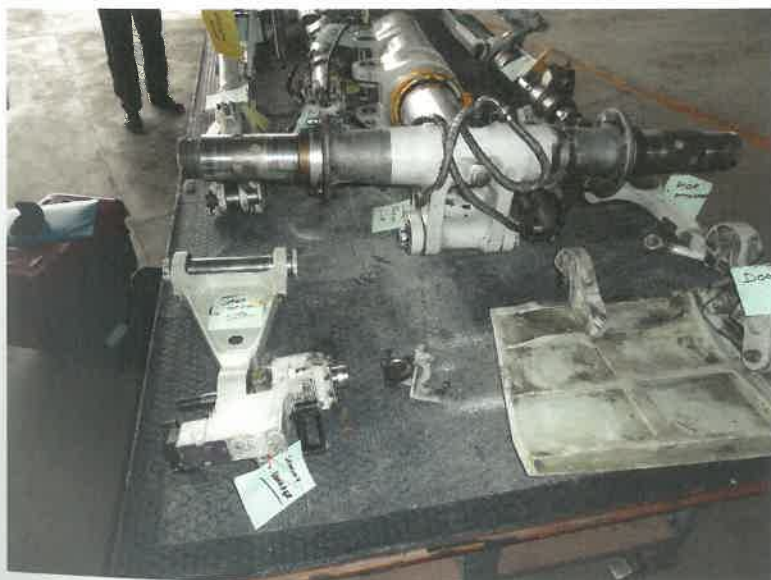
2.2.6 Most of the other damaged parts were found deformed and only a few had fractured apparently due to overload conditions consequent to LHS MLG collapse. The photographs of damaged parts after cleaning and examination are appended below:
