**PAKISTAN CIVIL AVIATION AUTHORITY**  
**(SAFETY & INVESTIGATION BOARD)**

**ACCIDENT TO M/S PIAC, AIRCRAFT  
FLIGHT # PK-653, ATR42-500  
REG. # AP-BHJ ON 31<sup>st</sup> AUGUST 2012 AT  
ALLAMA IQBAL INTERNATIONAL AIRPORT, LAHORE**

## INVESTIGATION REPORT

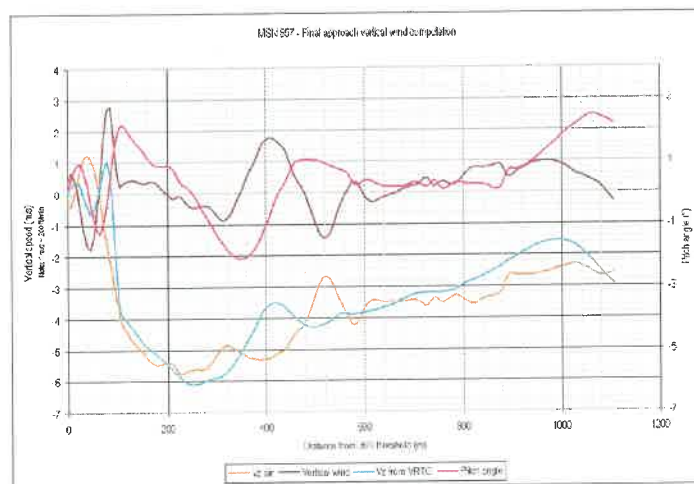
2.2.17 **Vertical Wind Component.** The vertical wind component computed from DFDR data revealed that there was a limited vertical wind component throughout the final approach (less than 1 m/sec). However, between 500 to 400 m from threshold, a downward vertical wind of about 1.4 m/sec (275 ft/min) changes to an upward component of about 1.8 m/sec (354 ft/min). This represents a relative updraft of approximately 3 m/sec (600 ft/min) which was possibly the cause of the pitch down input by the PF that resulted in the  $3^{\circ}$  pitch down movement.

- 3.6 Between 500 to 350 m from threshold, a downward vertical wind of about 1.4 m/sec (275 ft/min) changes to an upward component of about 1.8 m/sec (354 ft/min) which represents a relative updraft of approximately 3 m/sec (600 ft/min).

- 3.7 After encountering a relative updraft, the PF lowered the nose of aircraft to continue the final approach / landing which resulted in the 3° pitch down movement.

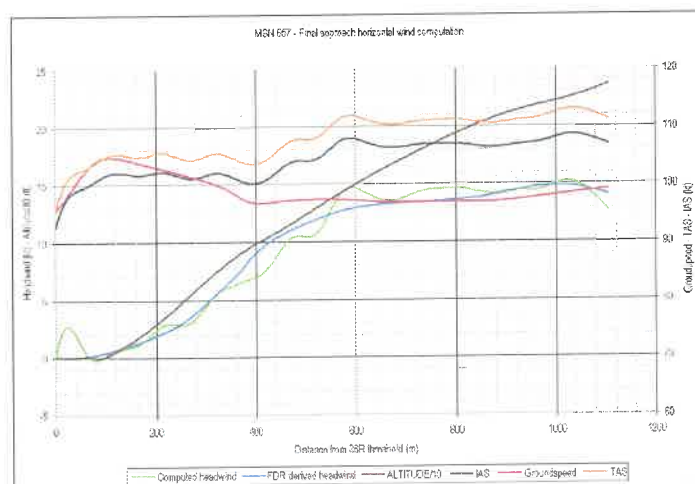
2.2.18 **Horizontal Wind Component.** The horizontal wind data was compared with the recorded wind data and they both follow the same trend in the last portion of flight before touchdown. The head wind component decreased from 13 to 4 kts between 600 m and 200 m from threshold which corresponds to an altitude of aircraft between 150 and 25 ft AGL.

**Note:** Throughout the final approach, the recorded wind varied from  $040^{\circ} - 080^{\circ} / 5 - 10$  kts between 1000 and 700 ft QNH to  $020^{\circ} - 040^{\circ} / 13 - 20$  kts down to 100 ft AGL. The last recorded data at touchdown is  $297^{\circ} / 3$  kts.

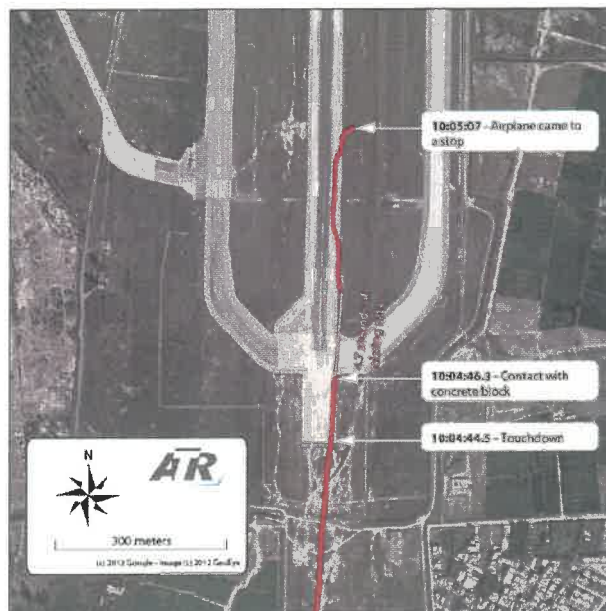
**2.2.19 Horizontal Flight Path.** The PF flew the aircraft in autopilot mode till crossing ILS minima and therefore the aircraft maintained runway centre line till crossing ILS minima. After crossing the ILS minima and disengagement of autopilot the aircraft drifted towards east (right) and the heading increased from  $001^{\circ}$  to  $005^{\circ}$  and then back to  $001^{\circ}$  before touchdown. The extracted horizontal flight path from ATR Report is appended below.

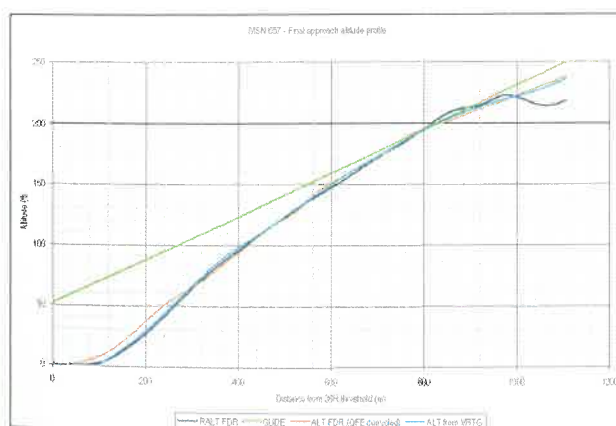
**2.2.20 Vertical Flight Path.** The vertical flight path profile is drawn in altitude above ground versus distance from runway 36R threshold. The chart below shows the pitch evolution as well as the various vertical speed parameters that are quite well correlated. It has to be noted that the  $3^{\circ}$  pitch down between approximately 500 and 350 m from threshold is reflected in the vertical speed evolution in the same time. It decreases from about -800 to -1200 ft/min, which represents a 50% increase in the rate of descent while flying only 100 ft AGL.

- 3.8 A 3° pitch down input by PF in between approximately 500 and 350 m from threshold resulted in increased rate of descent from about -800 to -1200 ft/min (a 50% increase in the rate of descent while flying only 100 ft AGL) which was probably experienced as sudden sink by cockpit crew.
