INVESTIGATION REPORT ON  
ACCIDENT TO M/S. KHAN AVIATION CESSNA 185 AP-BBC  
WHICH OCCURRED ON 8-10-1982 AT PASNI AIRPORT

Authority : DGCA Memorandum No. IB/7-16/82 dated  
9th October, 1982 (App. 'A')

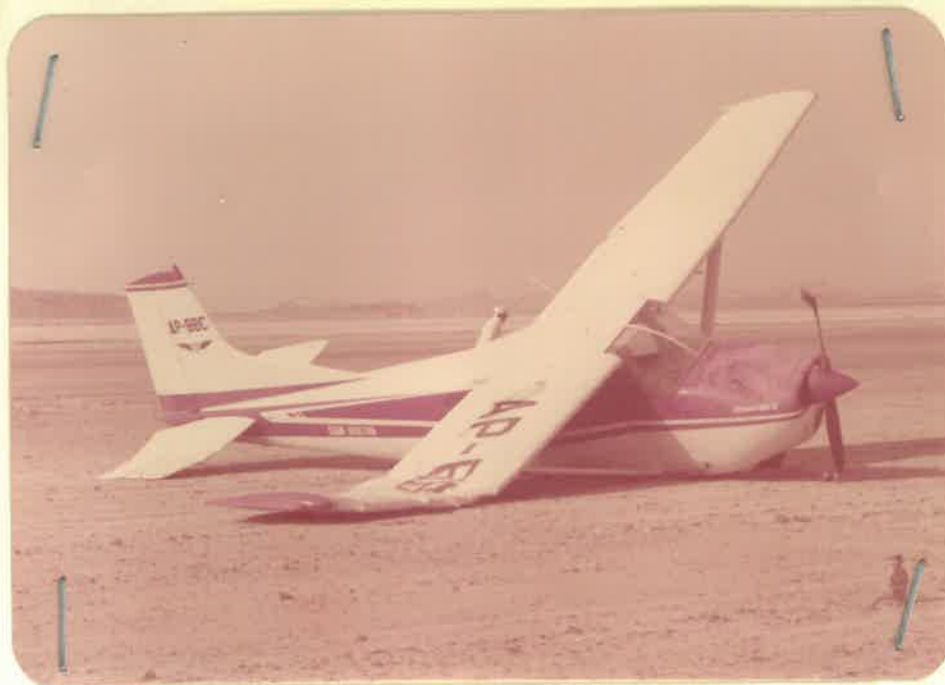
- 12.1. This damaged aircraft (App. 'U1') which was lying 100 feet South East of the runway, was identified as Cessna 185F bearing Nationality and Registration marks AP-BBC. The wreckage was in one piece except for the right main gear assembly, right main wheel and propeller tip. The right hand gear assembly and the right hand wheel were lying close to the wreckage (App. 'U2'). The propeller tip was found at a distance of approximately 600 feet from the wreckage towards the threshold of runway 24. It had flown away due to centrifugal force after its breakage from the propeller. One bolt and one screw, both corroded, were also picked up from the runway.

- 12.6. The main wreckage was found resting on its right wing in Kacha. In addition to the right wing tip, left main gear and belly of the aircraft were also supporting the wreckage. The tail wheel was not in contact with the ground. It could be spun with fingers. One of the propeller blade tip was also touching the ground. (APP-U1 ) •

A view of the wreckage of Cessna 185F. Nationality and Registration Mark AP-BBC can be seen clearly. Please also note propeller. The tip of the upper blades has broken-off.

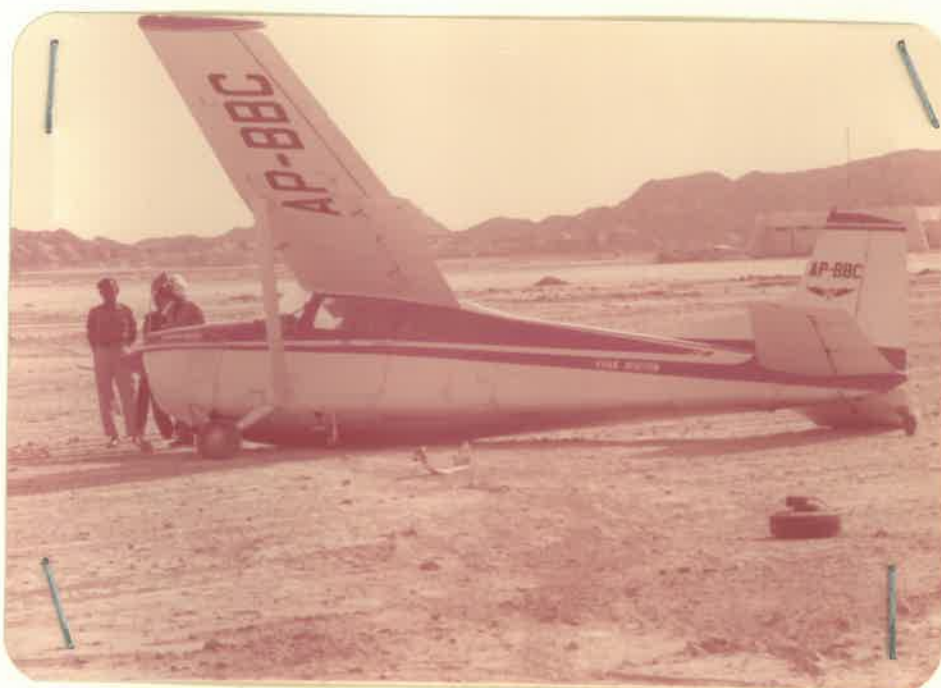
U-2

A view of the wreckage from left hand side. Please note port wheel and tail wheel are in tact. In the fore ground the damaged starboard tyre and wheel broken-off can be seen. The starboard landing gear spring and axle can be seen just below the aircraft fuselage.

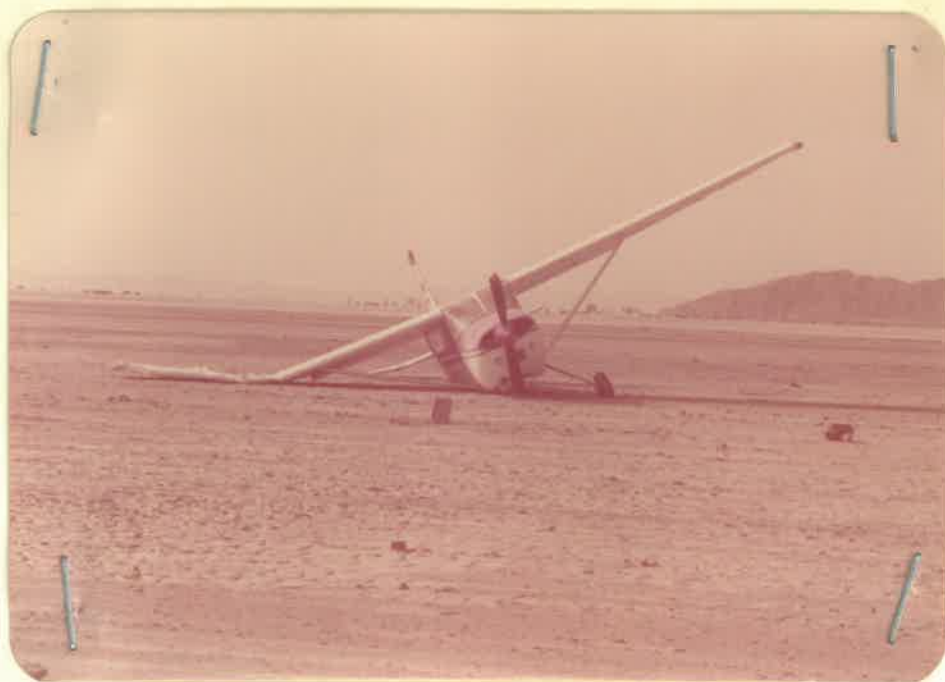
4  
U 3"

3  
A front view of the wreckage. Note port wheel and landing gear spring and damage to the starboard wing.

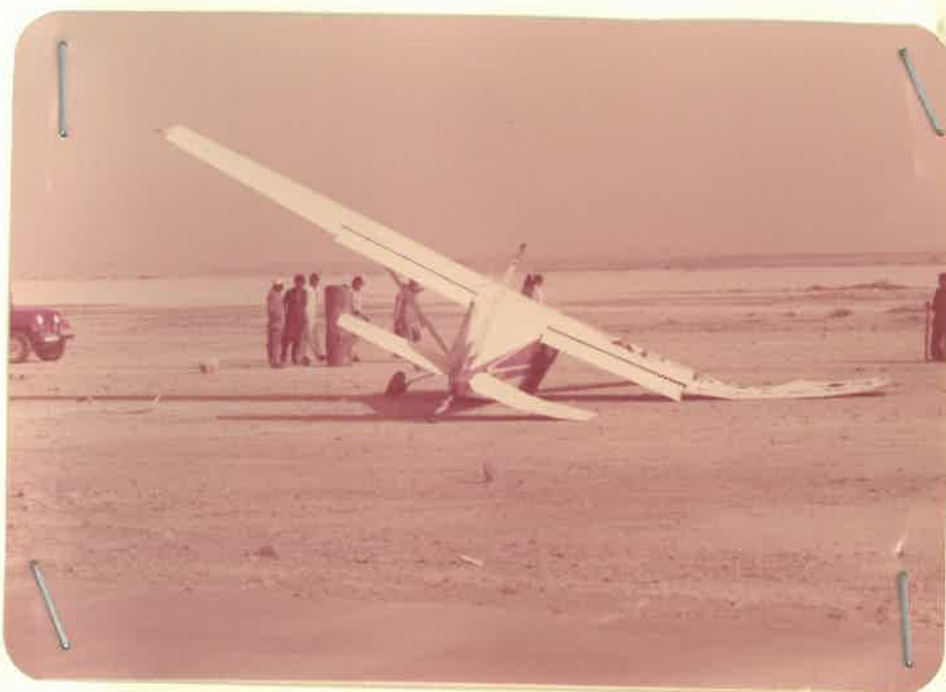
4  
U 4"

4  
Rear view of the wreckage. Please note tail wheel and damage to starboard tail plane and elevator. Also note position of flaps which are set for take-off.

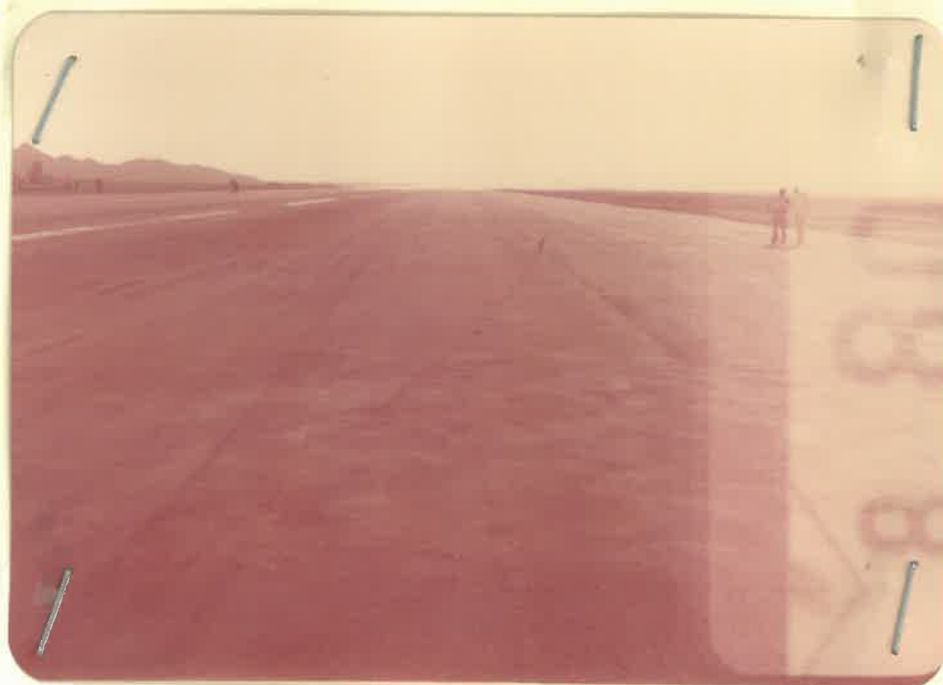
U-5"

View of the runway taken from the take-off direction. Please note tyre marks on the bituman to the right of the centre line. The extra dark spots are the stones placed by the investigators.

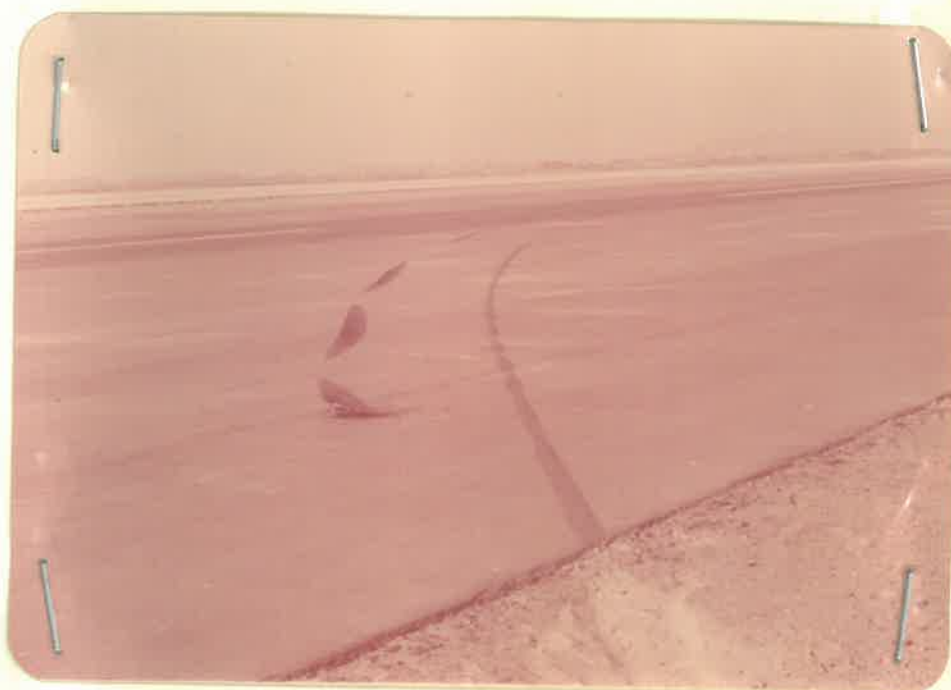
U-6"

View of the tyre marks on the runway left of the centre line as the aircraft left the runway. Note starboard tyre marks indicating final failure of the starboard wheel at this point.

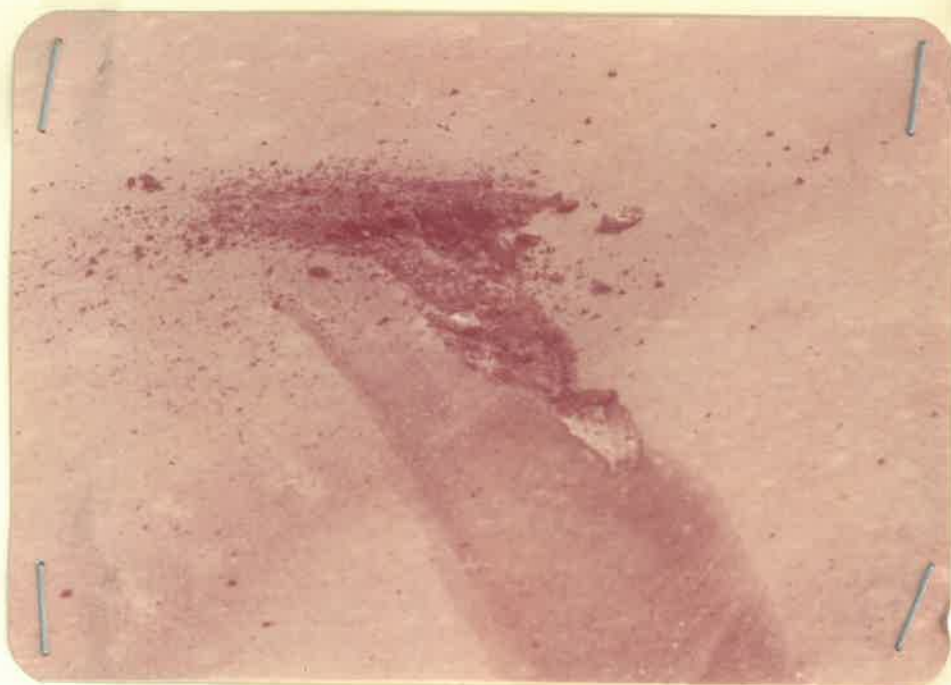
U-7

7  
View of the last point of the starboard wheel track at which point the wheel had broken-off.

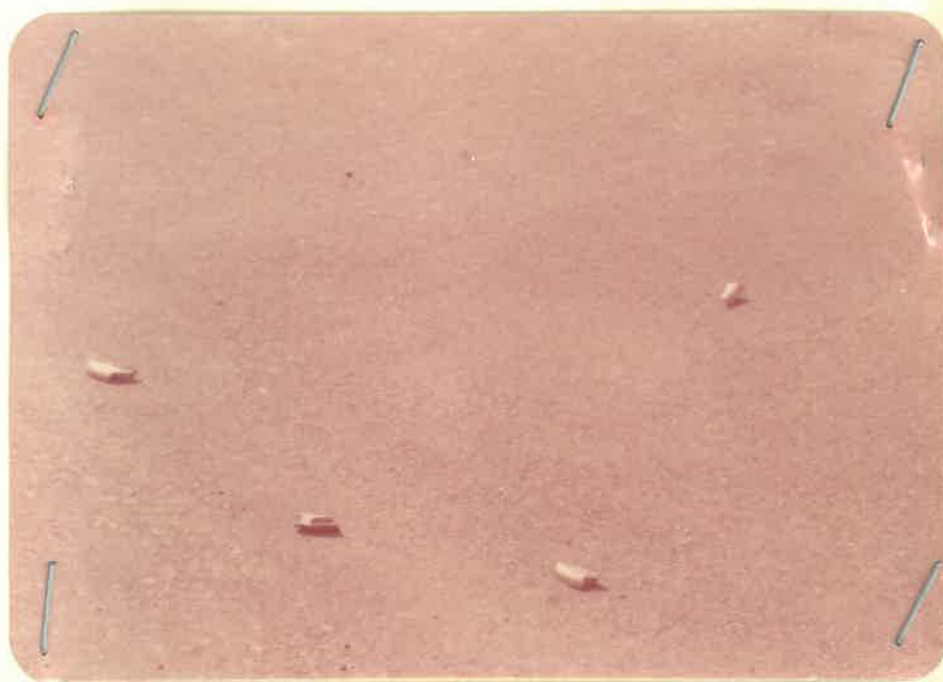
U-8

8  
View of pieces of the rim of the starboard wheel on the runway close to the tyre tracks shown on exhibit U-6.

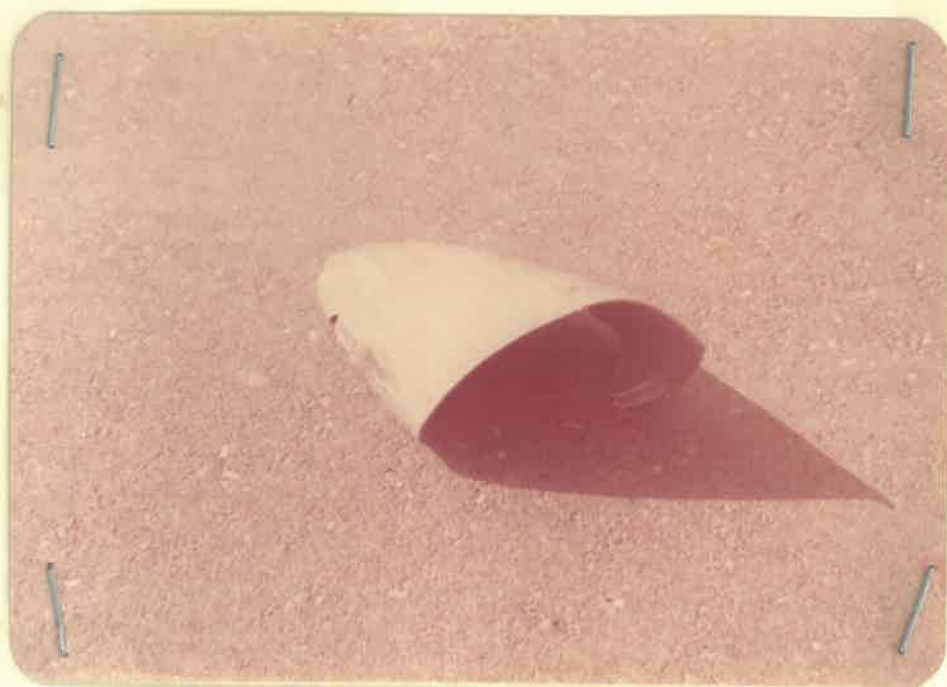
U-9\*

- 12.3. The fact that the screw and the bolt were corroded itself confirms the fact that these have not been in use for considerable length of time.
- 12.4. Propeller tip was found approximately 600 feet short of the mark where the left main gear had departed the runway. This 600 feet area was scanned by the Investigating Team. No evidence was found on the runway surface to show that the tip had come in contact with the runway. It is the opinion of the investigators that this part flew off when the propeller contacted the soft ground after the aircraft had departed the runway surface. This opinion is based on the fact that had the tip flown off at a position other than the aircraft being at 90° to the runway, it would not have been thrown to this position.

9 The tip of the propeller blade which had separated after the impact with the soft ground after the aircraft left the runway. No marks of propeller were evident on the runway surface.

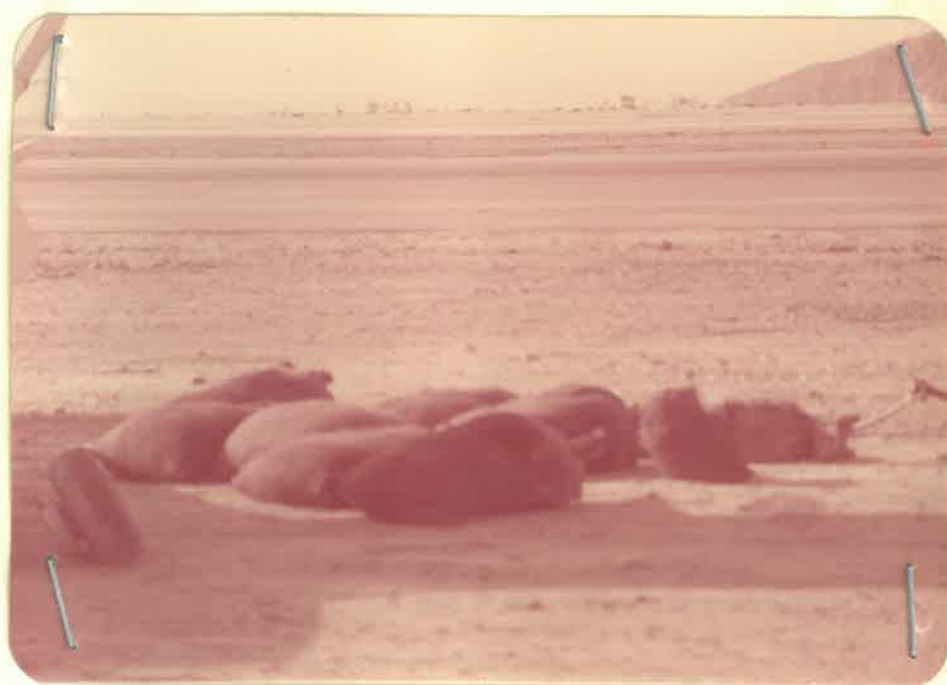
U-10\*

- 12.11. The water soaked gunny bags were off-loaded .from the cabin of the Cessna-185F aircraft (APF. U-10). These nine bags were weighed on M/S. PIAC Scale. The total weight came to be 501 Kgs or 1102.5 Lbs (App. "D-1 "). It was agreed by the Pilot of this aircraft and the two investigators that weight of these nine bags would have certainly been much more at the time of the occurrence. This opinion was based on the fact that the area under the belly of this aircraft was found wet. It wa.s attributed to the fact that the liquid, which had leaked from these bags, had found its passage through the floor board. A reasonable amount may also have evaporated due to the fact that this commodity was weighed 28 hours after the accident.

10 View of the Cargo removed from the aircraft on the 9th October, 1982. The Cargo of prawns were packed in gunny bags which were found to be soaked at the time of removal. The ground below the aircraft belly was also wet.
