**PAKISTAN CIVIL AVIATION AUTHORITY**  
**(SAFETY INVESTIGATION BOARD)**

**FINAL REPORT**

**M/S SCHON AIR PIPER SENECA – III (PA-34) AIRCRAFT**  
**REG # AP-BDK FORCED LANDING NEAR DHA CITY,**  
**KARACHI ON 20<sup>th</sup> OCTOBER, 2011**

### INVESTIGATION INTO SERIOUS INCIDENT OF M/s SCHON AIR PIPER SENECA – III (PA-34) AIRCRAFT, REG # AP-BDK NEAR DHA CITY KARACHI ON 20<sup>TH</sup> OCTOBER, 2011

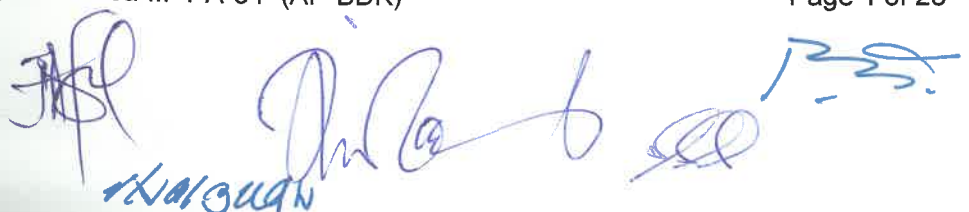
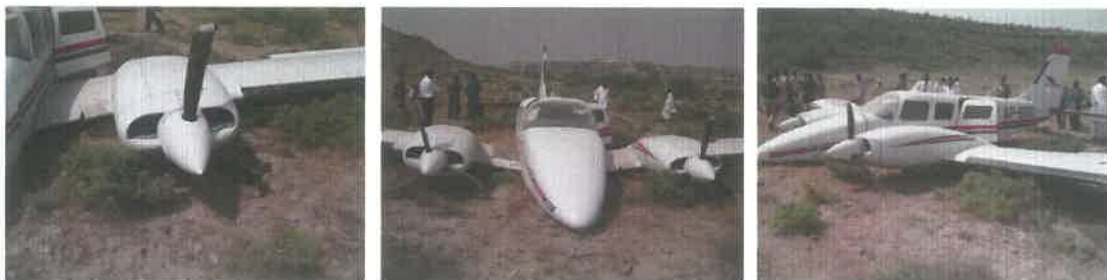
- 1.3. **Damage to Aircraft.** The mishap aircraft remained intact and in one piece on its belly after the forced landing, however it was estimated that aircraft had sustained substantial stresses and structural damages as shown below:-

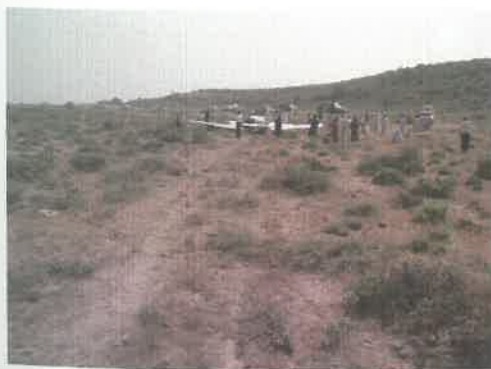
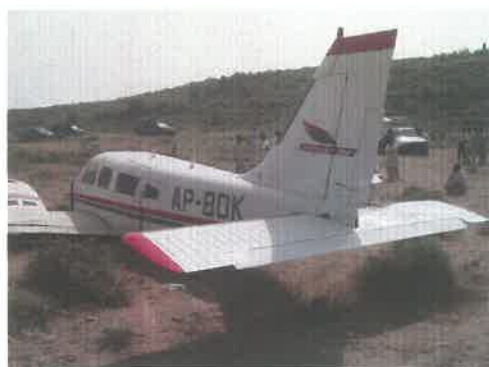
1.9. **Impact Information.** After the occurrence the survey of serious incident site was conducted, the important signs / rubbing marks of tyres on the rough surface and other related evidences were preserved through video and digital photography. Aircraft impacted the ground on main landing gears in the down and locked position as stated by Captain. Both the main landing gears broke away after forced landing. The right main landing gear then flew away and struck leading edge of right elevator. At about twenty feet from touchdown point dug marks of left Propeller were observed. The nose wheel was found housed in its well with door closed. The mishap aircraft stopped within approximately 150 feet of distance from the touchdown point after dragging its belly on ground. The pictorial views of the aircraft after forced landing and the site are as follow:

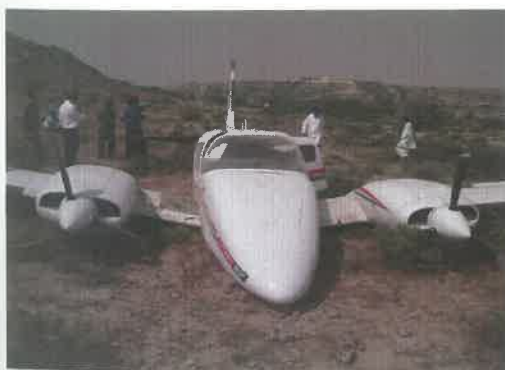
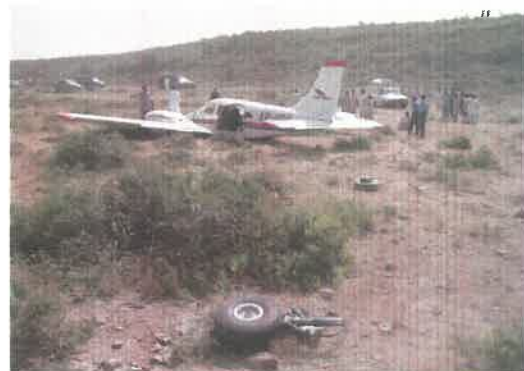
2.2.1.1. The propellers of both engines were still attached with respective assemblies, though bent, but intact and in one piece. This indicated that contact with the ground was made at relatively controlled and lesser speeds, and the aircraft did not travel much after touchdown.

2.2.1.2. Both the Engines' Propellers were found bent and damaged due to hitting with the ground. The propeller blade angles and damage pattern of both the propellers were significantly different from each other. The damage pattern was indicative of the fact that engine No 2 was at feathered position, and engine No 1 was running at power at the time of touchdown.
