**PAKISTAN CIVIL AVIATION AUTHORITY**  
**(SAFETY INVESTIGATION BOARD)**

**FINAL REPORT**

**M/S SHAHEED BENAZIR BHUTTO FLIGHT ACADEMY (PIAC)**  
**CESSNA – 172 AIRCRAFT, REG # AP-BAJ, FATALLY INJURED**  
**A PASSENGER AFTER DISEMBARKING AT SUKKER AIRPORT**  
**ON 21<sup>ST</sup> FEBRUARY, 2013**

### PROCEEDING OF INQUIRY INTO ACCIDENT IN WHICH CESSNA-172'S PROPELLER HIT A PASSENGER ON UPPER LEFT ARM, FATALLY INJURING THE PASSENGER

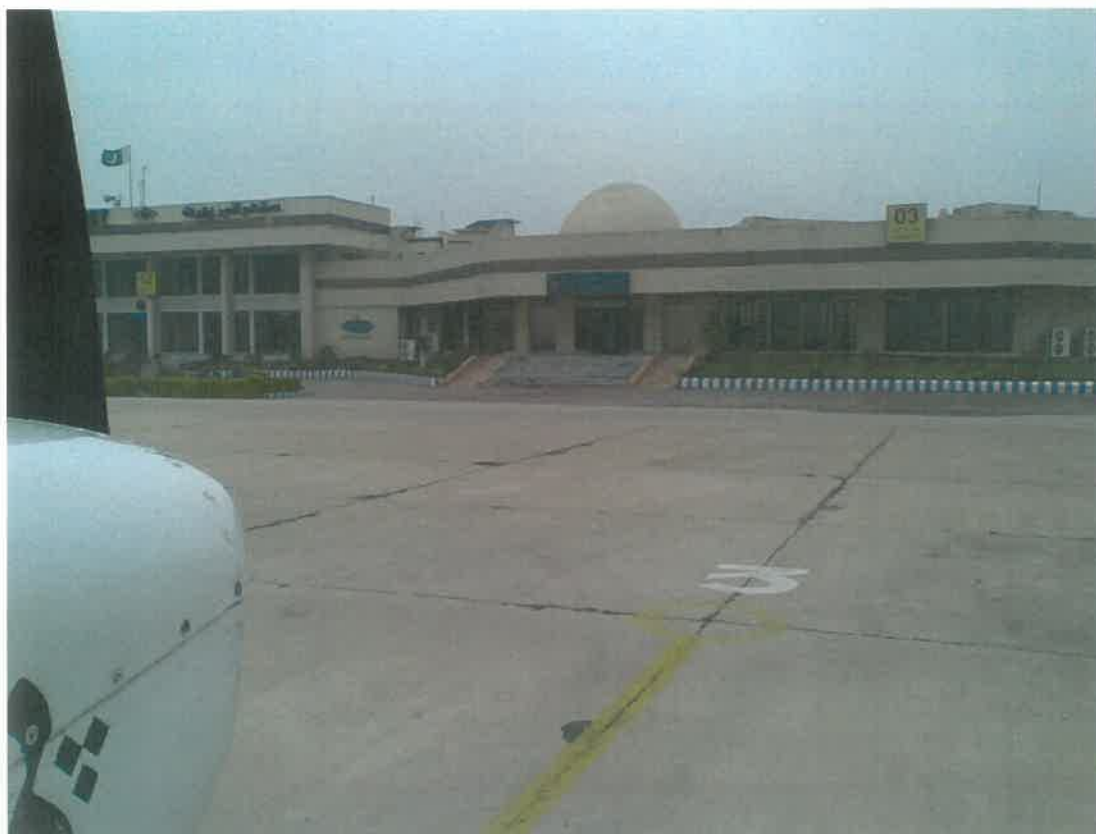
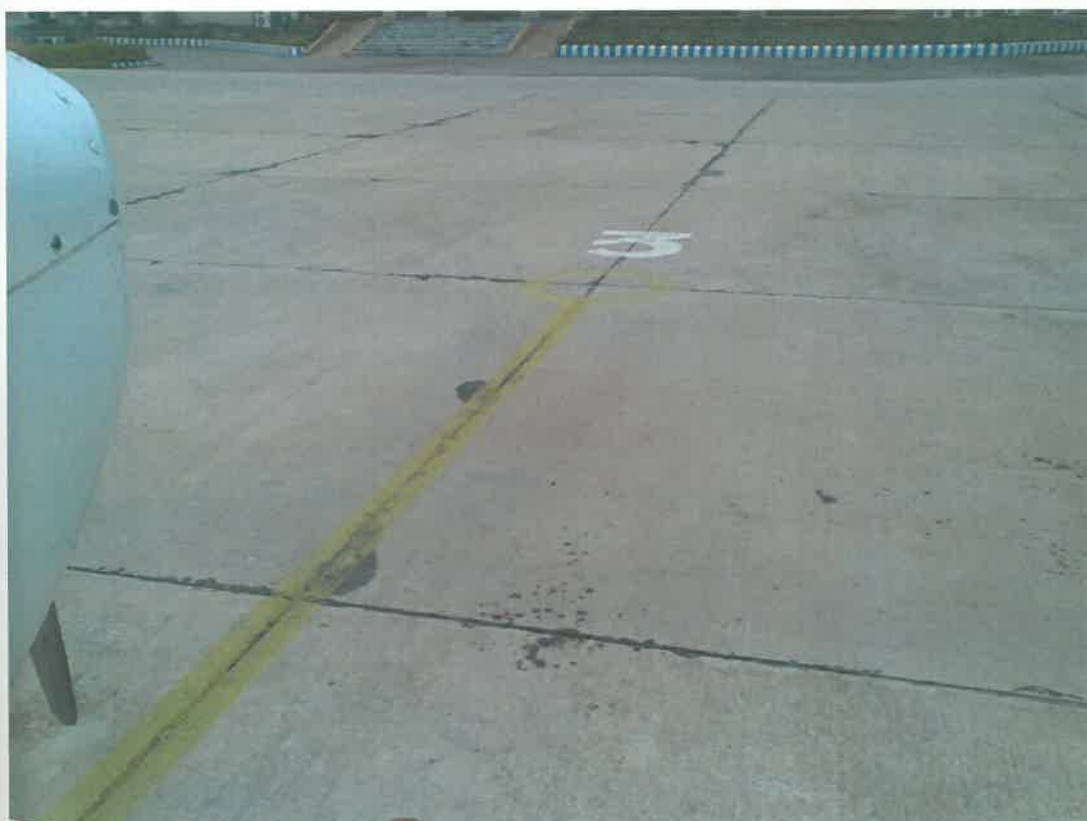
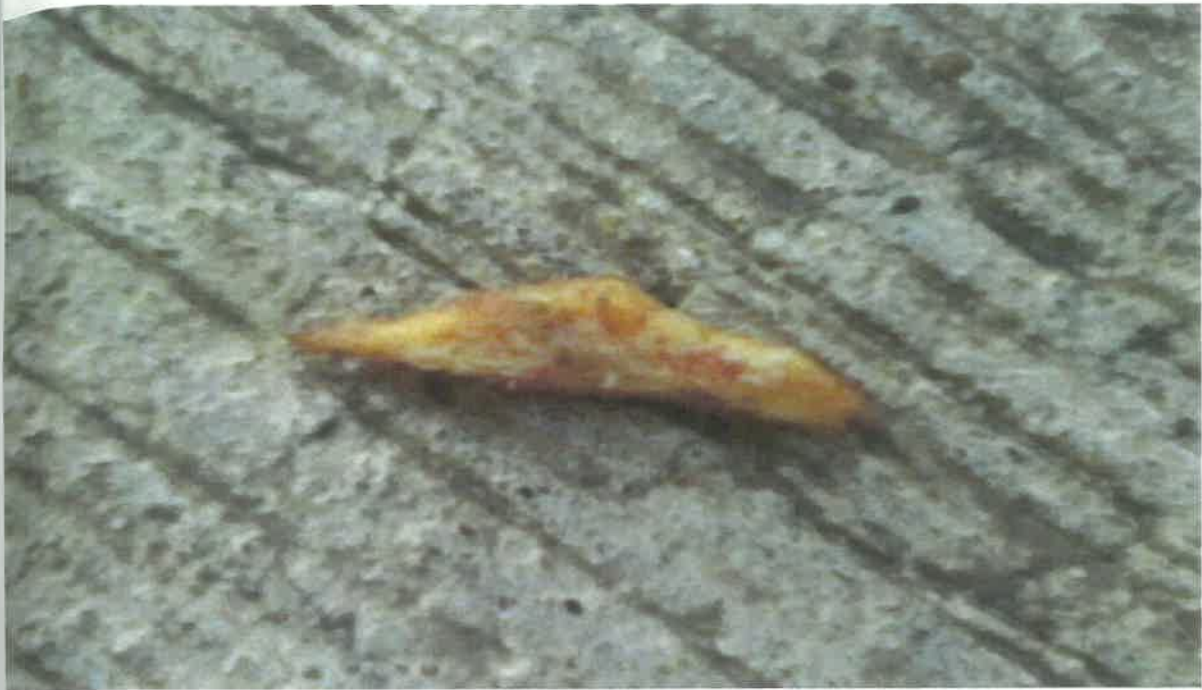
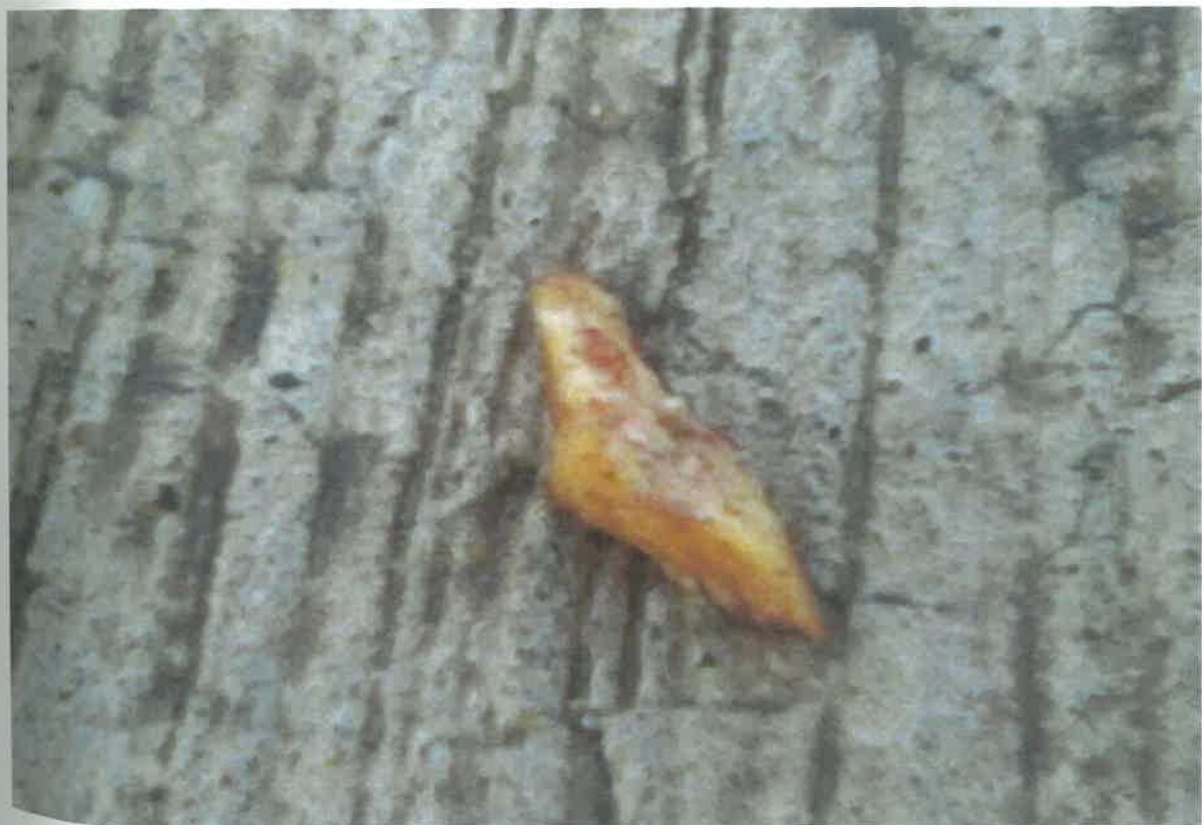
Appendix "M" TO  
M/s PIAC C-172 (AP-BAJ)  
Accident on 21<sup>st</sup> Feb, 2013

- h. Only logical explanation, which could be thought of, for Mr Tanveer going to left, after crossing wing strut be that the ASF personnel at Sukkur, who had come to receive Mr Tanveer, were standing left of Bay-3, close to stairs of terminal building (Appendix "M"). As a result Mr Tanveer, after crossing wing strut, started walking towards left and was hit by the tip of the propeller. However, this logic was not supported by concrete evidence available. In that, the blood marks (after the accident) were seen going towards right of aircraft (Appendix "M"). It is natural that an injured person would move towards other people for help. Therefore, it can be convincingly deduced without any doubt that the reception party was to the right of aircraft. By all logics Mr Tanveer, after crossing strut, should have gone to right, instead of left. Hence reason for moving to left cannot be ascertained.

- a. As discussed earlier, diameter of propeller of the aircraft is about 75 inches (37.1" radius). Therefore, tip of propeller is about 3 feet and 1 inch away from longitudinal axis of aircraft. When Mr Tanveer, moved to left, tip of the propeller hit left upper arm. The tip of the propeller broke part of bone of left upper arm and the piece of the bone was found lying on the ground close to propeller (Appendix "M-1"). Mr
