## ***AIRCRAFT ACCIDENT 2/01***

# ***FINAL REPORT ON THE ACCIDENT INVOLVING PAKISTAN INTERNATIONAL AIRLINES AIRBUS A300-B4, AP-BCJ AT DUBAI INTERNATIONAL AIRPORT, UNITED ARAB EMIRATES ON 17 OCTOBER, 2001***

***REPORT DATE: 01 FEBRUARY, 2003***

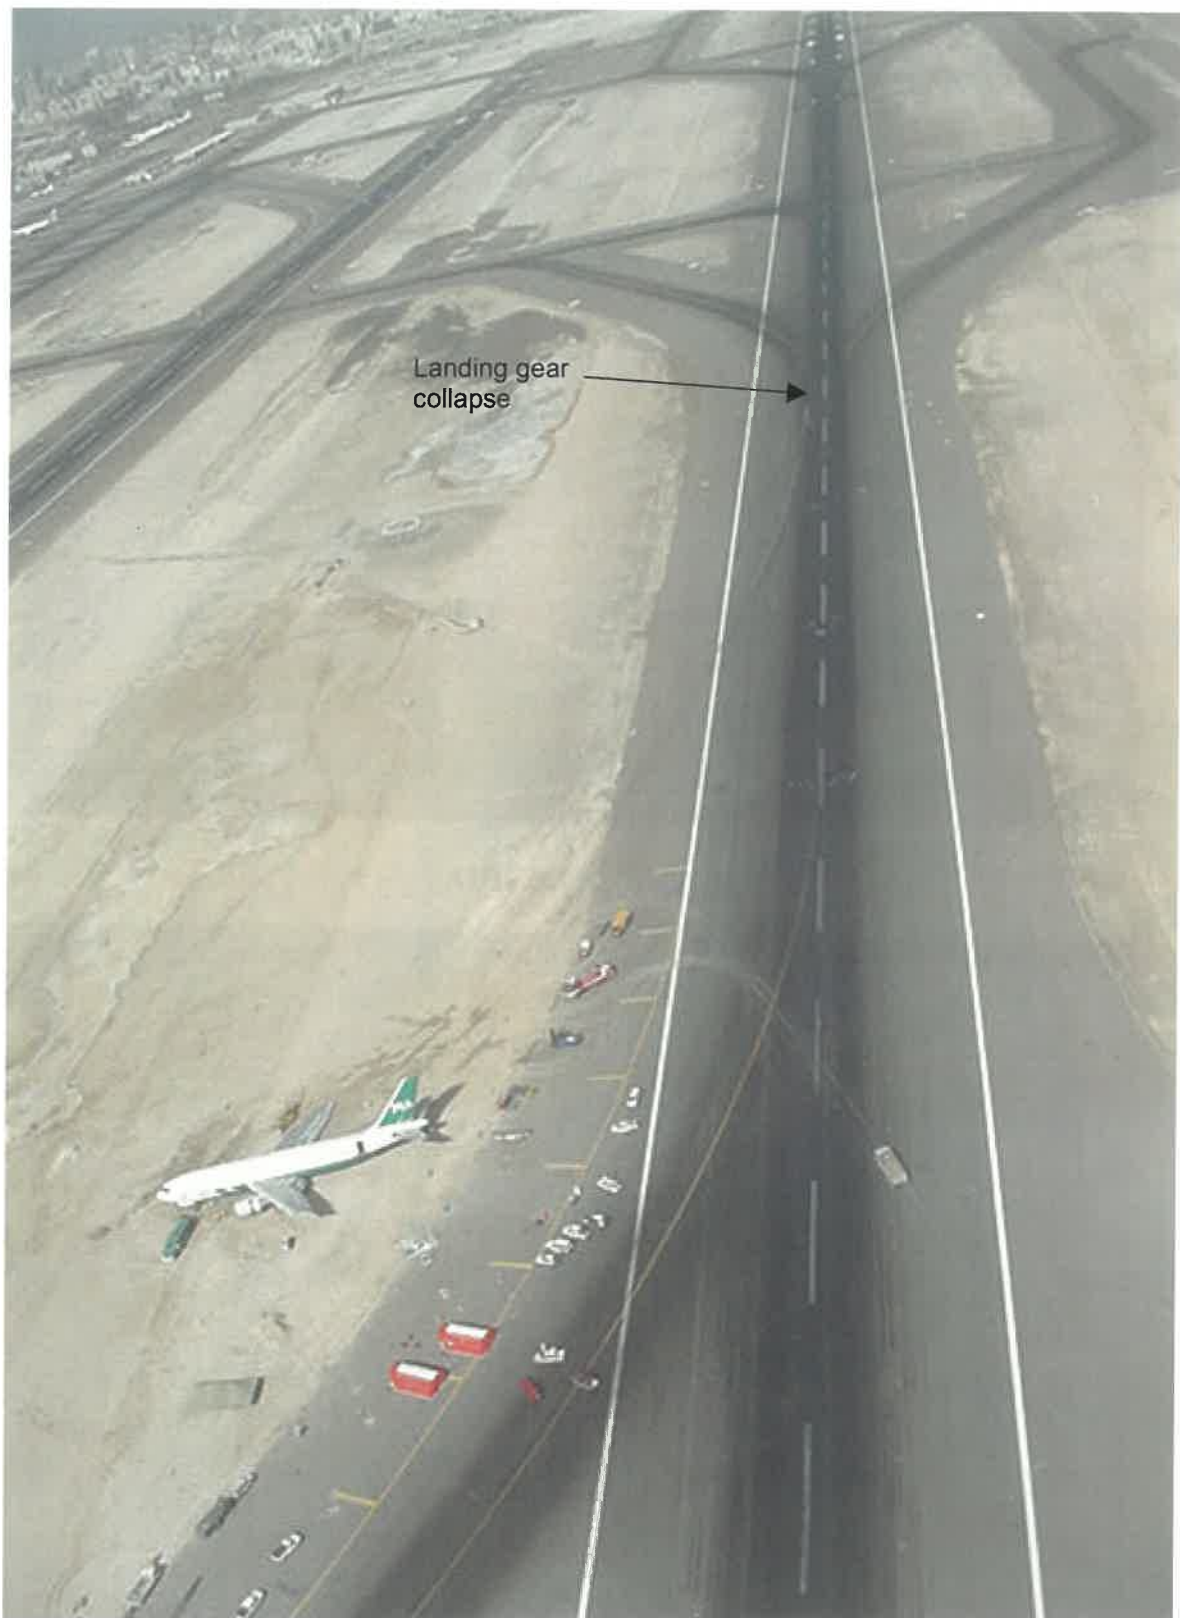
AERIAL VIEW

The right landing gear collapsed rearwards when the aircraft was decelerating along the runway. As it collapsed, the right engine and right flap tracks contacted the runway and were damaged. As the aircraft left the runway onto the unprepared sandy surface, the right engine was further damaged and pushed upwards into the leading edge of the wing.

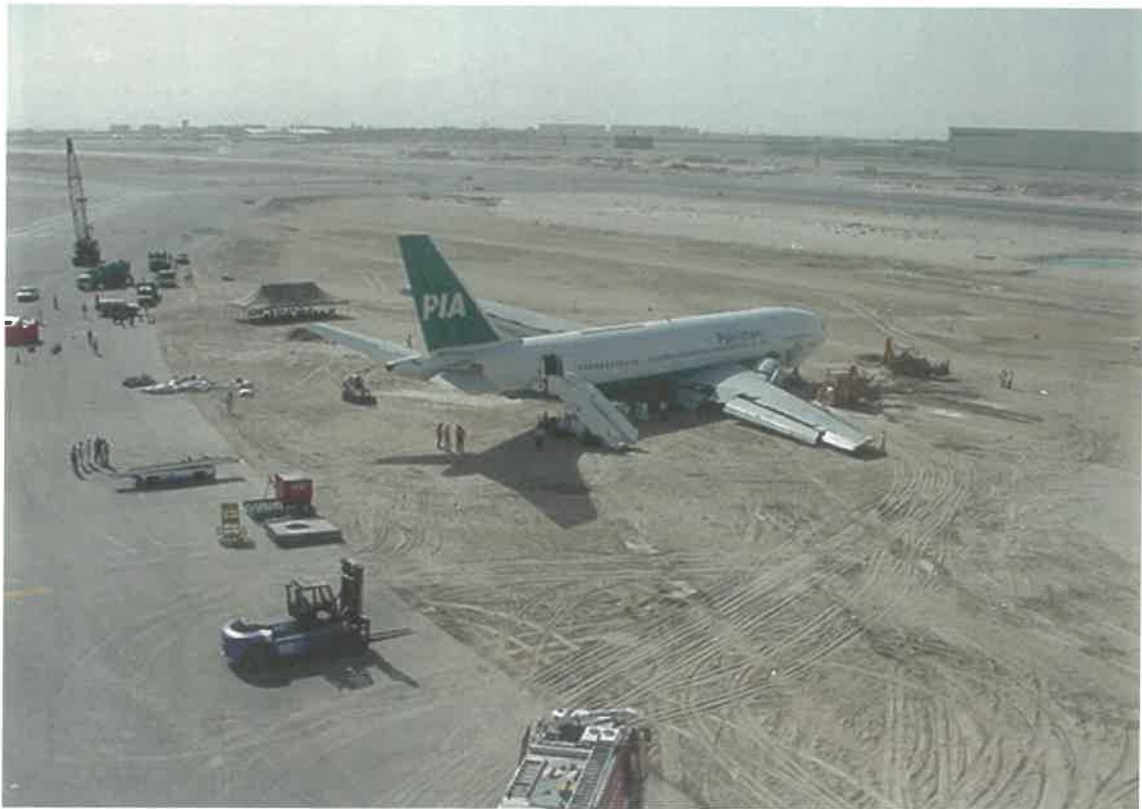
**AIRCRAFT RHS**

The lower section of the right engine suffered scraping damage and the engine was then further damaged by impact with the unprepared sandy surface. The engine did not separate from the wing but was forced upwards into the pylon and wing leading edge. The left engine was undamaged.

The leading edge of the right wing was damaged by the right engine and the leading edge slats were forced back to their retracted position. The flap tracks on the right wing all suffered scrape damage after contact with the runway surface and sand. The right inboard trailing edge flaps were damaged by the wheels of the collapsed right landing gear. There was evidence of damage to the wing tank above the right landing gear. The left wing was undamaged.

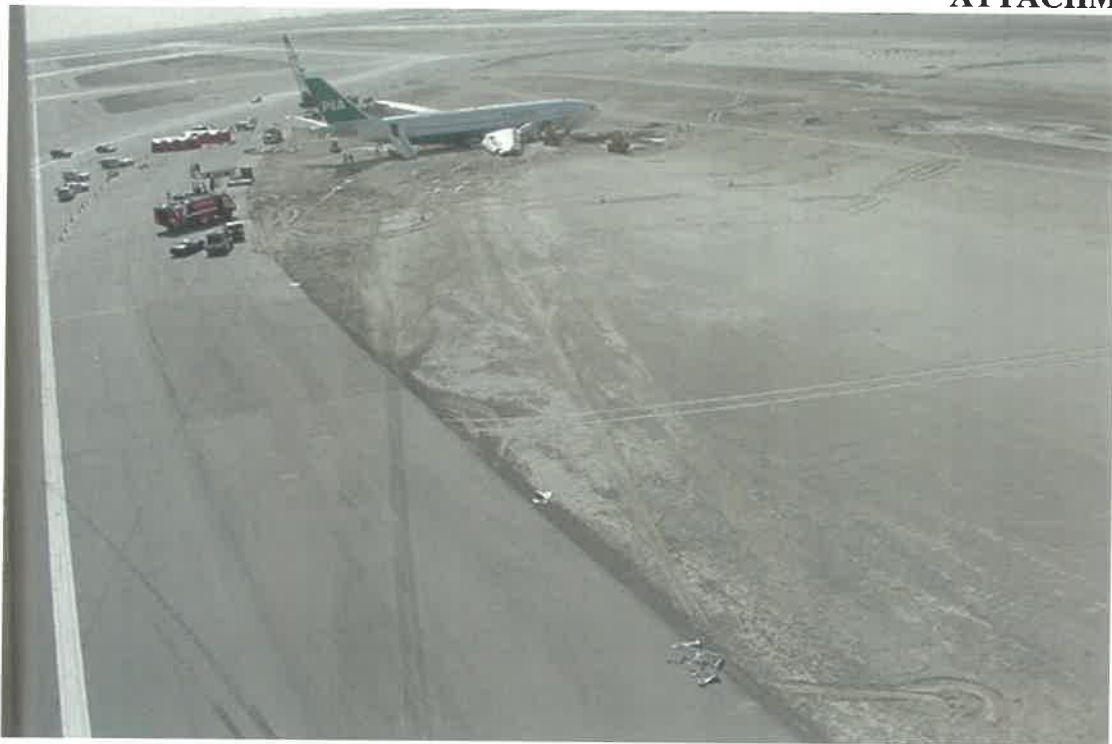
**DEPARTURE OFF RUNWAY**

The first impact information was a series of gouges found on the runway surface from 1395-1575 m from the runway 12 L end. Pieces from the right landing gear hinge arm were found on the runway from 1515-1530 m and 1590 m from the runway 12 L end. The aircraft touch-down tyre marks on the runway were not determined. The first identifiable tyre mark was at 2230 m where the right landing gear twisted inwards and backwards. The second mark was a green paint scrape on the runway centreline at 2250 m where the aircraft fuselage touched momentarily. These were shortly followed by right wing flap and right engine scrapes. The aircraft left the runway edge at 2505 m and came to rest at 2700 m heading 210° M. (Refer to Attachment 6)

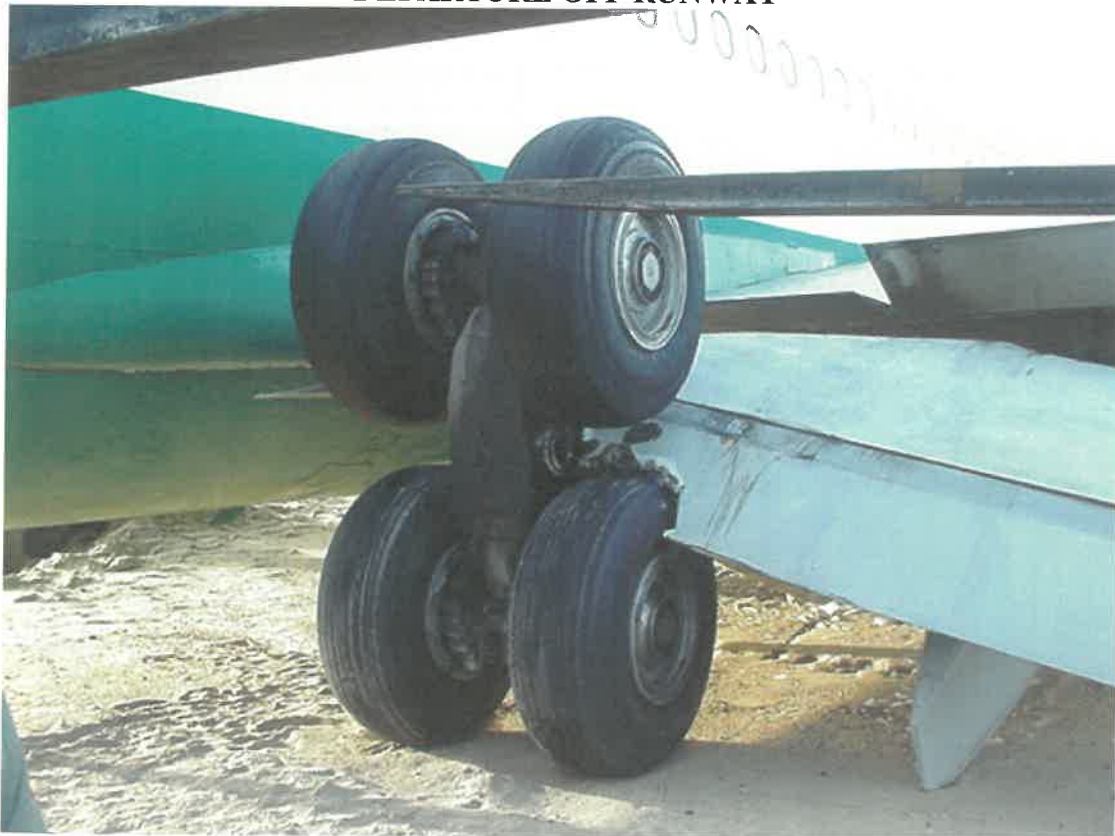
**LANDING GEAR AFTER COLLAPSE**

**1.3.5.2 Right Main.** The right main landing gear had collapsed rearwards and the hinge arm was broken. The down-lock was still attached in the locked position.

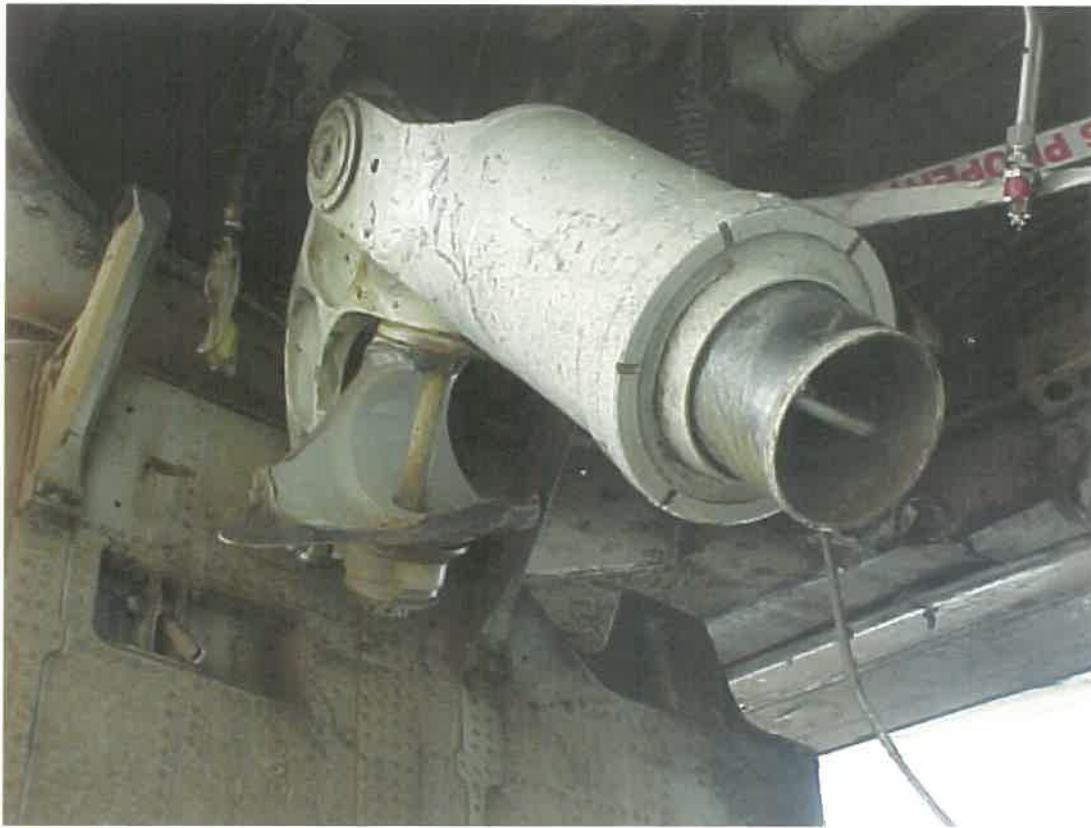
**HINGE ARM FAILURE (ATTACHED TO AIRCRAFT)**

- (a) The hinge arm rupture was the consequence of two main fatigue cracks in the lower part of the blending radii of the lateral trunnion. The cracks reached 2.75 mm and 1.3 mm depth prior to the final static rupture of the hinge arm.
- (b) The size of crack calculated as being critical and capable of rupturing the hinge arm when under an operating load was determined to be 1.7 mm.

- (c) These cracks initiated from two separate corrosion pits, located on the surface of the base metal, measuring 0.15 mm and 0.11 mm depth.
- (d) In addition to these two main crack initiation points, several corrosion pits were noted in the same area of the rupture. Fatigue cracks had also developed from some of these corrosion pits.

The right landing gear collapsed as a consequence of hinge arm failure due to two main fatigue cracks initiated from two separate corrosion pits.

The corrosion pits, which led to the fatigue failure, occurred during the overhaul at the PIA engineering facility.

PIA is recommended to strictly adhere to the Airbus A300 B4 maintenance practices during the overhaul of components.

Airbus, in consultation with the landing gear manufacturer, is recommended to define the acceptable period of time between the stripping of the protective treatment and the application of another protective treatment on the hinge arm component.

Airbus, in consultation with the landing gear manufacturer, is recommended to ensure the CMM is amended to include the acceptable period of time in recommendation 4.3 above and to include adequate warnings regarding the protective treatments.

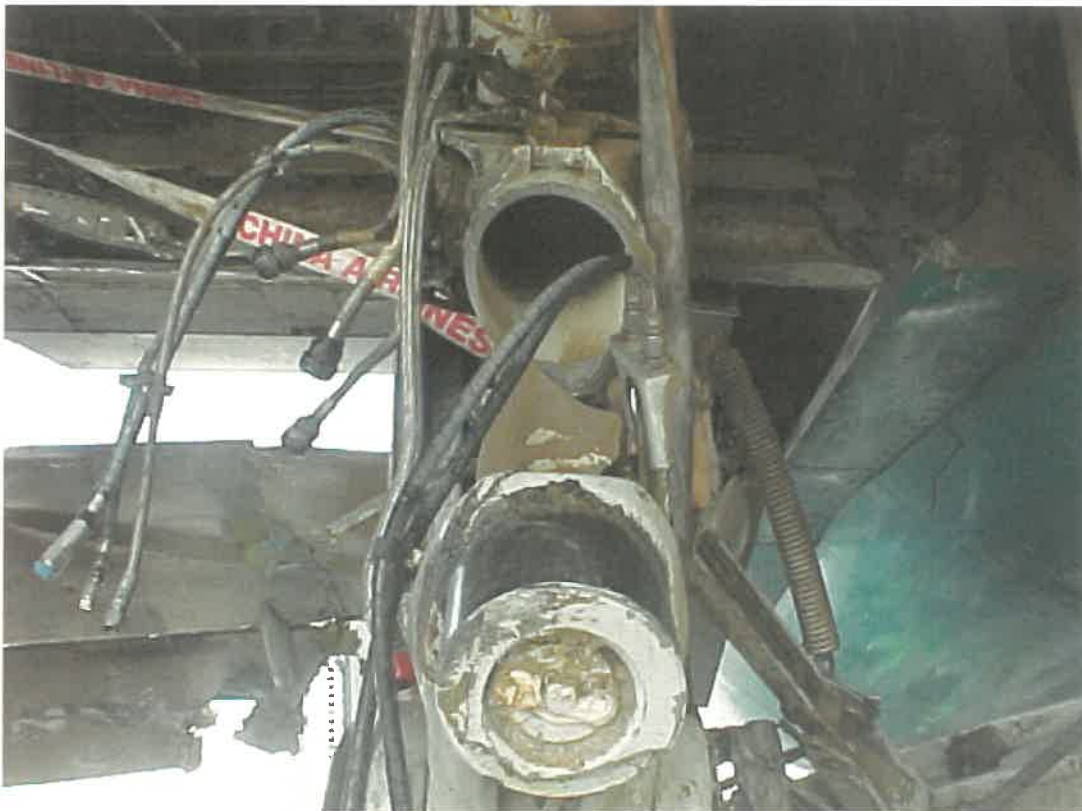
**HINGE ARM FAILURE (SEPARATED FROM AIRCRAFT)**

- (e) From measurement of the striations, it was estimated that the longer crack propagated during approximately 1900 landing gear cycles and the other crack during approximately 1700 cycles. Considering that a flight is two cycles (a take-off and landing), cracks propagated during a minimum of 950 and 850 flights respectively.
