**PAKISTAN CIVIL AVIATION AUTHORITY**  
**(SAFETY INVESTIGATION BOARD)**

**FINAL REPORT**

**ACCIDENT OF ULTRALIGHT "FLIGHT STAR-II"**  
**AIRCRAFT REG: AP-ZAK, OF M/S ULTRA LIGHT AND SPORTS**  
**FLYING CLUB (USFC) PAKISTAN, ON 05<sup>TH</sup> JULY 2012,**  
**AT WALTON AERODROME, LAHORE**

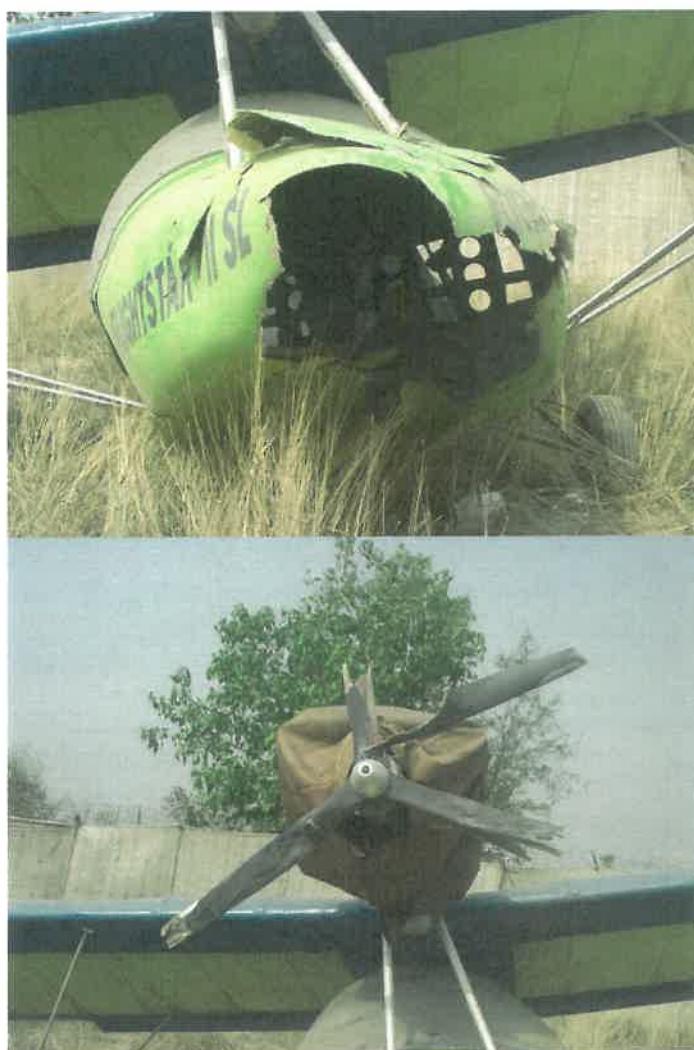
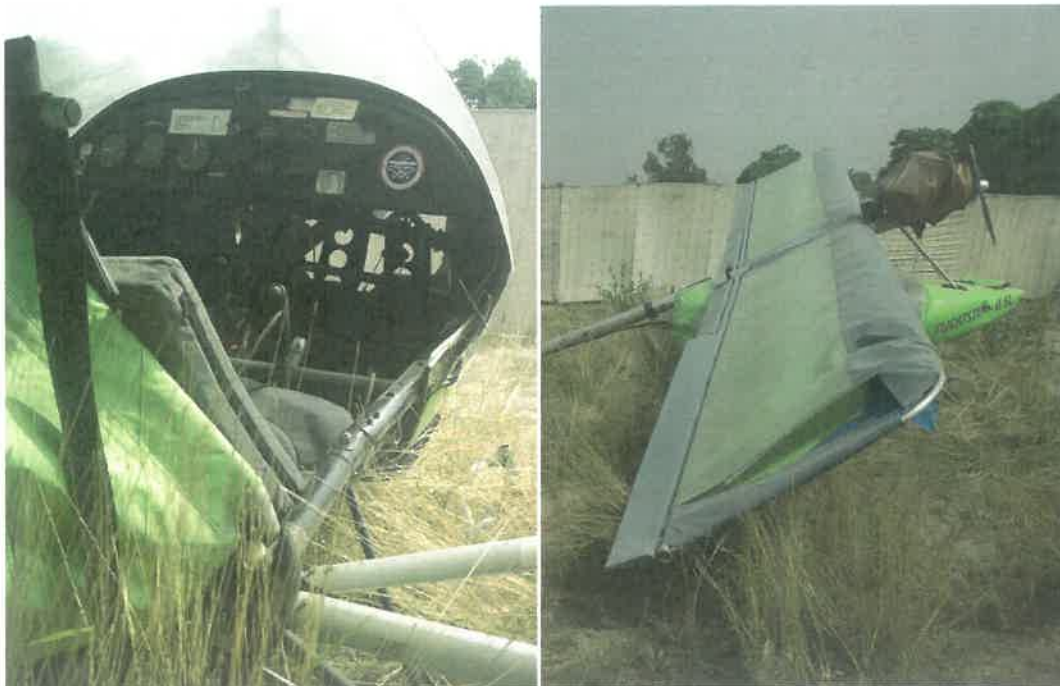
- 1.10 **Flight Register:** The solo circuit and landing training flight of SP was duly recorded and authorized by Ultra light and Sports Flying Club.
- 1.11 **Impact Information:** The mishap aircraft after hopping over the boundary wall / fence of Walton Aerodrome impacted ground in Falcon Complex area in a shallow nose down attitude in almost wings level state. The aircraft suffered severe structural damages along with ruptured nose, broken landing gears and engine propeller. The photographs depicting various serious damages on mishap aircraft are appended below:

- 2.2.5 The details of damages recorded on forced landing site included broken propeller blades, nose landing gear fork leg, right main landing gear bungee cord for suspension and ruptured aircraft skin from two places / locations (Refer Appendix "F").

- 2.2.6 All these apparent damages to the structure of mishap aircraft were the result of impact with boundary wall at Walton Aerodrome.
- 2.2.7 USFC engineering management repaired and recovered the aircraft without formal release of aircraft for recovery by Safety Investigation Board (SIB) CAA Pakistan.
