- 1.1 Nationality & Registration Marks : AP - AOJ
- 1.2 Aircraft type : Cessna - 320A
- 1.3 Engine type : Continental TSIO470B
- 1.4 Certificate of Registration Number : 336

3. SUMMARY OF ACCIDENT/INCIDENT.

DAMAGE REPORT OF CESSNA-320 AIRCRAFT  
AP-AOJ OF RAWALPINDI FLYING CLUB

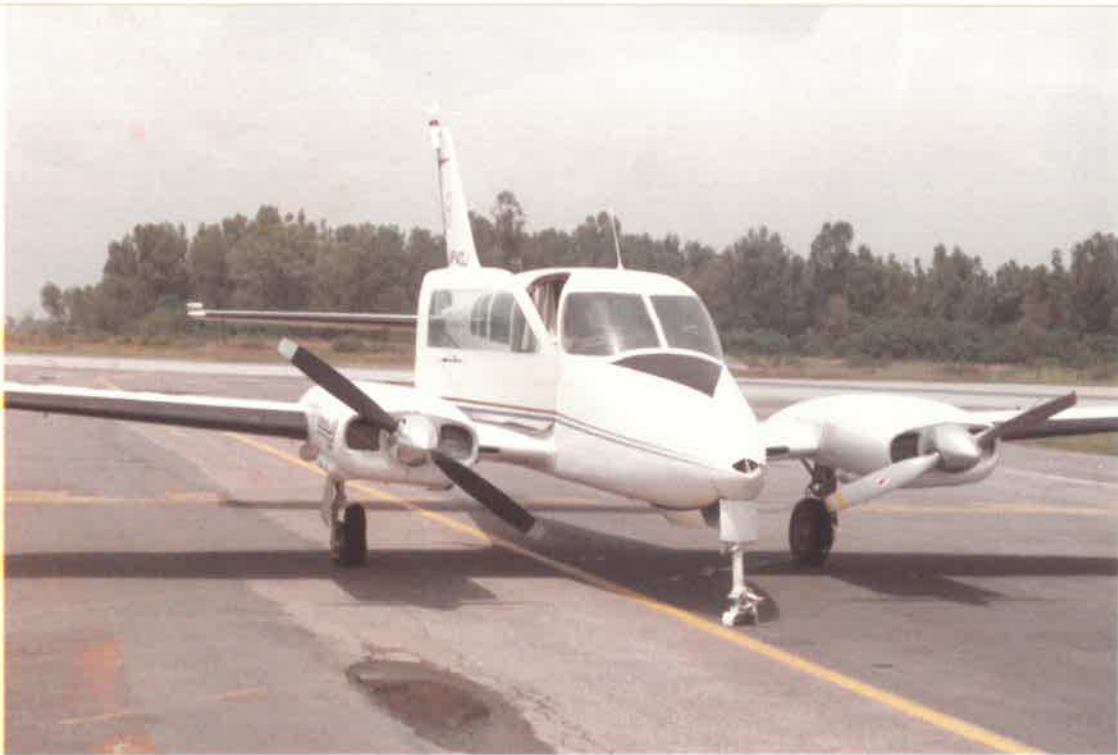
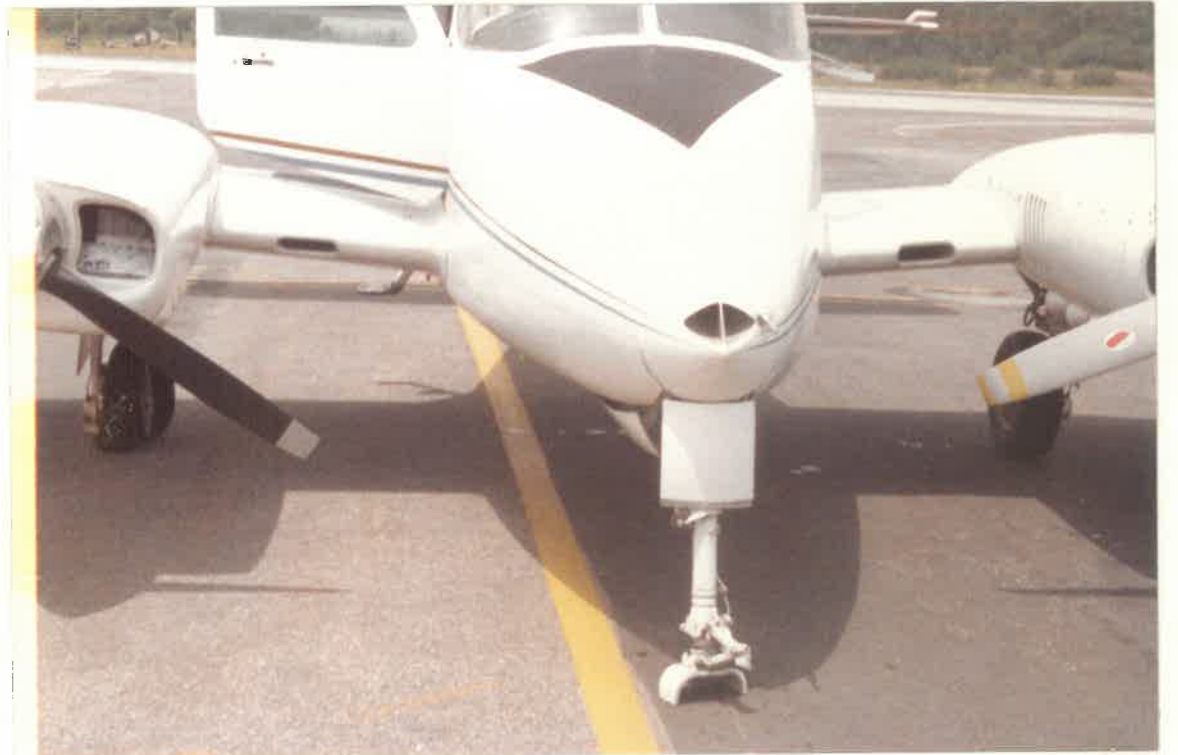
AIRCRAFT PARKED ON TAXIWAY 'BRAVO'

Yoke of nose landing gear broke. Rubbing marks of the same were visible on the runway for about 700 ft (i.e. between 3600 ft and 4300 ft of runway 12). Because of this breakage, tips of both blades of L/H & R/H propellers rubbed against the runway and were bent rearward. Because of braking action by Pilot for controlling /stopping aircraft; R/H main wheel burst due to overheating. Nose landing gear door was also damaged by the separated nose wheel. The aircraft was immediately removed to taxi way 'Bravo', to clear the runway, by PAF authorities.

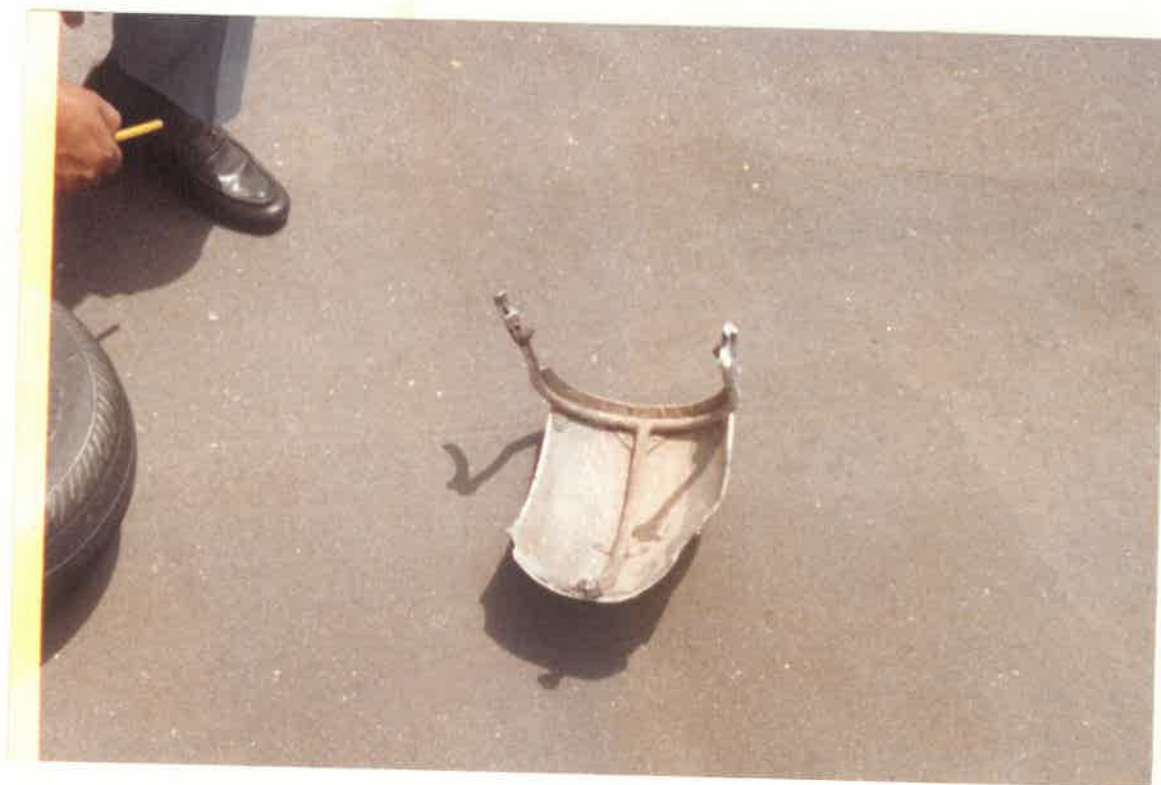
- 17.2 'Axle bolt bucket' had to be removed with lot of force and 'spacer' was found damaged. Pieces of mounting holes of the yoke were found pressed to the 'axle bolt bucket' fixed to the mud guard and scraper assembly attachment points. Signs of overheating were noticed on these pieces. Examination of parts revealed extensive corrosion on 'axle tube' under 'bearing cup'. 'Bearing cone' was also found to be corroded. Moreover, bearing was found to be dry (i.e. lack of grease) and partially seized. Signs of overheating were also noticeable. Detailed damaged report is attached as Appendix 'A'.

- l) Mounting holes in yoke separated from the yoke and were found in pieces. Signs of overheating were also noticed on pieces of these holes.
  - m) 'Spacers' were found to be damaged.

- n) Pieces of mounting holes of yoke were found pressed to the axle bolt buckets.

MUD GUARD AND SCRAPER ASSEMBLY. PIECES OF MOUNTING  
HOLES OF YOKE ARE FIXED TO ITS ATTACHEMENTS POINTS.

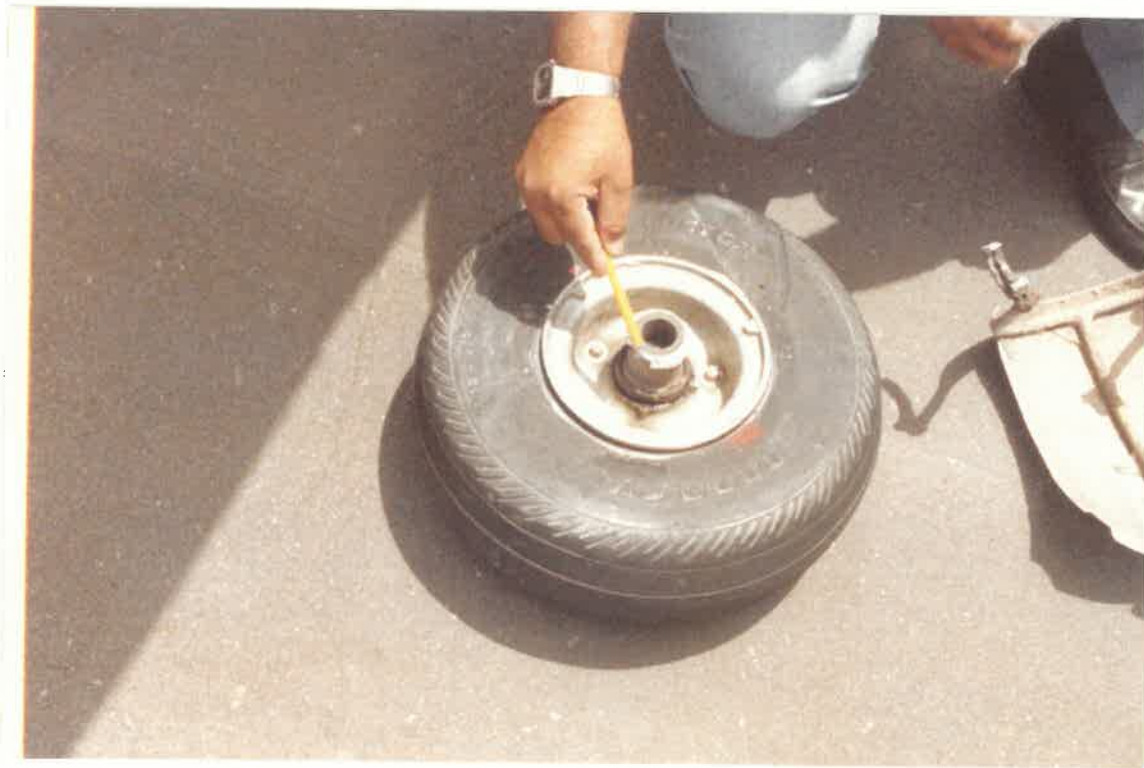
NOSE WHEEL. SPACER DAMAGE IS INDICATED (LEFT SIDE)

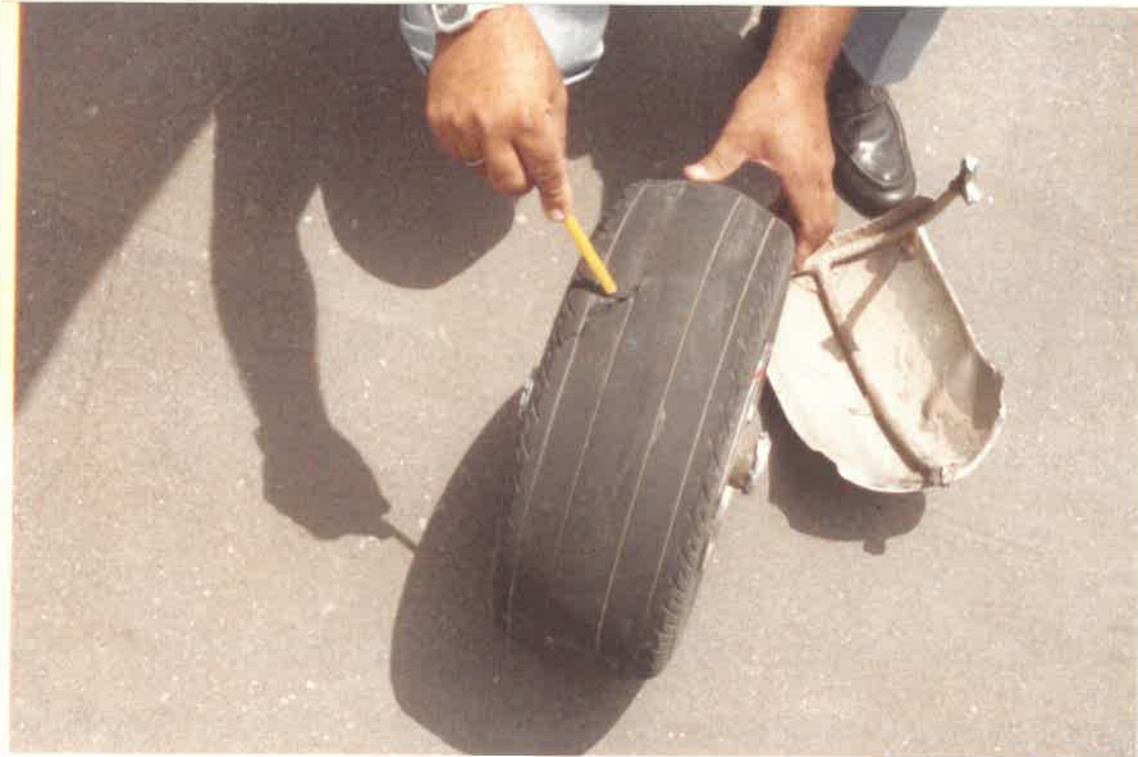
- 17.4 Investigation clearly established lack of servicing/maintenance on "Nose wheel and tyre assembly". It would be worth mentioning here that the wear on Nose wheel tyre was uneven. It was less in the centre and more on both sides. Cut on the nose wheel tyre and tube was due to impact with the nose landing gear door.
- 17.5 Contributory factor to this incident is exposure of aircraft to vagaries of weather since Rawalpindi Flying Club does not possess hangar for housing and maintenance/repair of aircraft.

- c) L/H eye bolt of 'mud guard and scraper assembly' was found to be loose.
  - d) Dust covers were found missing.
  - e) Cuts on the tyre.
  - f) Tube was found to have very long cut circumferentially.

CUT ON THE TYRE OF NOSE WHEEL.
