**PAKISTAN CIVIL AVIATION AUTHORITY**  
**(SAFETY & INVESTIGATION BOARD)**

**SERIOUS INCIDENT TO M/S. SCHON AIR CESSNA – 152**  
**AIRCRAFT, REG. # AP-BET (TRAINING FLIGHT)**  
**ON 23 JUNE 2010**  
**AT**  
**NAWABSHAH AIRPORT**

## FINAL REPORT

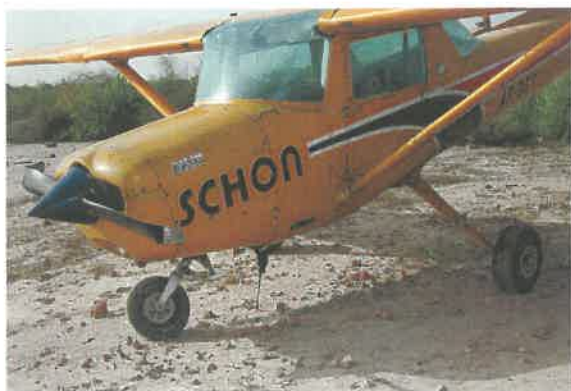
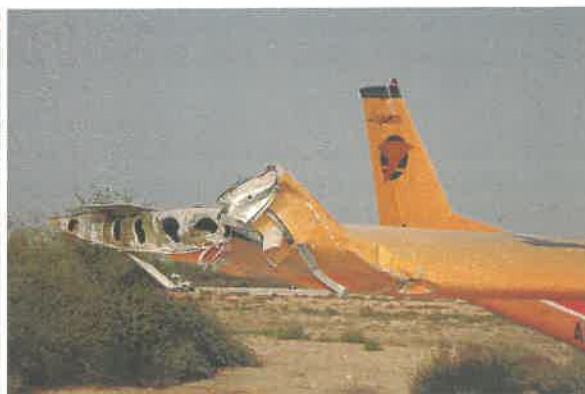
- 1.1 **History of the Flight:** Local Training Flight from Nawabshah airport. Earlier, the aircraft had flown 02 serviceable flights on the same day.
- 1.2 **Injuries to Persons:** No injury to the only crew member on board.
- 1.3 **Damage to Aircraft:** Propeller and nose gear severely damaged, wings leading edges ruptured due to hitting with bushes / trees, and wing tips damaged. Due to extensive damage and stress pattern, the aircraft was declared beyond economical repairs by AME.

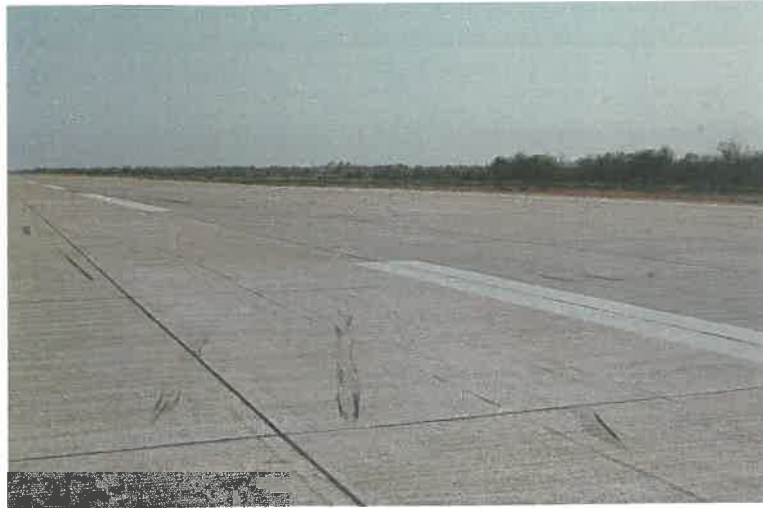
- 1.8 **Impact Information:** There was no impact, as such, observed on the runway surface caused by the landing. However, after landing, aircraft bounced, and at about 4500 feet down the runway, propeller blades touched the runway surface leaving dug marks. Propellers once again touched ground on unprepared surface. Pictorial view indicating tyre marks making appreciable diversion from the RWY centre line is shown as below.
