**ACCIDENT INVESTIGATION REPORT IN RESPECT  
OF M/S SCHON AIR C-172 AIRCRAFT REG.NO. AP-BDU**

**WHICH OCCURRED ON 23RD JUNE, 1998**

**QUAID-E-AZAM INT'L AIRPORT  
KARACHI**

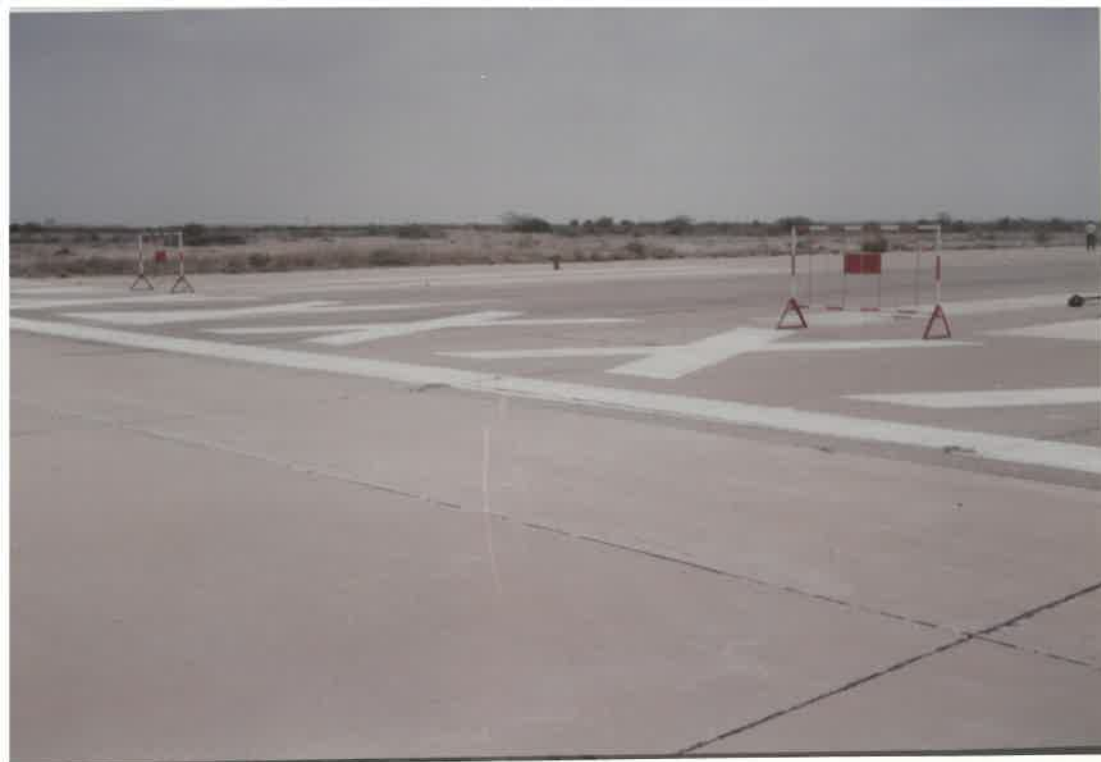
Portion of  
→ stabilizer  
of right size  
was recovered  
from this  
point.

BARRICADES ABOUT 2500 FT DOWN THE RUNWAY.

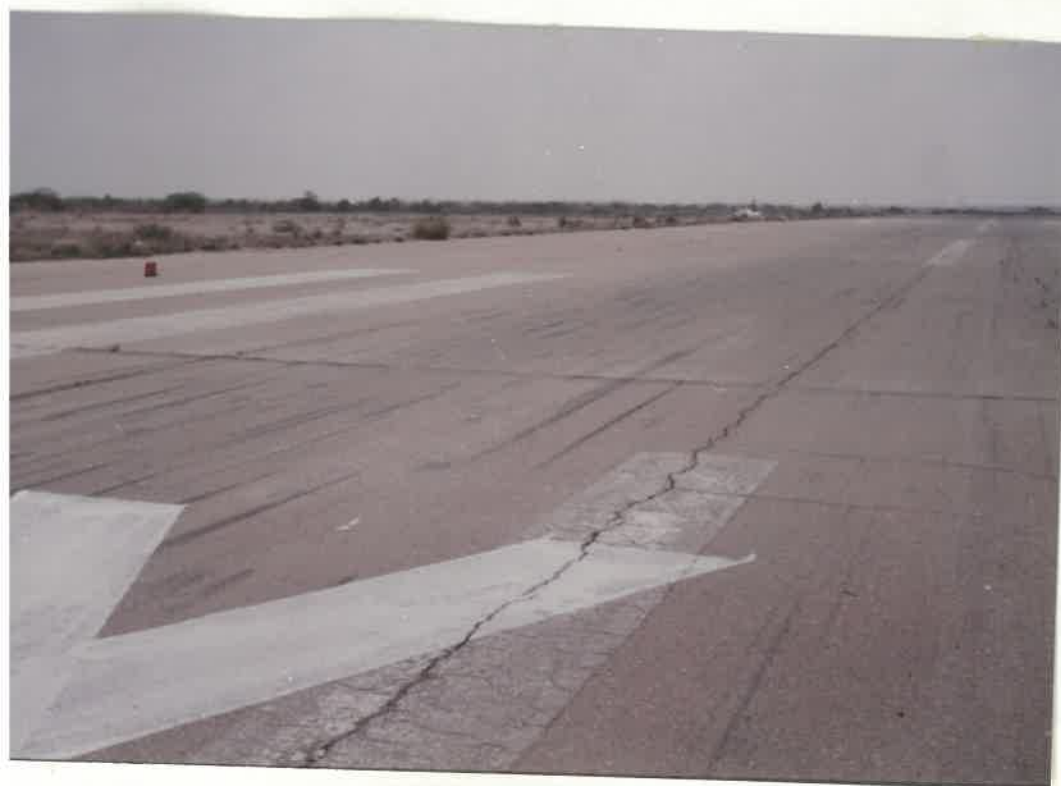
APR-C2

VIEW OF CRASH SITE FROM BARRICADES.

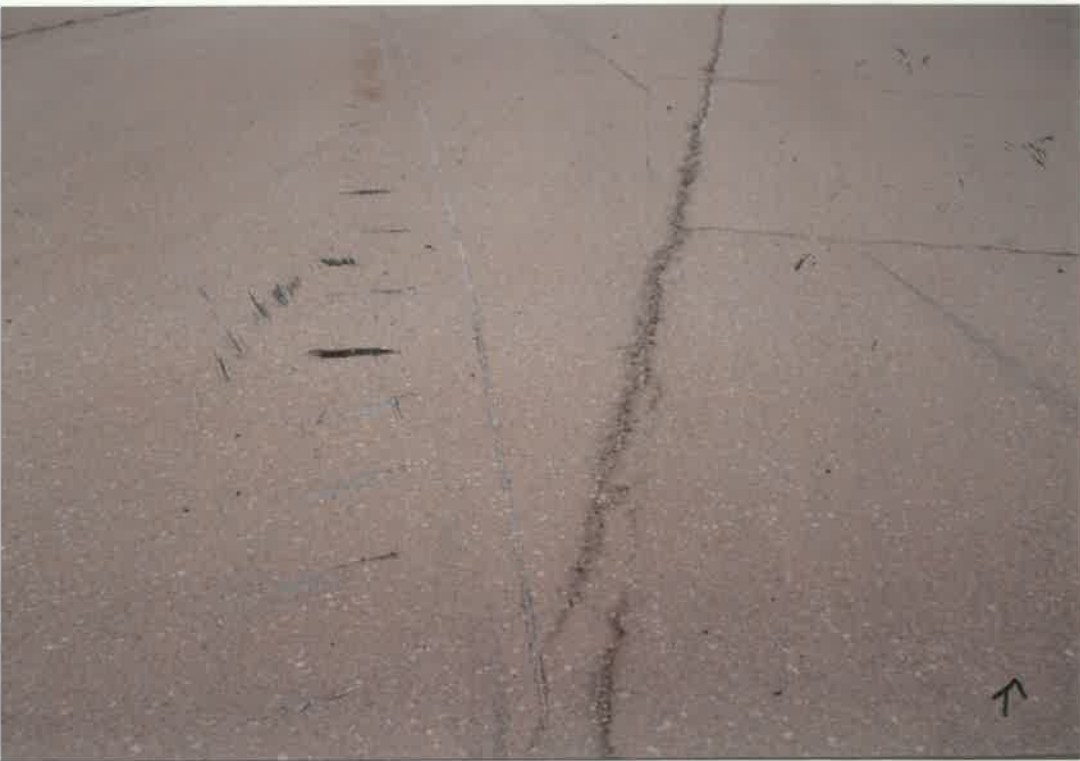
MARKS ON GROUND ABOUT 340FT FROM BARRICADES. ANOTHER VIEW.

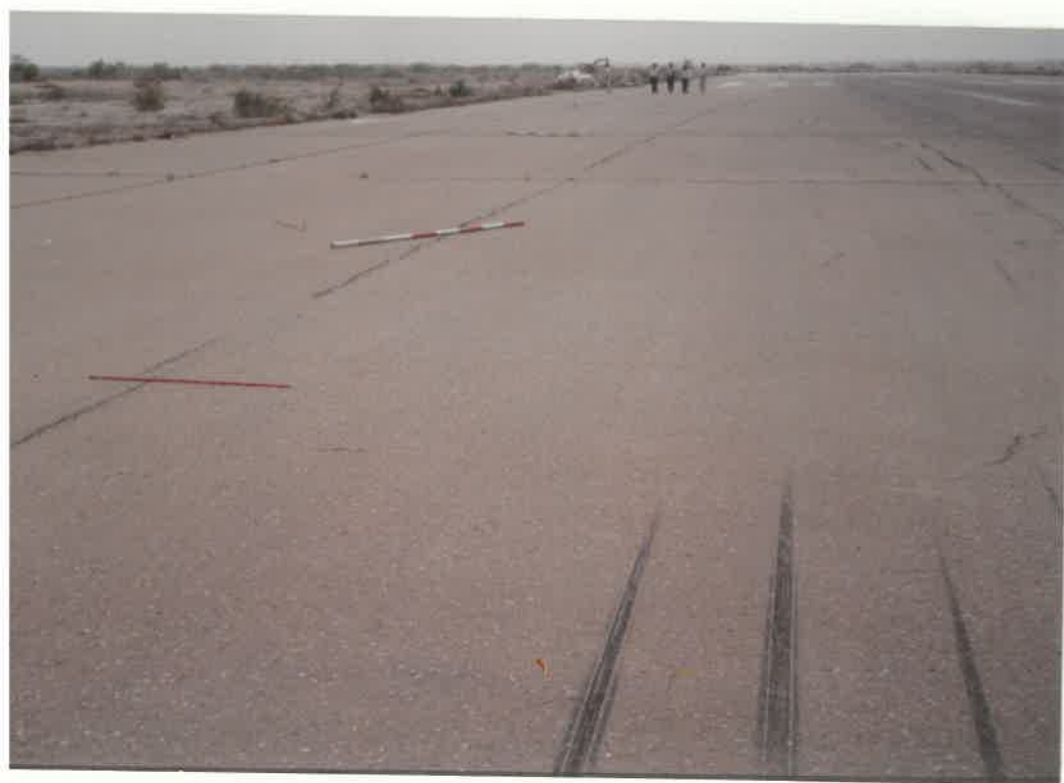
14.6 Inspection of crash site revealed that the aircraft right elevator first impacted the centre barricade, knocking and breaking it down. A portion of right stabiliser was found about fifty feet from the position of the other two side barricades, (Appendix 'C-1'). Broken portions of the centre barricade were lying about 100 feet away. First propeller mark impact was about 340 feet from the barricades (Appendix 'C-2'). The aircraft was lying inverted facing west about 540 feet from the barricade. The right stabiliser portion was found broken and it had red colour embedded in it suggesting that it had impacted the centre barricade first (Appendix 'C-8'). Right elevator half portion was found lying 100 feet from the main wreckage, (Appendix 'C-6'). The cockpit instruments were found compressed but the ASI was serviceable and was recovered. It was sent for testing and found to be satisfactory (Appendix 'H'). The pilot/passenger seats were slightly buckled and right nose wheel had broken off. The propellers were bent forward clearly indicating that they were under torque (developing

BARRICADE BROKEN PARTS.

18.4 Chief Operations Officer QIAP to replace the present barricades with ones with heights of two feet or less.

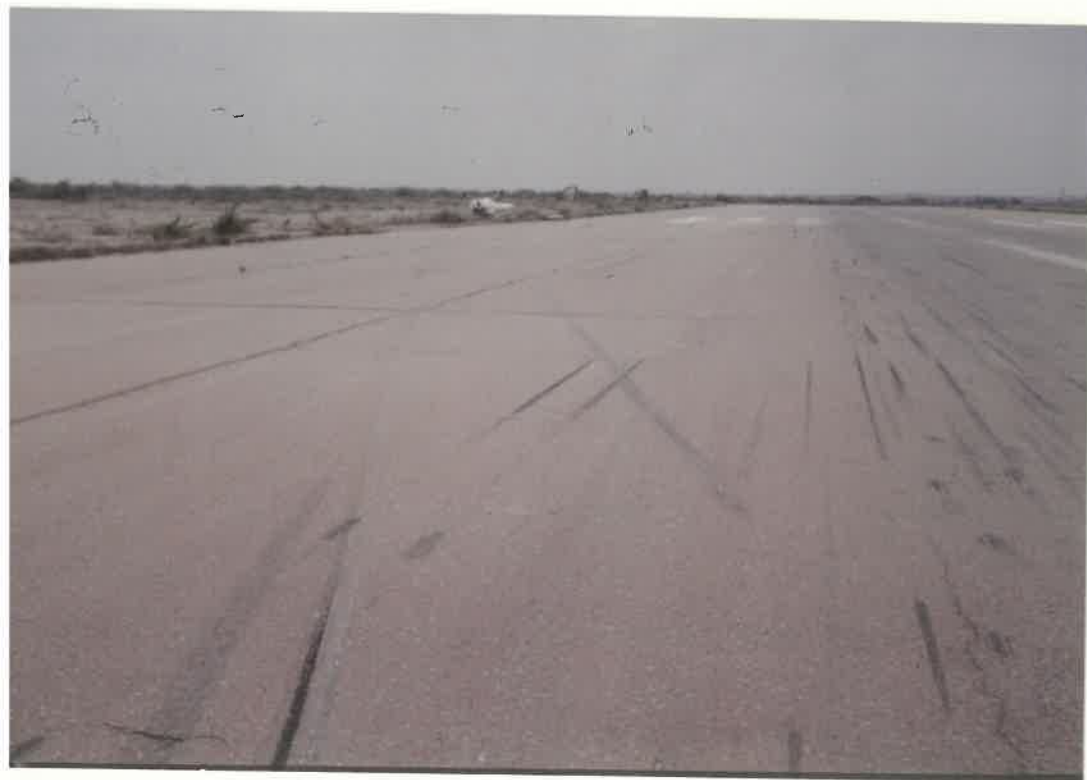
EVIDENCE OF TYRE MARKS ABOUT 180 FT FROM THE AIRCRAFT.

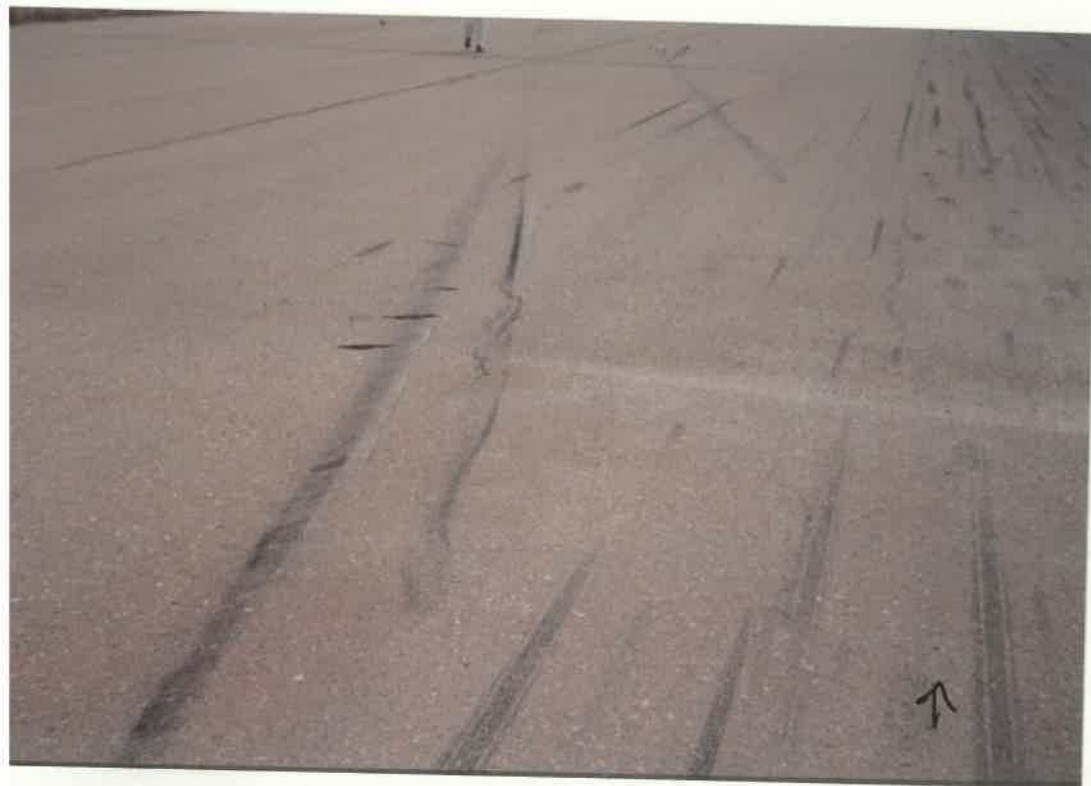
TOP MARKS ON THE GROUND - ABOUT 240FT FROM BARRICADES.

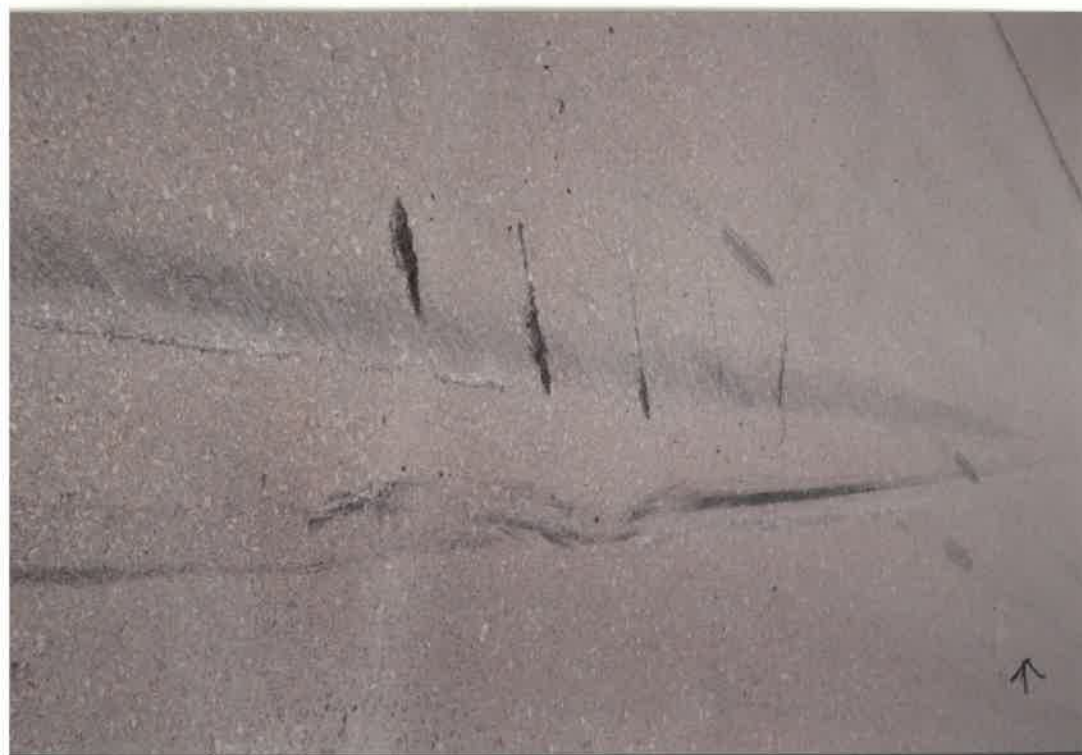
APP-C6

TOP GROUND MARKS ABOUT 240FT FROM THE BARRICADES - CLOSE-UP  
VIEW. NOTE:- TYRE RUBBING MARKS - PATTERN.

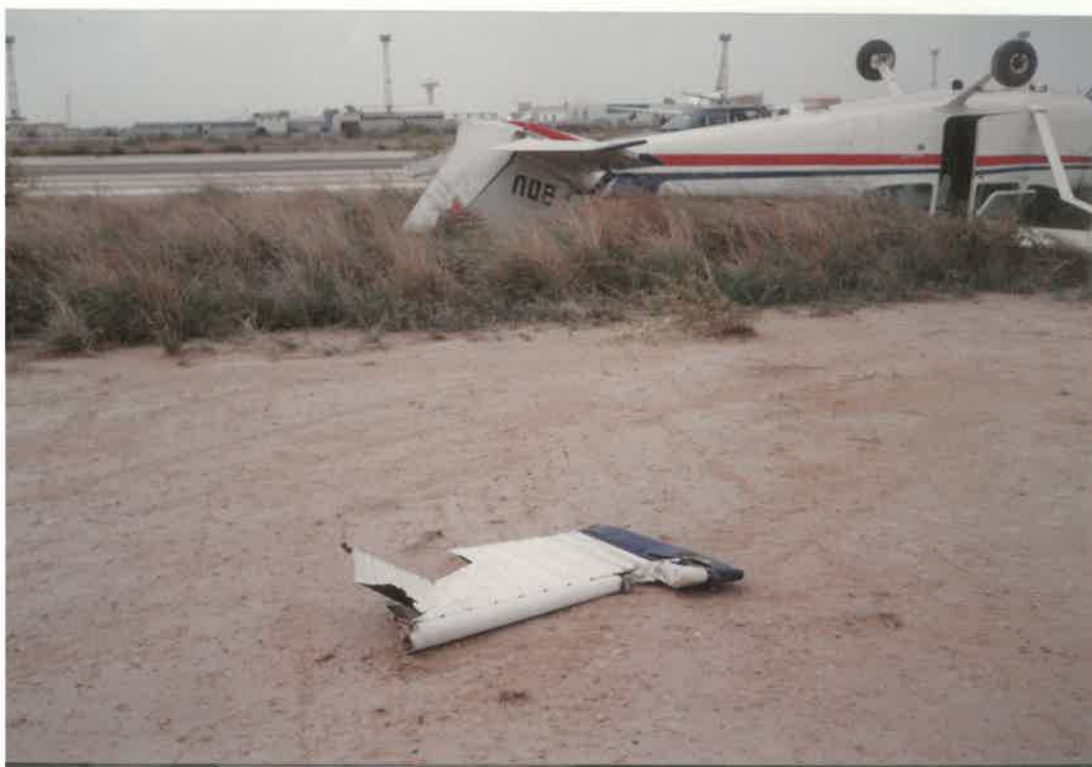
CRASH SITE ANOTHER VIEW

Right  
elevator  
(half  
portion)  
which had  
broken off  
after impact  
with barricade  
and ground.

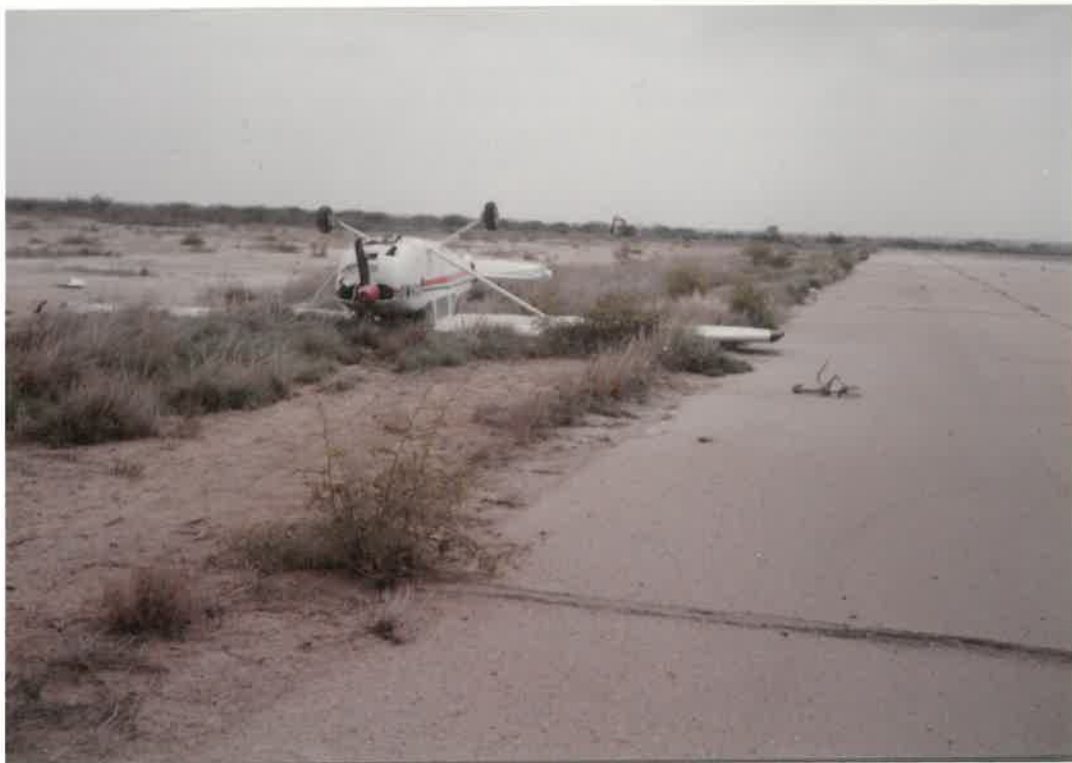
AIRCRAFT CRASHED SITE \_ ABOUT 540' FROM BARRICADES.

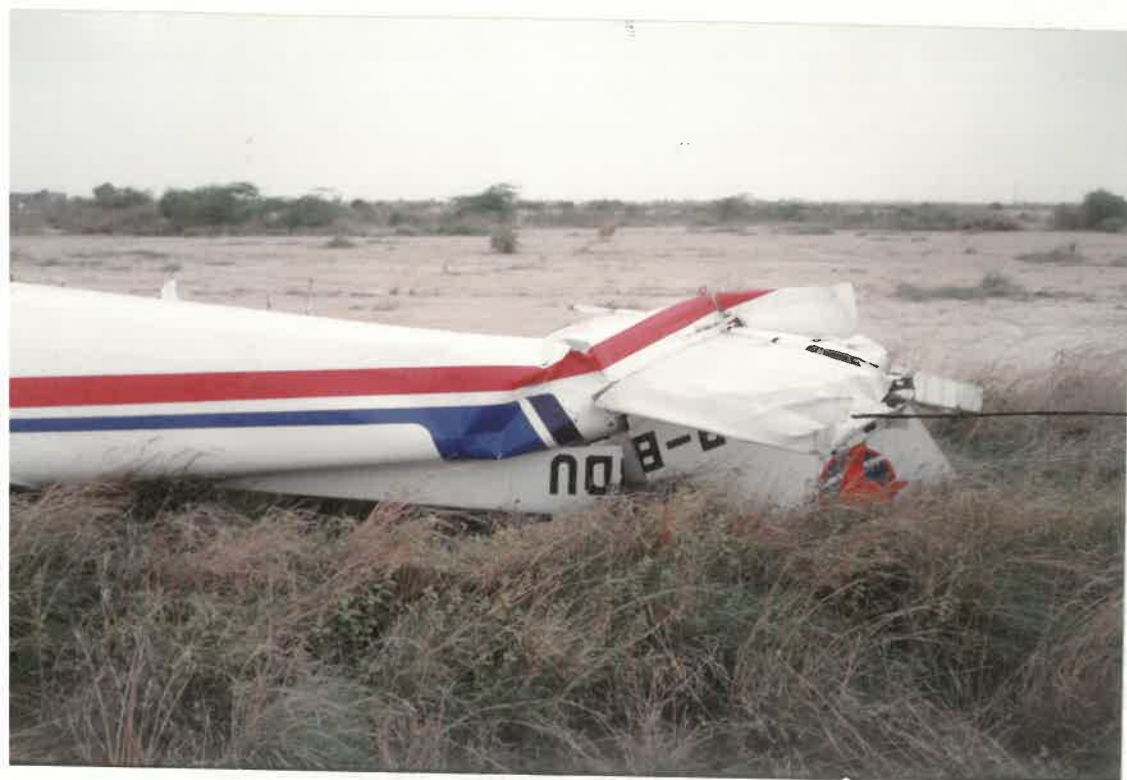
→ Right stabilizer damage (red colour of the barricade was found embedded in the broken portion of the stabilizer)

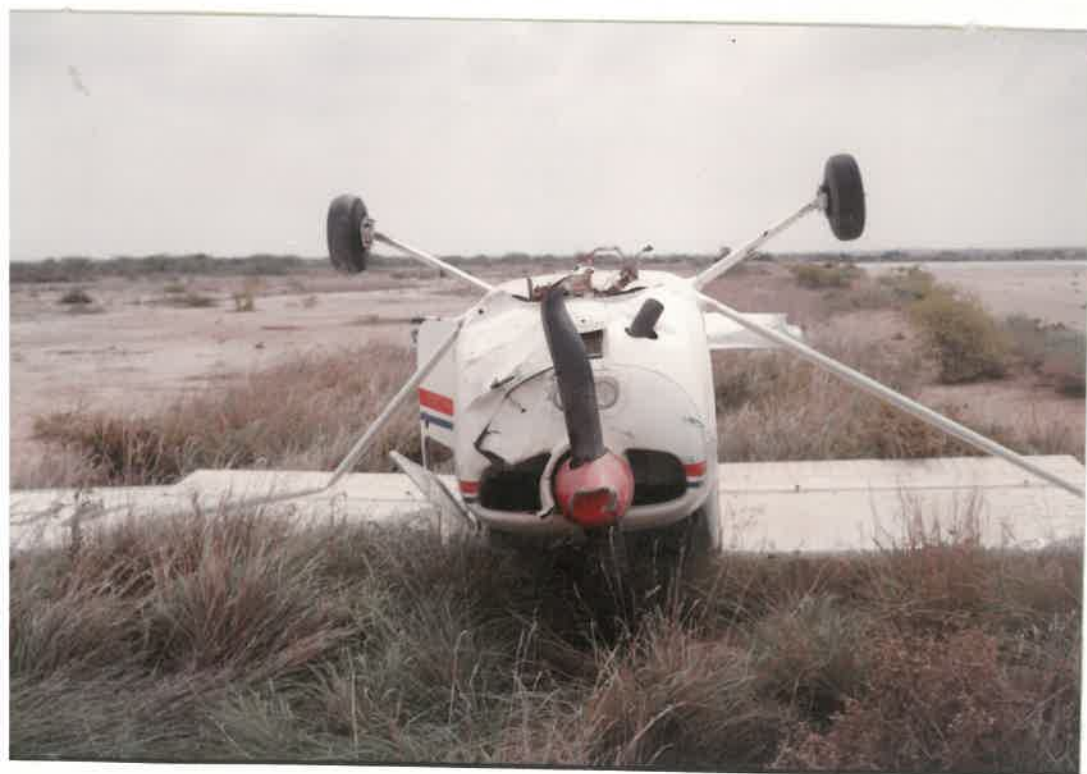
CRASH SITE ANOTHER VIEW.
