INVESTIGATION REPORT INTO THE ACCIDENT CESSNA-150 REG.MK.  
AP-BAR M/S. RAJI AVIATION WHICH OCCURRED ON 18-03-86 AT  
KARACHI AIRPORT.

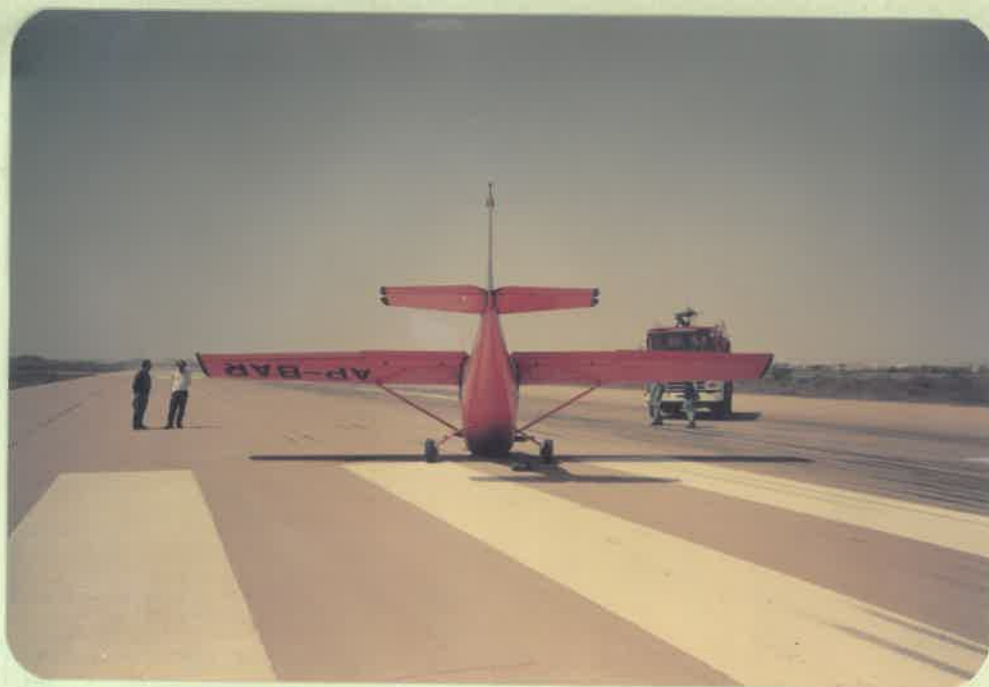
APP K<sub>1</sub>

17.2. The aircraft was identified as C-150 bearing Nationality and Registration Mark AP-BAR. It was found lying at a distance of 2500' from the threshold of runway 25L (the runway in use). It was in a nose down and tail up position. It was facing 268 degrees. The nose wheel had broken and was found at a distance of 350 feet towards North from the main wreckage.

Aircraft position after the accident

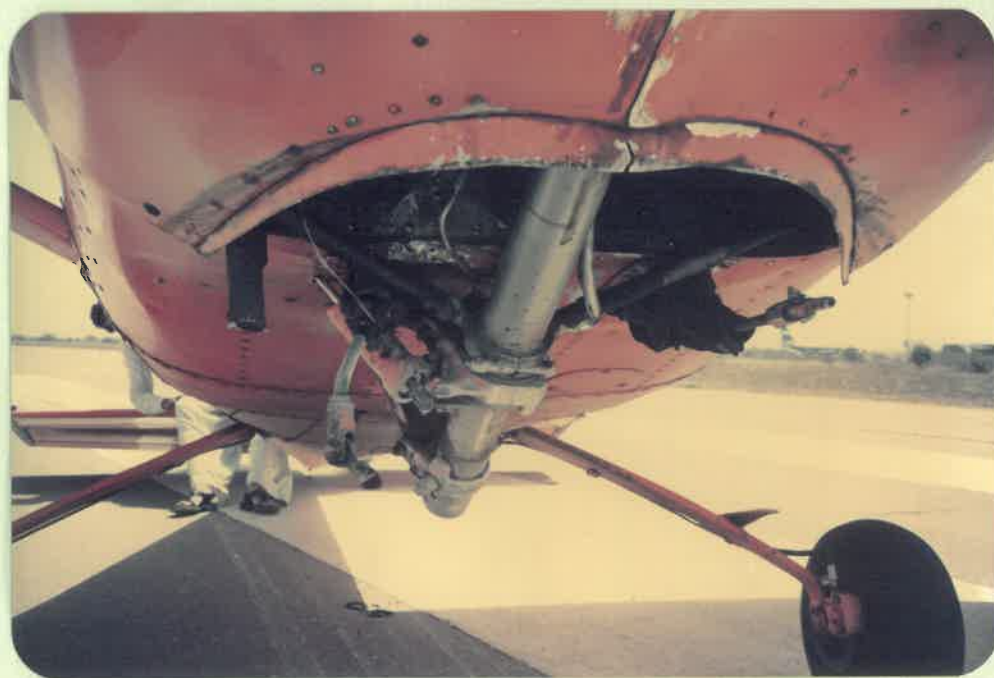
APP. K<sub>2</sub>

12.1. The aircraft AP-BAR was found 2500 from the threshold of runway 25L on the centre line. The nose gear which had broken on impact was found on the Northern side of the runway. After thorough inspection carried out by the Investigators and recording to statement of the pilot, the wreckage was released not being required any longer for investigation.

Photograph showing damage to the nose wheel strut and the point where the nose wheel broke.

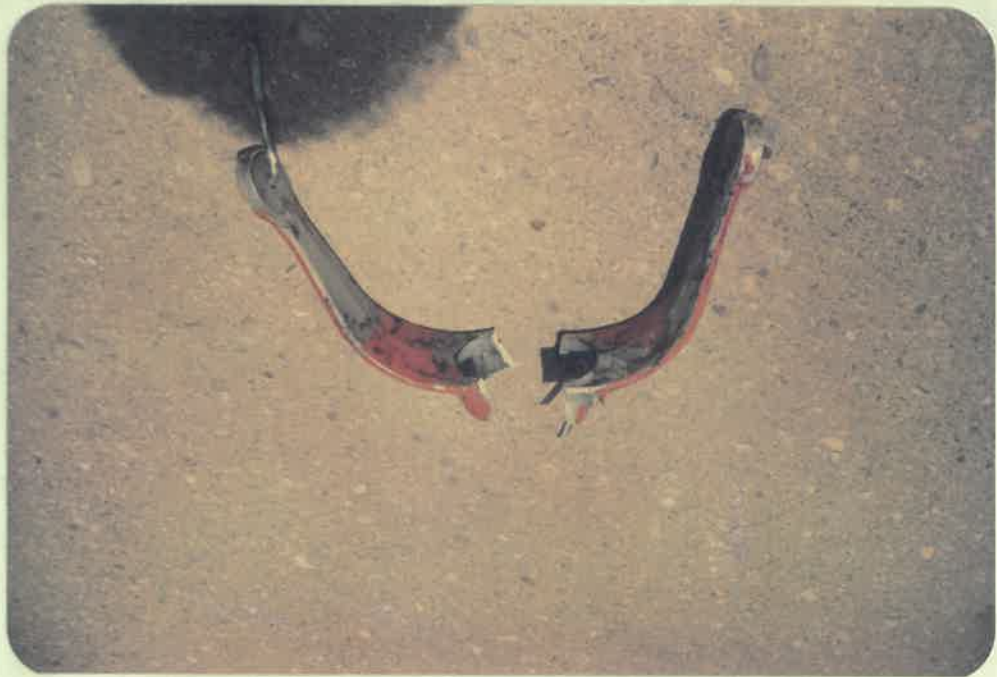
APP. K<sub>3</sub>

Broken nose wheel fairing.

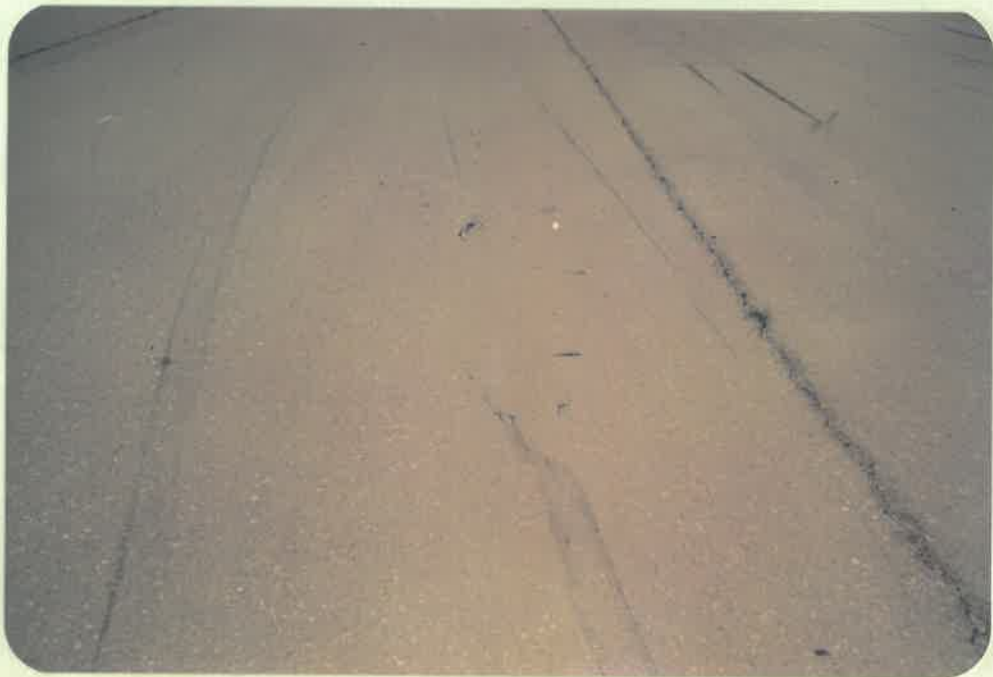
APP. K<sub>4</sub>

The track made on the runway after the nose wheel broke.

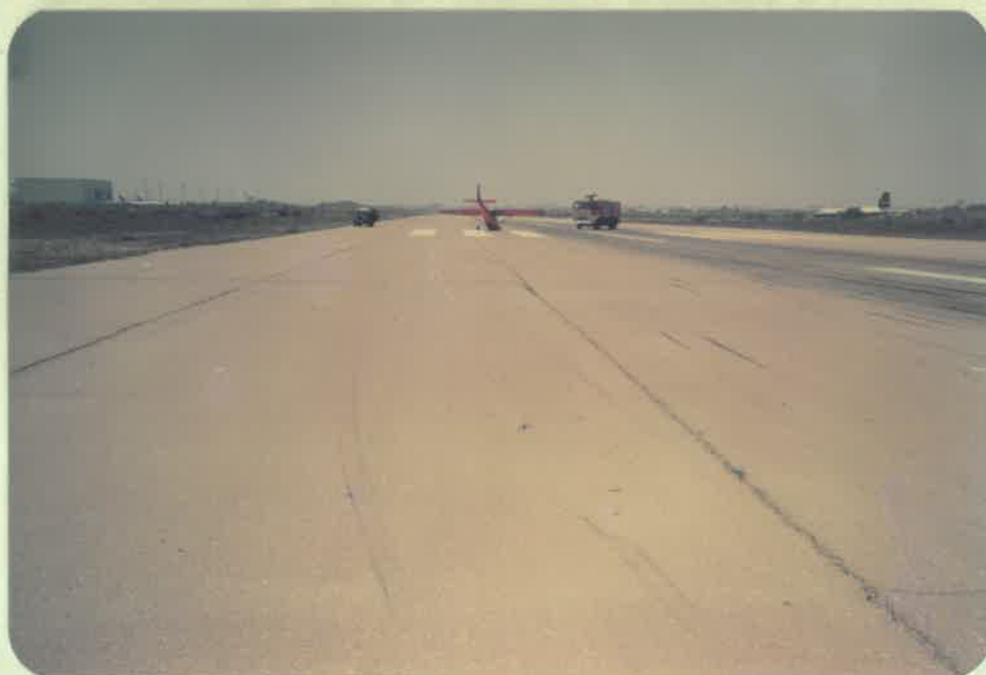
APP. K 5

Another view of the track followed by the aircraft.

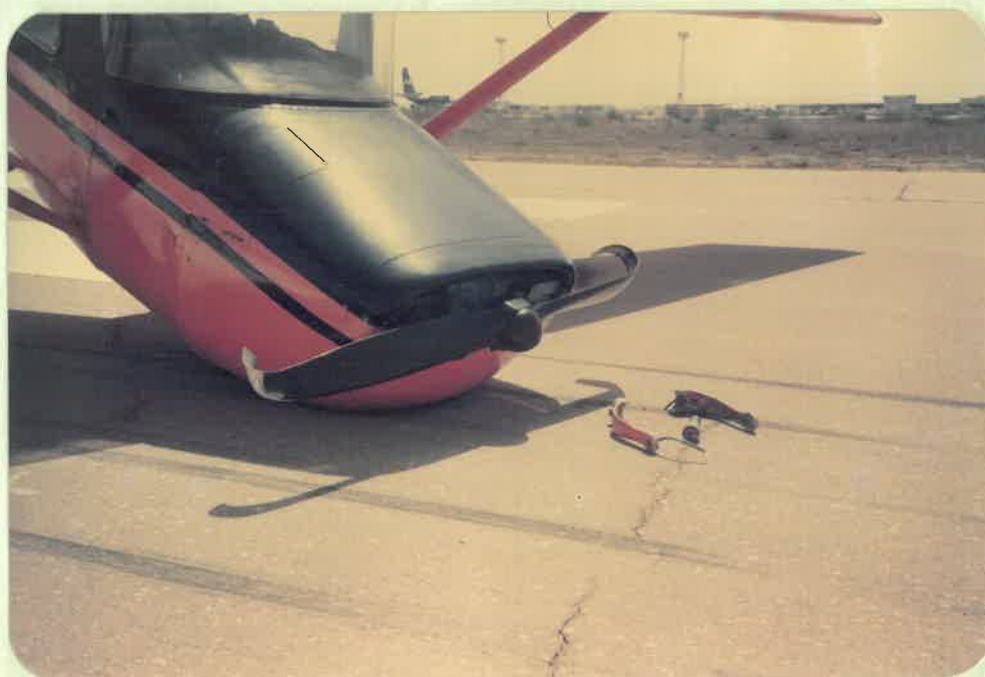
APP K 6

Damaged propeller.

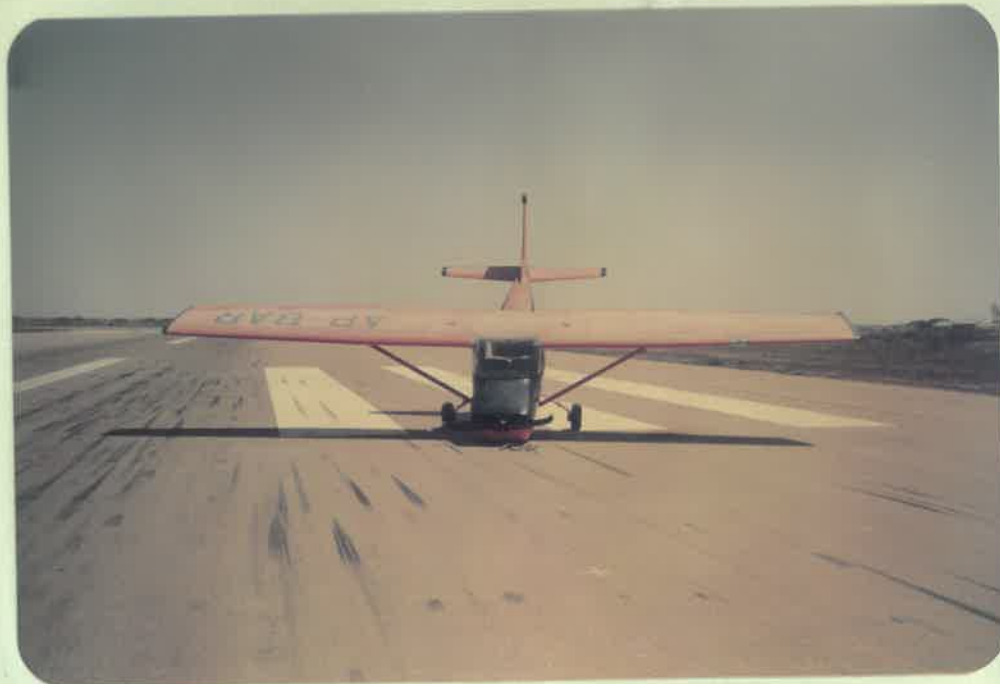
APP K 7

Front view of the damaged aircraft.

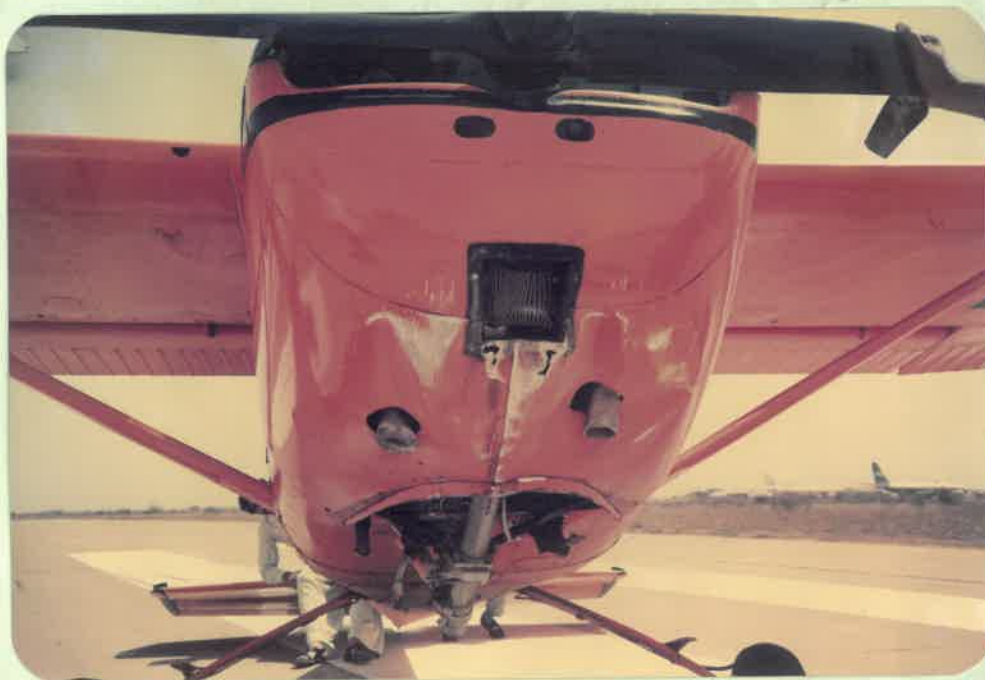
APP K 8

Photograph showing drag marks on the fuselage.

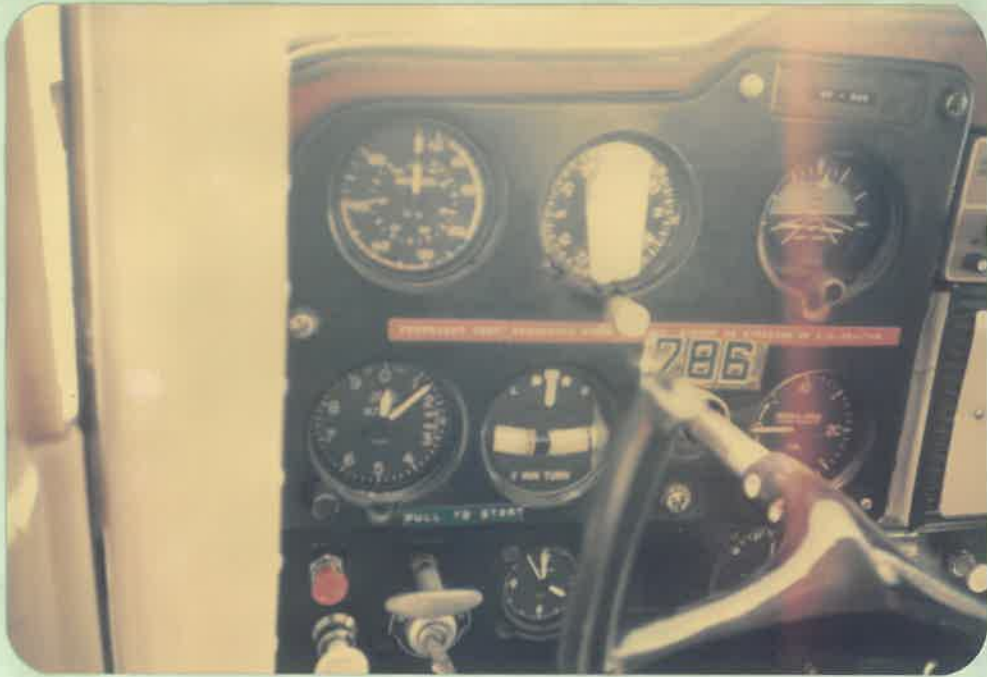
APPK<sub>9</sub>

Cockpit

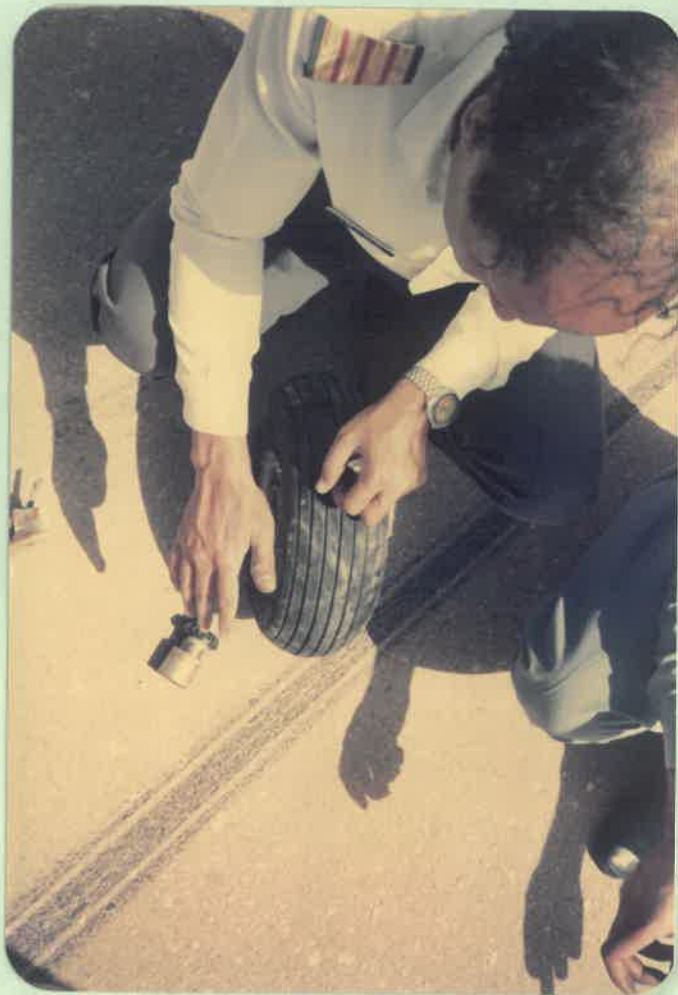
APPK<sub>10</sub>

Deflated nose wheel with its components.
