AIRCRAFT INCIDENT INVESTIGATION  
REPORT  
ON THE GROUND FATAL INCIDENT TO M/S  
P.I.A.C F-27 REG. MKS. AP-BBF  
AT SUKKUR AIRPORT  
ON  
15TH JUNE 1989

**INVESTIGATION REPORT ON GROUND FATAL INCIDENT TO**  
**M/S.PIAC F-27 AIRCRAFT AP-BBF ON 15TH JUNE, 1989**  
**AT SUKKUR AIRPORT**

(WHILE GROUND ENGINEER WAS CARRYING OUT SNAG  
RECTIFICATION OF PK-589 DURING TRANSIT TIME  
SUKKUR - KARACHI SECTOR)

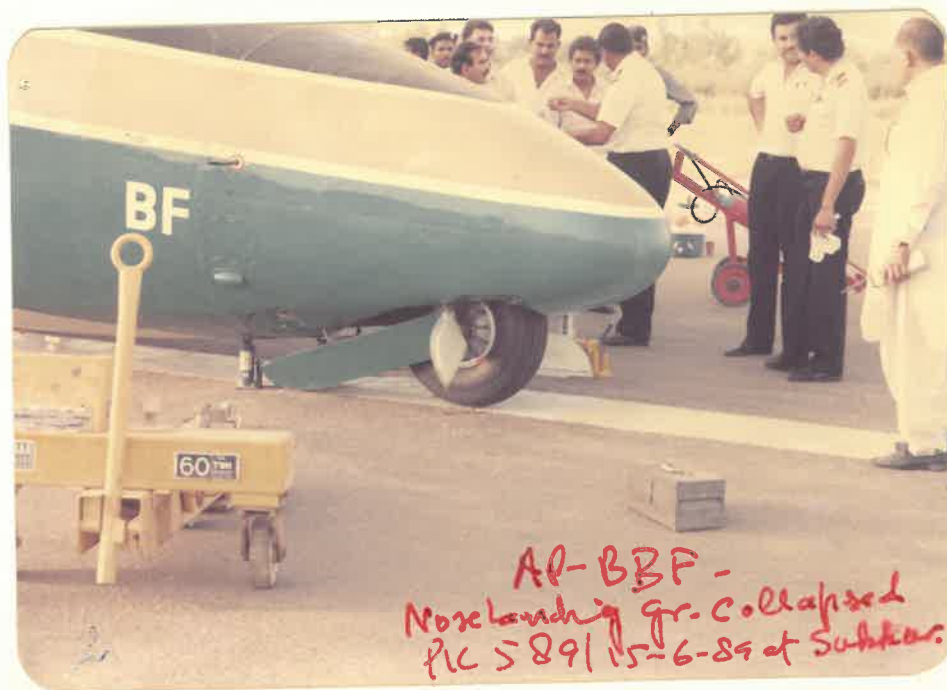
APP 'C2'

AP-BBF -  
Nose landing gr. collapsed  
PIC 58915-6-89 at Sukkur.
