# **FINAL INVESTIGATION REPORT**

**SERIOUS INCIDENT OF M/S. PRINCELY JETS FLIGHT**  
**PJP-786 EC130-B4 AIRBUS HELICOPTER**  
**REG NO. AP-BKH ON 12-01-2018**

### SERIOUS INCIDENT OF M/S. PRINCELY JETS FLIGHT PJP-786 EC130-B4 AIRBUS HELICOPTER REG NO. AP-BKH (SECTOR BANI GALA – SIAL SHARIF) ON 12-01-2018

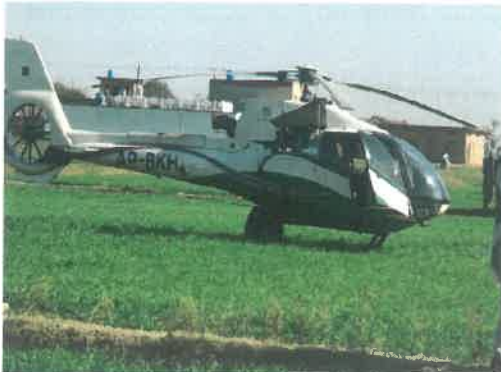
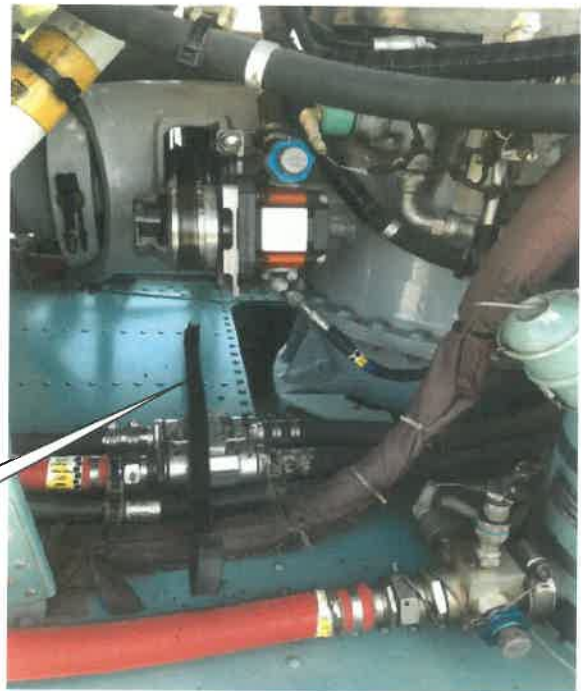
- 2.1.1 An initial survey at the site revealed no damage to the helicopter except broken Belt of the hydraulic pump.

Broken Belt of the Hydraulic Pump

- 2.1.9 In the light of established facts about the sequence of events encountered by this flight, the smoke in cockpit was due to burning of the V-Belt as a consequence of bearing cessation.

- 2.1.2 Accordingly, the Hydraulic pump and the belt were replaced by the operator in accordance with the OEM's laid down procedure to make the helicopter serviceable.
- 2.1.3 An analysis of the Hydraulic Pump Drive Assembly (Part No. 350A35-0132-00) revealed that the bearing (Part No. 704A33-651-243) seems to have been ceased.

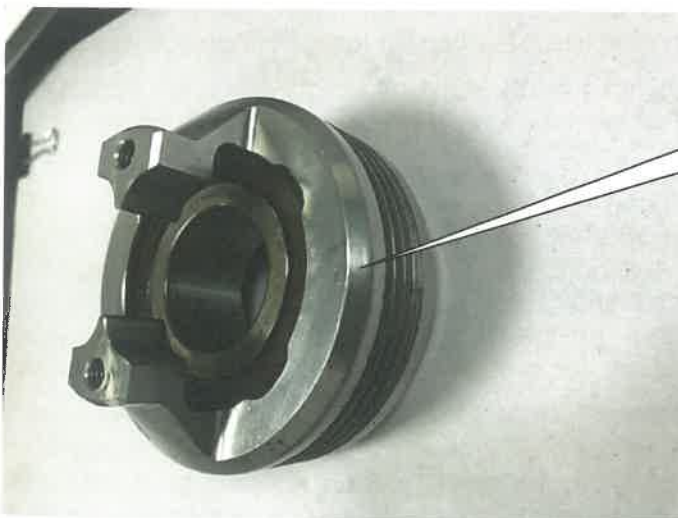
Pump Drive Assembly and its Bearing

*"The analysis confirms the behavior of this bearing which was POST MOD 07-9566 (P/N 704A33-651-243) but PRE MOD 07-9568 (P/N 704A33-651-269). This kind of incident was explained by all the investigations which were performed following the first events. The limited internal clearance of the bearing associated with environmental conditions generates abnormal heating of the rolling bodies and a deterioration of the grease which leads to the bearing seizing and the belt failure".*

- 2.1.6 The investigation report from the OEM explains that such failures have been faced by many other customers in the industry. Main reason for this failure is the in-adequacies of the design of Bearing (lesser clearance etc) which has already been improved thru various modifications. The latest modification (MOD 07-9568) had already been advised to the customers.

- 4.1 Although, this model of the helicopter is equipped with a double hydraulic system and replacement of the bearing is not mandatory, however the operator (M/s Princely Jets) is recommended to implement SB No. EC130-63-009A in order to replace the bearing of the hydraulic pump to avoid recurrence in future.
