## **FINAL INVESTIGATION REPORT**

### **SERIOUS INCIDENT OF LAHORE FLYING CLUB CESSNA-172 AIRCRAFT, REG. NO. AP-BIX WHILE FLYING FROM LAHORE TO MULTAN ON 04<sup>TH</sup> APRIL, 2019**

Dated: 20<sup>th</sup> September, 2023

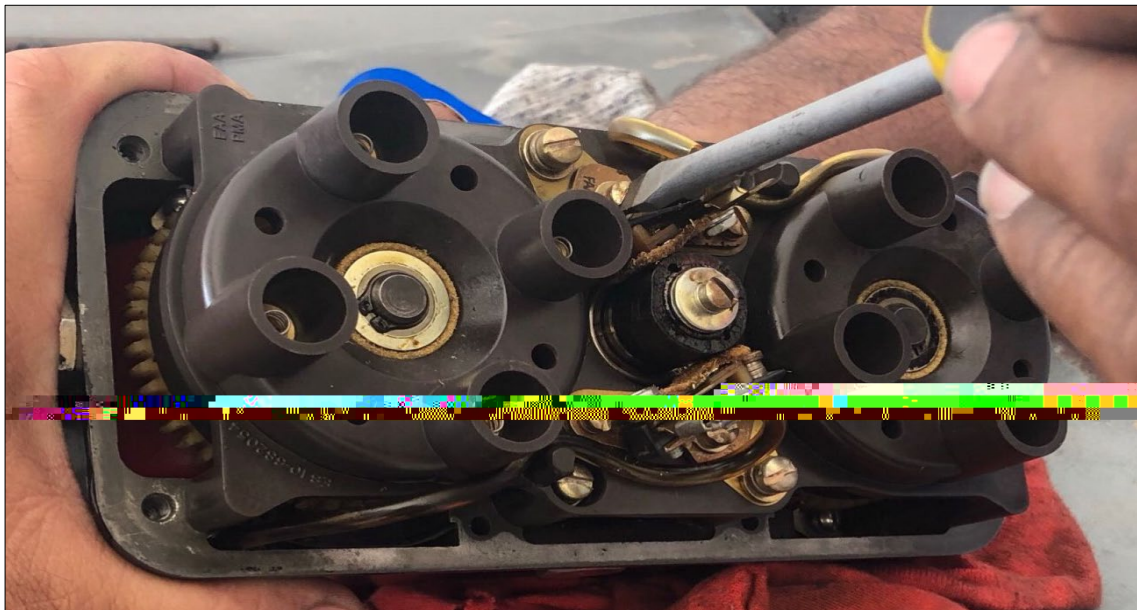
Figure 4 Adjustment of Contact Point of Magneto – Event Aircraft

2.3.2.3. Magneto Contact clearance was observed less than 0.005 in on both left and right side.

2.3.2.4. The Operator engineering staff adjusted the clearance on both sides at 0.011 in instead of  $0.018 \pm 0.006$  in, carried out the ground run and declared the aircraft airworthy.

2.3.2.5. Adjustment of Magneto Contact clearance by the Operator Engineering staff was out of limit as per para 9.2.9 of System Support Manual S20/ S-200 Magneto Ignition System.

- 3.1.12. The Operator engineering staff adjusted the clearance on both sides at 0.011 in instead of  $0.018 \pm .006$  in, carried out the ground run and declared the aircraft airworthy.

- 3.1.13. Adjustment of Magneto Contact clearance by the Operator engineering staff was out of limit as per para 9.2.9 of System Support Manual S20/ S-200 Magneto Ignition System.

- 3.2.1. Magneto contact clearance was observed less than 0.005 in on both left and right side which caused vibrations and subsequent flameout of the engine.

4.1.1. The Operator may ensure compliance of instructions contained in Technical Manuals by its Engineering staff.
