INVESTIGATION REPORT ON INCIDENT TO  
M/S. I.I.A.C. BOEING-747 AIRCRAFT REG.  
AP-BAK WHICH OCCURRED ON 16-12-82  
AT ISLAMABAD AIRPORT.

Authority : Director General of Civil Aviation

Memorandum No. CAA/1901/14/FS. (App. "A").

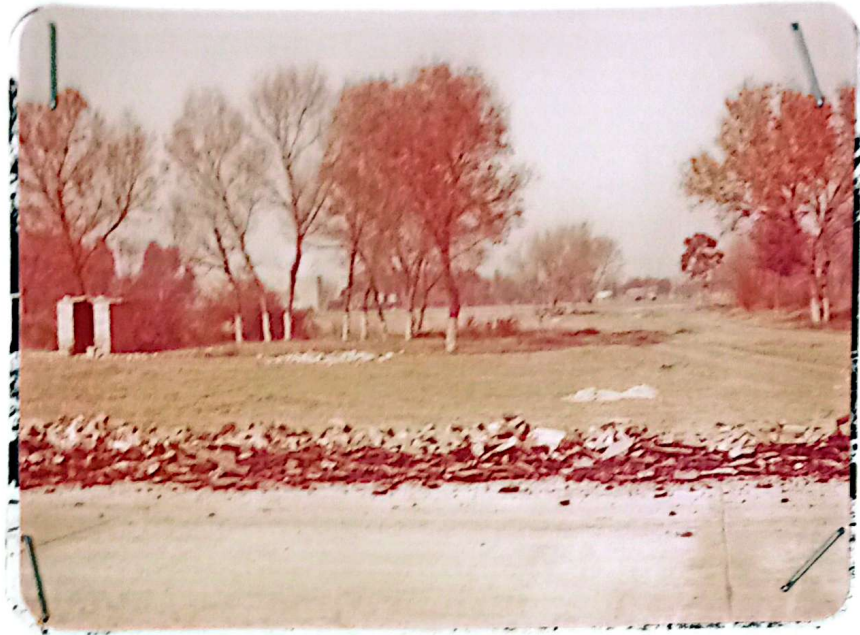
APP. C<sup>1</sup>

- 21.1. The drain mast of the right hand outer engine collided with the passenger baggage pallet which was lying unattended close to the taxiway and was not removed due to the negligence of an employee of M/s. P.I.A.C.
- 21.2. Failure by the Pilot-in-Command to be vigilant is a contributory factor.

ARROW INDICATES THE LOCATION OF PASSENGER PALLET WITH WHICH THE DRAIN MAST COLLIDED. NOTE THAT THE CONTROL TOWER IS HIDDEN BEHIND THE TREES.

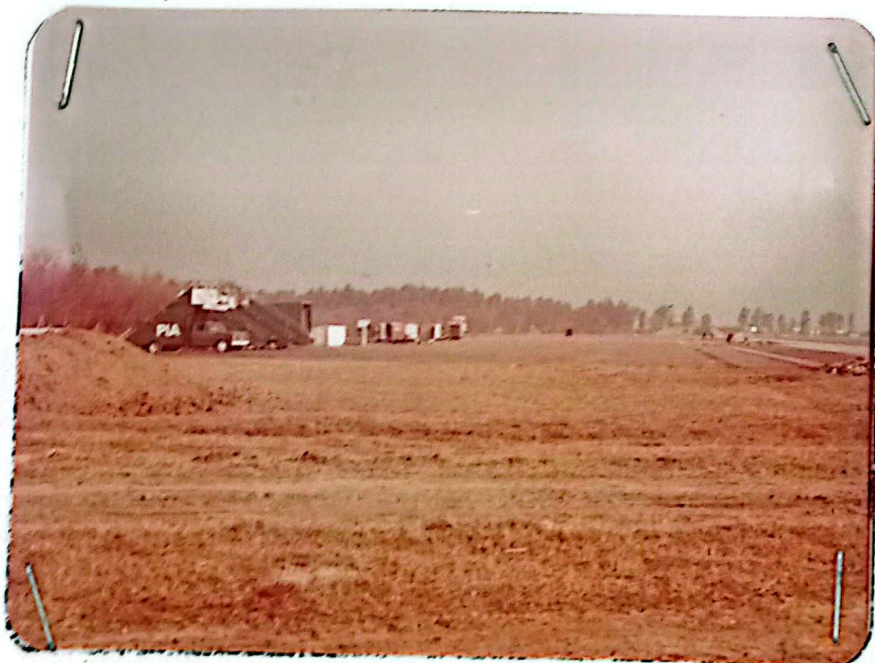
APP. C<sup>2</sup>

cross the taxiway every time an aircraft arrives. Some of the equipment was seen parked on soft ground. In addition to being hazard to the moving aircraft on manoeuvring area and apron, it brings with its tyres mud, pebbles and stones. This material is source of "Foreign object Damage" to the jet engines. The matter has been reported many a times in the Flight Safety meeting held at Islamabad. A strong need is felt to provide suitable place for the TGS equipment east of the parking bays.

HARDSTAND FOR M/S. P.I.A.C. GROUND EQUIPMENT. THIS IS WEST OF THE TAXIWAY AND RESULTS IN GROUND EQUIPMENT CROSSING THE TAXIWAY TO PROCEED TO AND FROM THE APRON. THIS IS UNDESIRABLE SINCE IT CAN BE A CAUSE OF FOREIGN OBJECTS ON THE TAXIWAY/APRON.

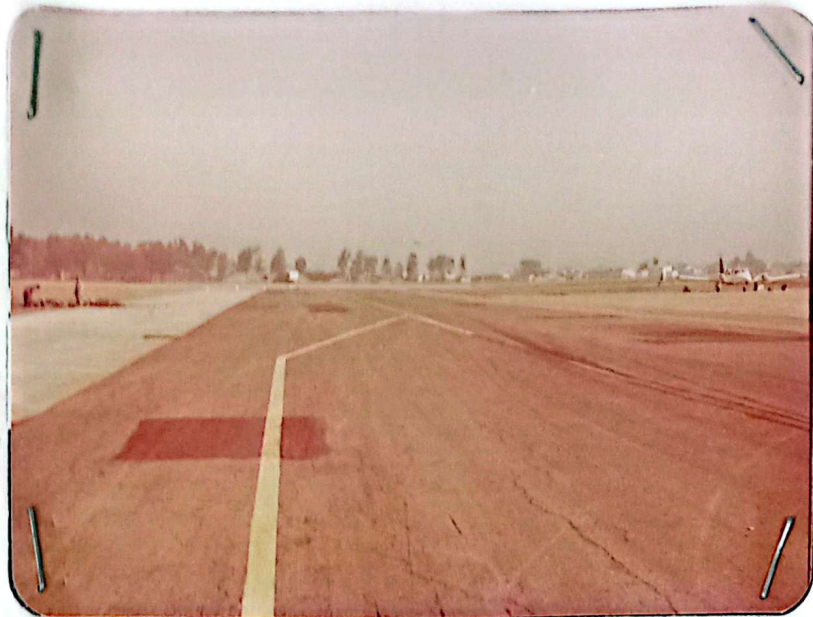
APP. C3

3  
TAXIWAY NO. 1 INTER SECTION WITH RUNWAY.  
THIS VIEW SHOWS THE OFF SET CENTRE LINE  
AS SEEN FROM APRON.

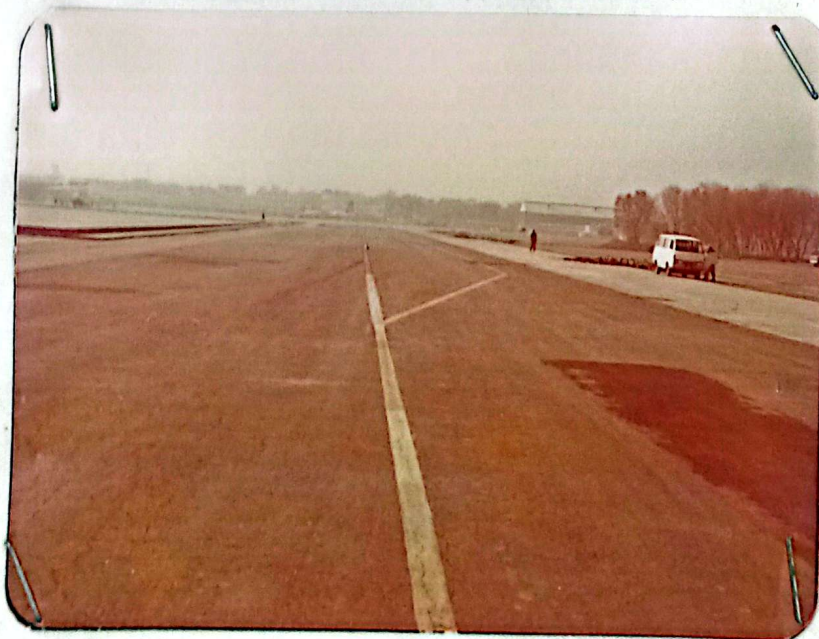
APP. C4

4  
VIEW OF APRON FROM TAXIWAY NO.1. THE PASSENGER  
PALLET WAS LYING FEW FEET RIGHT OF THE VEHICLE.

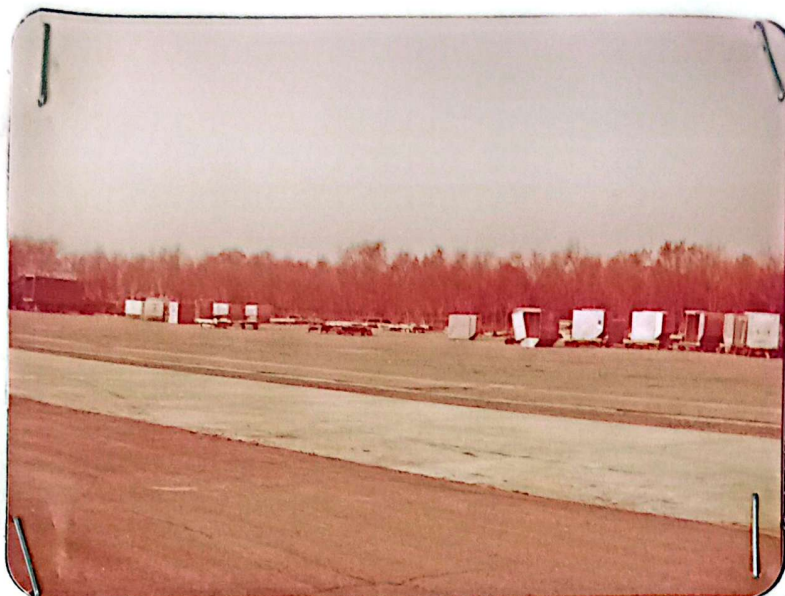
APP. "C5"

19.2. In accordance with Rule 98 sub rule 1 (a) of the Civil Aviation Rules 1978 it is the function of the Air Traffic Control to prevent collision between aircraft and on the manoeuvring area, between the aircraft and the obstruction. In this case also the responsibility rested with the Air Traffic Control. However this Airport has a peculiarity that certain areas on the manoeuvring area are obscured from view of the controller from his position in the control tower due to tall trees. The area which is not visible from the control tower ~~it~~ includes first 2000 feet of runway 30 (Appendix "C"), part of runway 12 and certain portions of the taxiway No.1 and taxiway No.2 (Appendix "C"). Due to this very reason a near collision took place between an F-6 aircraft (on take-off roll) and an F-27 which entered the runway from taxiway one and was back tracking on the runway. This would have resulted in a collision between two aircraft but for the vigilance on part of ~~pilot~~ pilot of F-6, who took timely action. Although the responsibility to ensure that the manoeuvring area remain clear from any obstruction falls within the purview of the aerodrome controller, blame not be apportioned to him. It is opinion of the investigator that a controller may not be blamed for the logical reason that his view is obscured due to the tall trees in this area.

5  
VIEW OF CONTROL TOWER FROM TAXIWAY ONE.  
NOTE ONLY TOP OF THE A.T.C. BUILDING CAN  
BE SEEN.

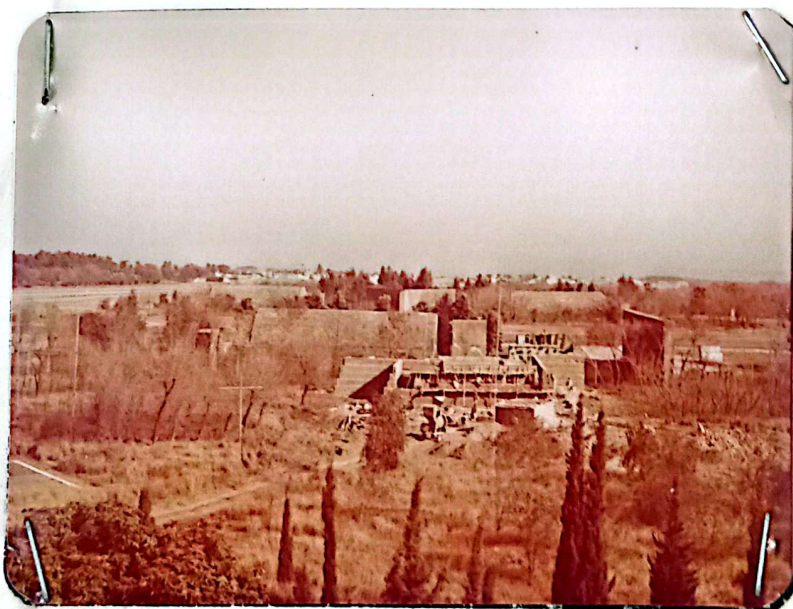
APP. "C6"

6  
VIEW OF MANOEUVRING AREA FROM THE CONTROL TOWER.

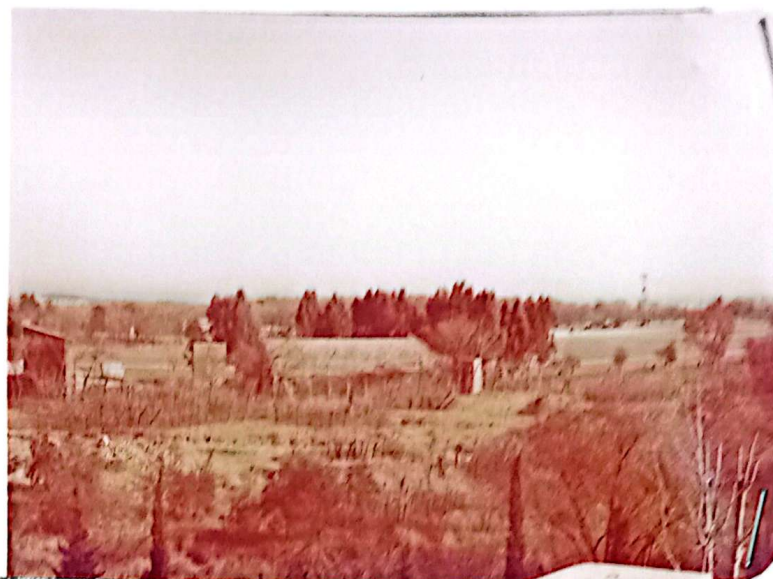
APP. C<sup>7</sup>

VIEW OF TAXIWAY NO.1, 2 AND APRON FROM THE  
CONTROL TOWER. NOTE THE RUNWAY IS NOT VISIBLE.  
NOR CAN THE TAXIWAYS BE COMPLETELY MONITORED.

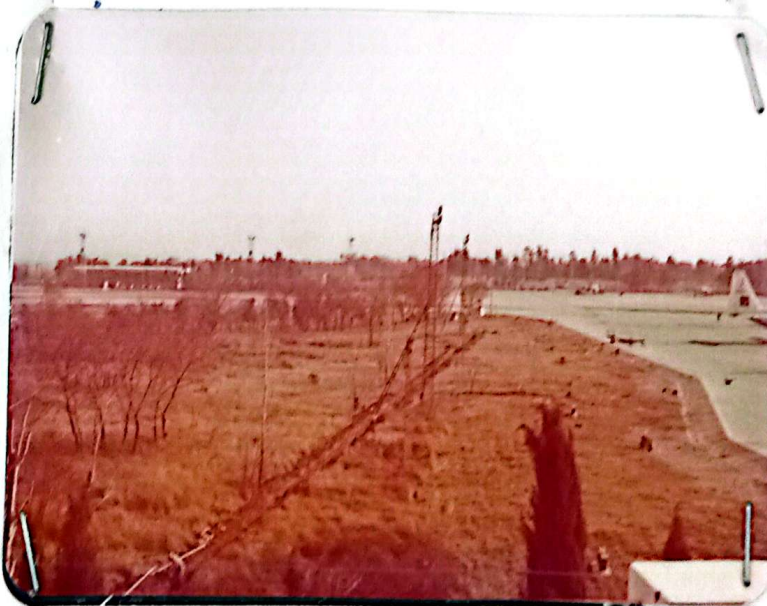
APP. C<sup>8</sup>

VIEW OF A PORTION OF TAXIWAY NO.1 AND APRON.  
FROM THE CONTROL TOWER. NOTE TAXIWAY NO. 1  
OBSCURED BY TREES.

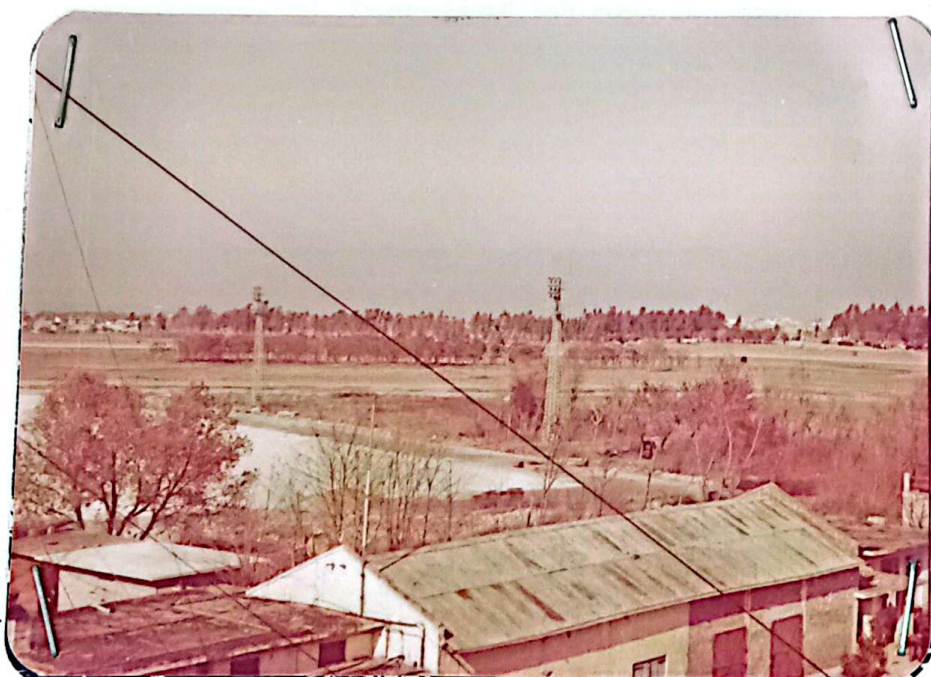
APP-C'9'

VIEW OF 1ST 2000 FEET OF RUNWAY 30 TAXIWAY  
NO.1 AND 2. FROM THE CONTROL TOWER.
