NO.HQCAA/1901/222/SIB

**AIRCRAFT INCIDENT INVESTIGATION**

**INVESTIGATION REPORT : M/S RAWALPINDI FLYING CLUB,**  
**CESSNA -152 AIRCRAFT REG NO AP-BAW WHICH EXECUTED**  
**AN EMERGENCY LANDING IN A PLOUGHED FIELD NEAR**  
**VILLAGE RAKH GAKHRAN CLOSE TO MANDRA ON 17TH JULY, 1997**

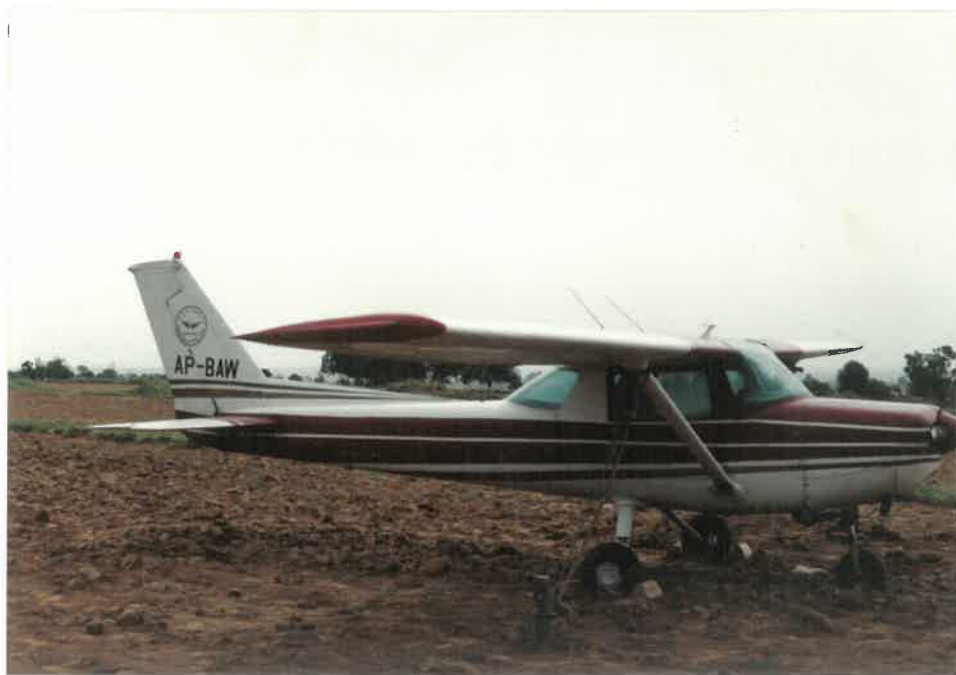
APP. 'B<sub>1</sub>'

SIDE VIEW:  
NO DAMAGE CAUSED TO AIRCRAFT STRUCTURE

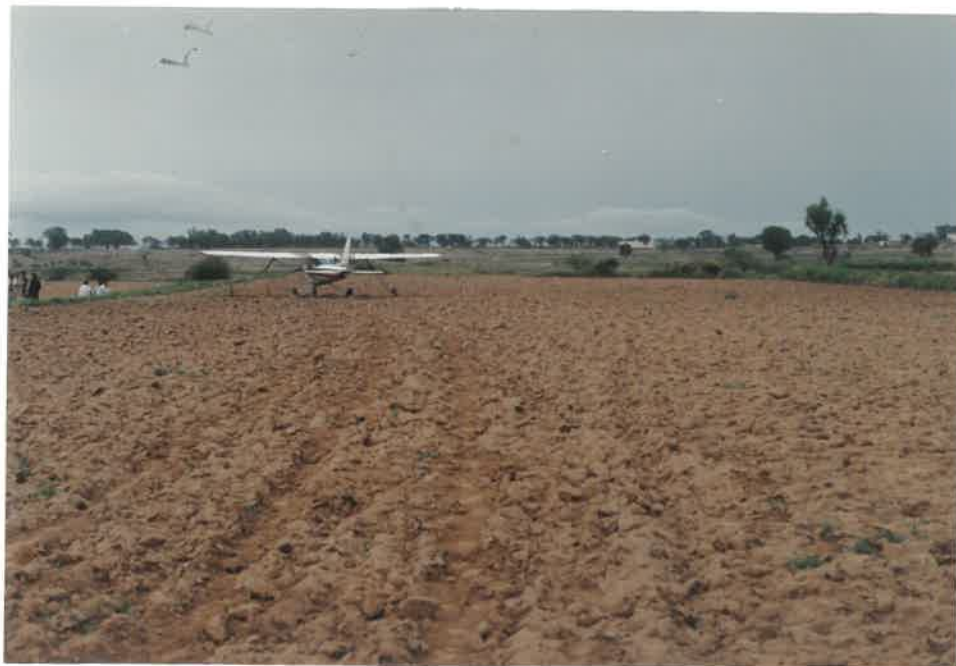
APP. 'B<sub>2</sub>'

CESSNA-152 AIRCRAFT REG NO. AP-BAW  
FORCED LANDING  
NOTE:- SEE TRACK

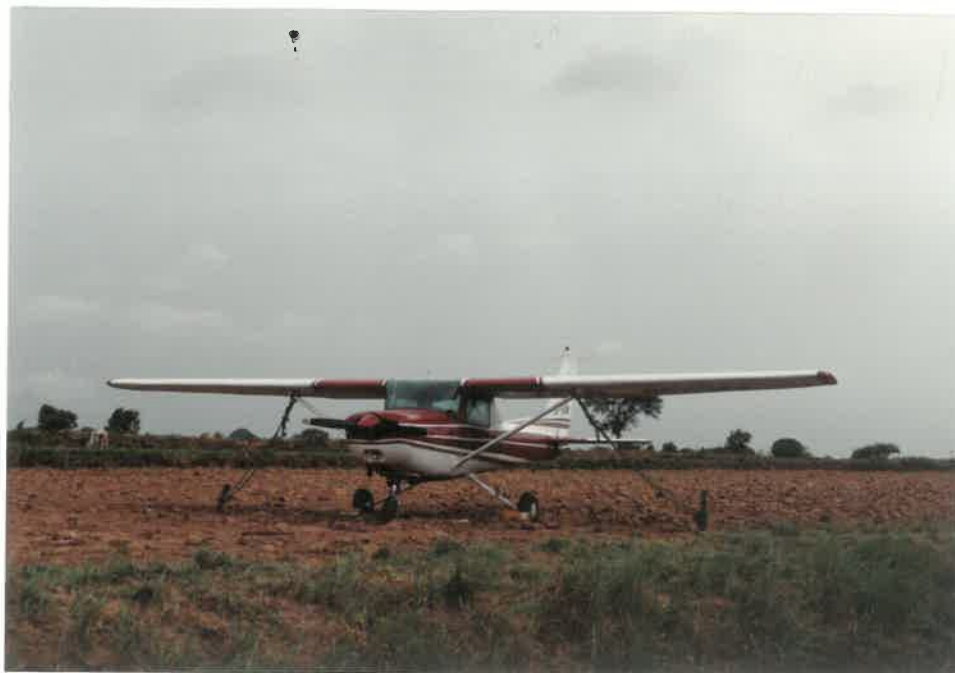
APP. 'B3'

FRONT VIEW:  
AIRCRAFT STOPPED CLOSED TO THE EDGE  
OF THE FIELD

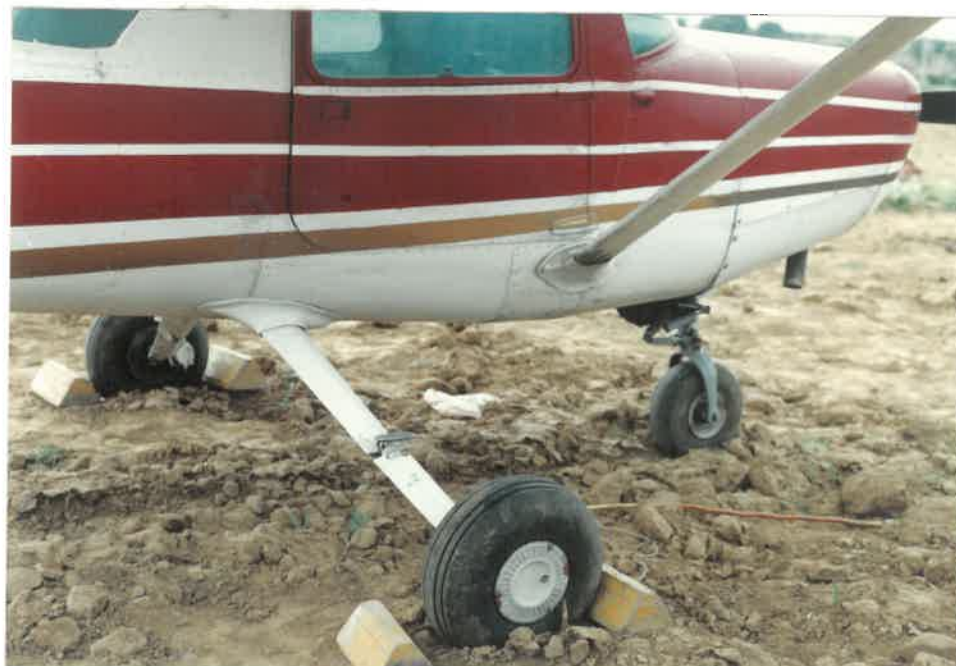
APP. 'B4'

CLOSE-UP VIEW:  
NO DAMAGE CAUSED TO THE LANDING GEARS
