**CIVIL AVIATION AUTHORITY**

**AIRCRAFT INCIDENT INVESTIGATION  
M/S AIRCRAFT SALES & SERVICES (PVT) LTD.  
PIPER SENECA-III REG.NO.AP-BCK**

**WHICH OCCURRED ON 9TH MAY, 1995**

**KARACHI AIRPORT**

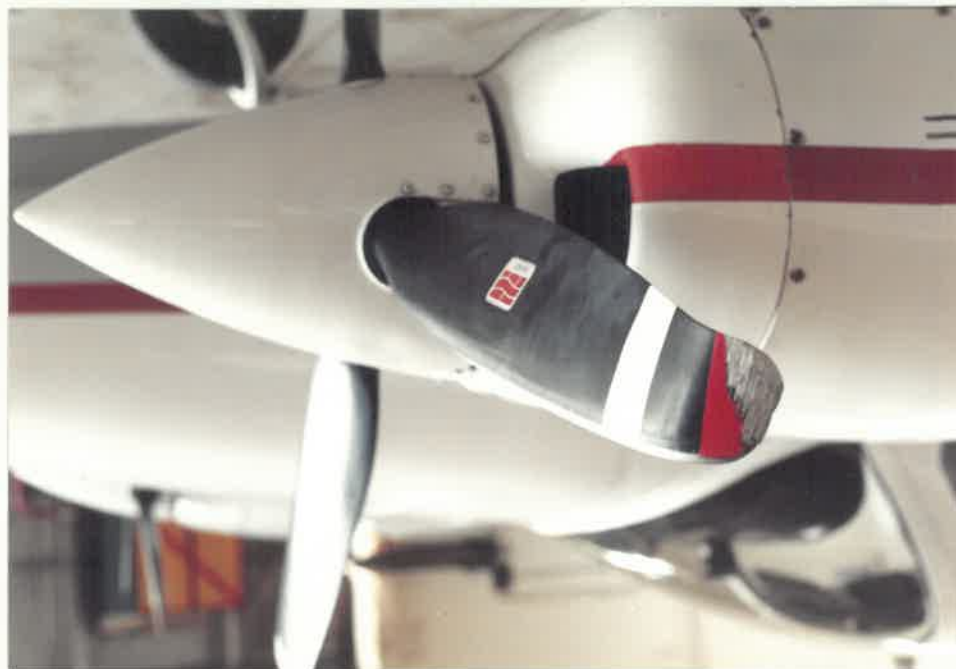
5.1. Right engine propellers tip were bend 2 inches rearward.

RIGHT ENGINE PROPELLER BLADE DAMAGE ANOTHER VIEW

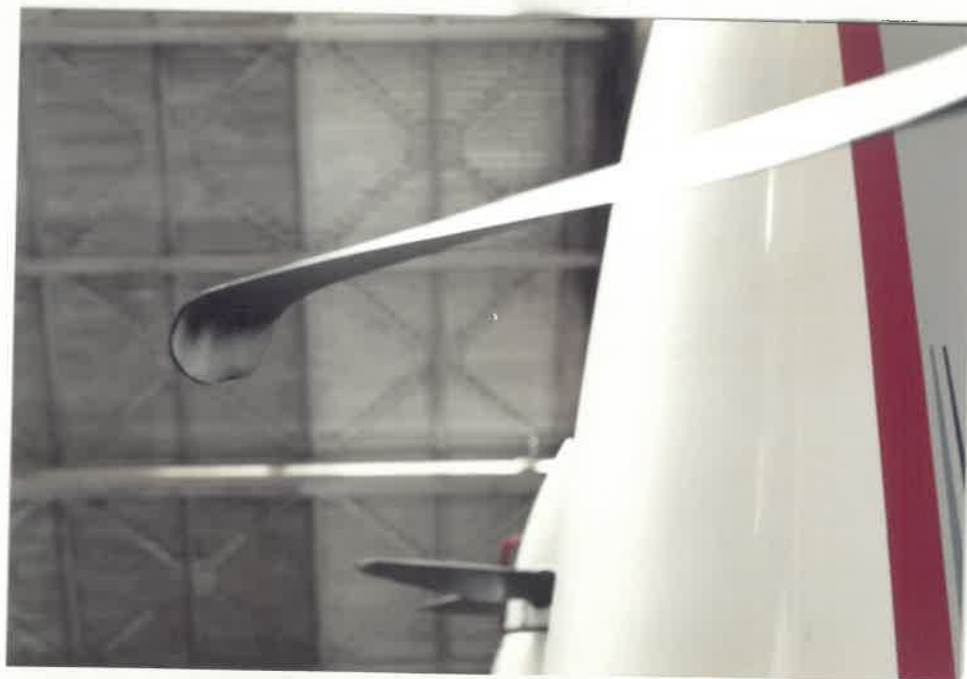
RIGHT ENGINE PROPELLER BLADES DAMAGE ANOTHER VIEW

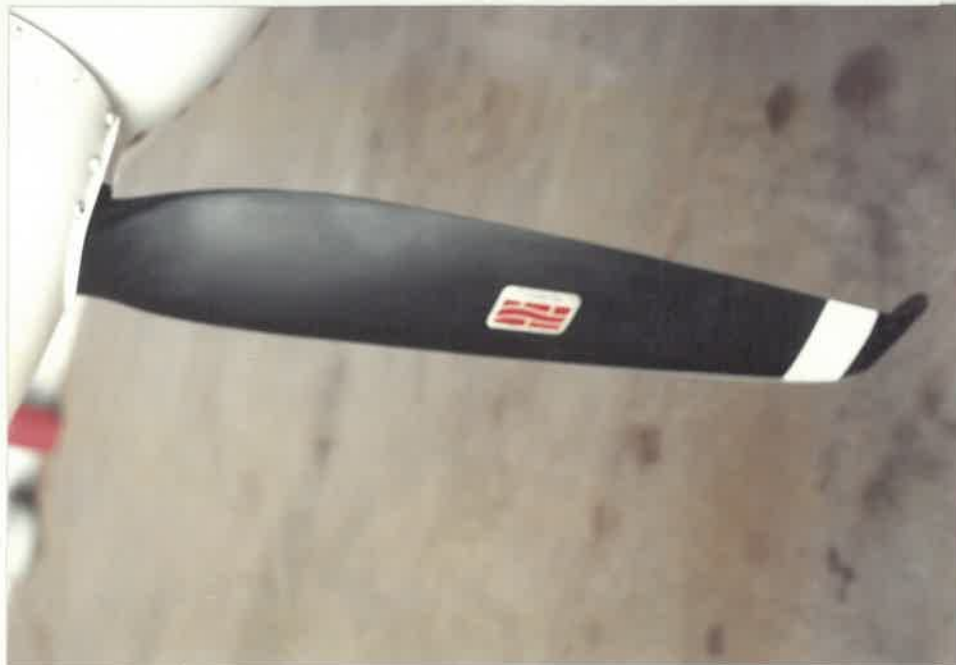
BLADE DAMAGE ANOTHER VIEW

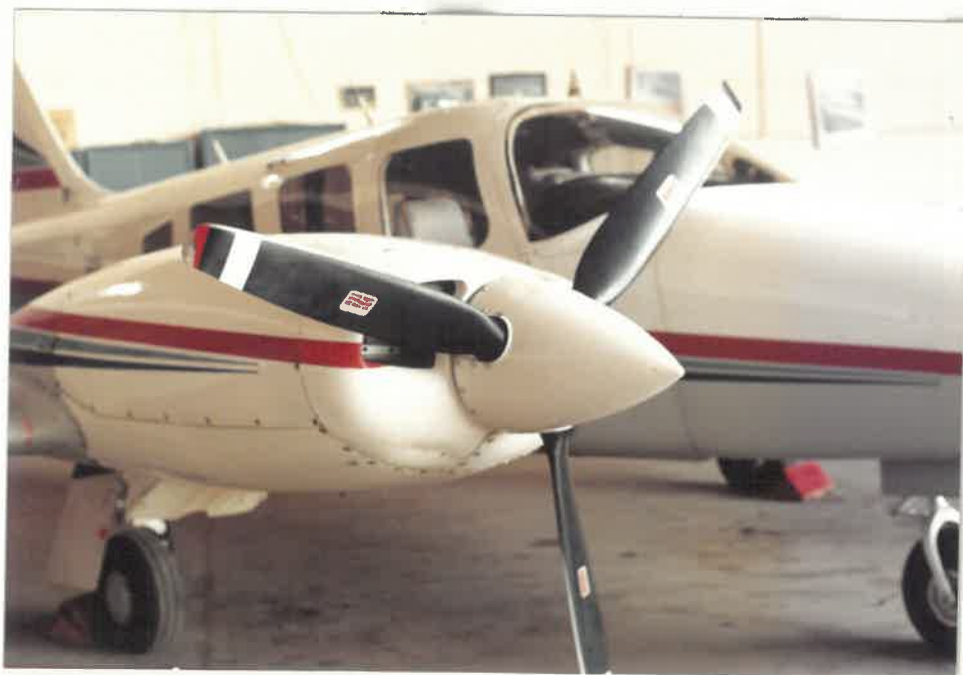
18.4.1. Piper Seneca-III aircraft requires precision handling during landing as it has a floating tendency due to ground effects due to it low wings. Captain Nadeem during landing experienced gust of wind due to which the aircraft became unstable and ballooned due to ground effects. The pilot tried to control the aircraft and eventually executed a go round. However, in this process the right engine propeller blades tip contacted the runway.

20.1 The incident was caused due to sudden gust of wind which rendered the aircraft unstable and the aircraft ballooned because of ground effects which is an inherent design feature in Piper Seneca-III aircraft due to low wings.

RIGHT ENGINE PROPELLER BLADES DAMAGED

21.1. Chief Pilot should brief all pilots in the company especially those with less experience to exercise precise handling while landing Piper Seneca-III aircraft because of its floating tendency due to ground effects.
