# FINAL INVESTIGATION REPORT

SERIOUS INCIDENT OF SHAHEEN AIR INTERNATIONAL FLIGHT NL-122,  
B737-400, REG# AP-BJT EXPERIENCED ENGINE NO. 1 ANOMALY  
ON 21<sup>ST</sup> APRIL, 2015 AT BBIAP, ISLAMABAD

**FINAL REPORT**  
**SERIOUS INCIDENT OF SHAHEEN AIR INTERNATIONAL FLIGHT NL-122**  
**B737-400, REG# AP-BJT EXPERIENCED ENGINE NO. 1 ANOMALY**  
**ON 21<sup>ST</sup> APRIL, 2015 AT BBIAP, ISLAMABAD**

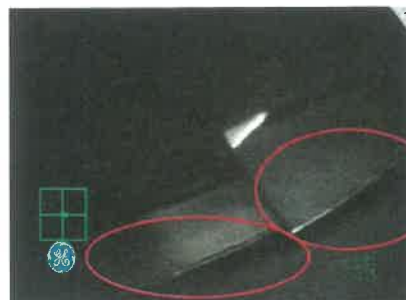
- 2.4.2 High Pressure Compressor (HPC) blades had heavy tip rubbing on almost 80% of the blades in all stages. Leading edge erosion was noted on maximum blades and some blades had tip curled but were not found in contact with stationary part. Uneven tip clearances were found on almost all stages blades. The erosion coating was intact on all blades. The leading edge erosion may possibly be a cumulative effect over time. The curling and bends on the tip of the blades without being in contact with stationary parts possibly indicated cumulative effects over period of time and aggravation due to compressor stall/severe airflow disturbance in the mishap flight.

1<sup>st</sup> Stage H.P.C. Blades with clappers  
With tip rubbed

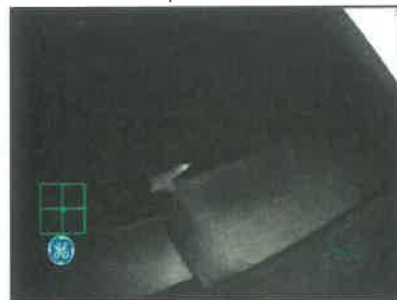
1<sup>st</sup> Stage H.P.C. Blades with clappers  
without tip rubbing

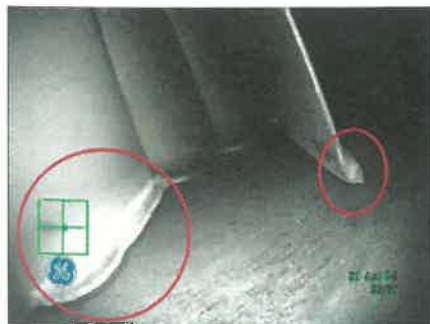
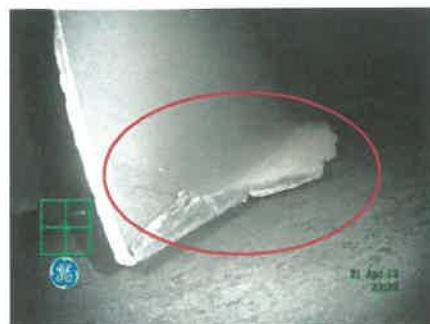
2<sup>nd</sup> Stage H.P.C. Blade with rubbing from tip and tip curled as well

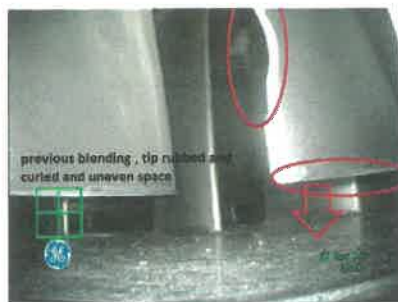
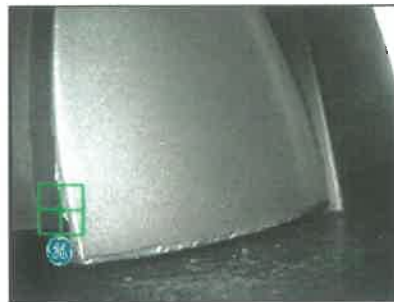
6<sup>th</sup> Stage H.P.C. Blade with uneven clearance and tip erosion

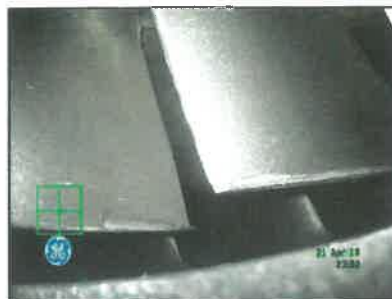
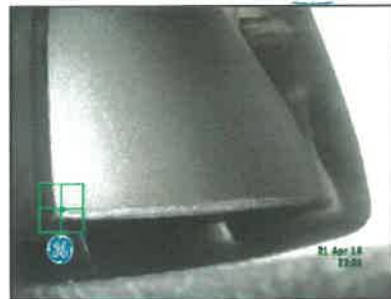
9<sup>th</sup> Stage H.P.C. Blade with uneven clearance and tip rubbing

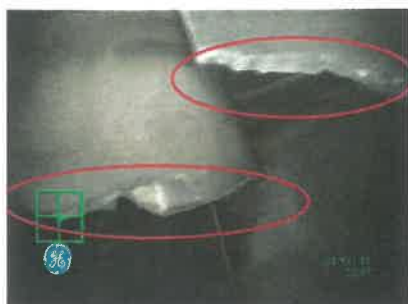
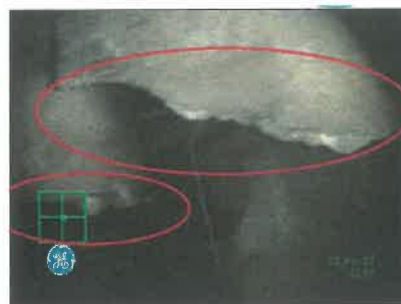
- 2.4.3 Combustor and fuel nozzles were declared satisfactory in accordance with applicable publications.
- 2.4.4 High pressure (HP) Nozzle Guide Vanes (NGV) had heavy carbon deposits and discoloration was also noted at different locations. The condition remained undetermined due to carbon deposits.
- 2.4.5 On trailing edge of HP turbine blades material was found missing from area "A", "B" and extending to area "C". More than 50% of blade material was missing on 09 blades. Discoloration was noted at different locations with carbon deposits on the surface and CODEP coating material was found missing. The condition was declared unsatisfactory based on applicable publications.

**More than 50% of blade is missing extending to area C, which is found on 09 blades**

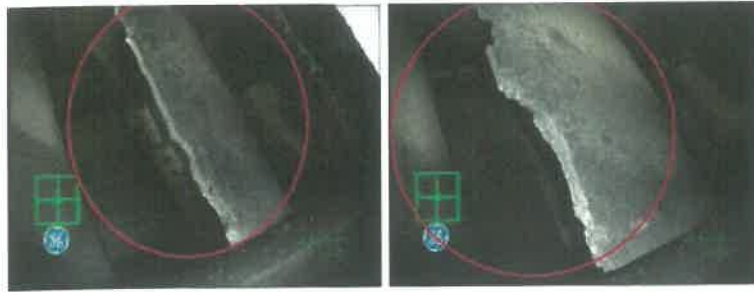
**Material missing/ burn from leading edge extending to area C on T/E**

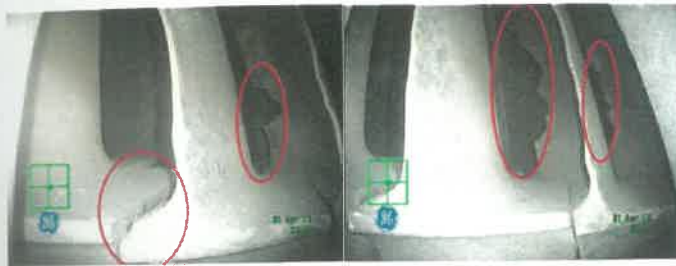
- 2.4.6 Low Pressure Turbine (LPT) all stages' blades had missing material, nicks, tip shrouds overlap and unlatched. Discoloration and coating loss were also observed. The condition was declared unsatisfactory in accordance with applicable publications.

**1<sup>st</sup> Stage L.P.T. Blades with nicks, metal missing, distortion**

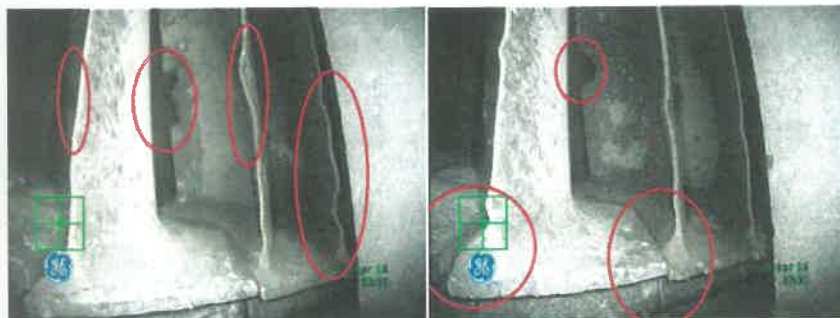
**2<sup>nd</sup> Stage L.P.T. Blades with nicks, metal missing, distortion and tip shroud overlap**

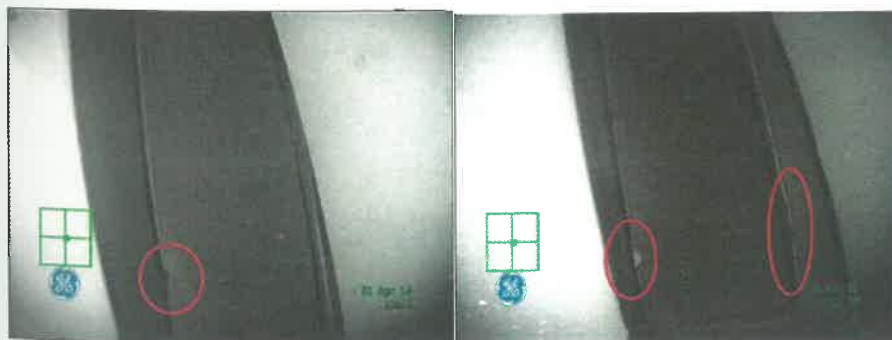
**4<sup>th</sup> Stage L.P.T. Blades with nicks in the area E**

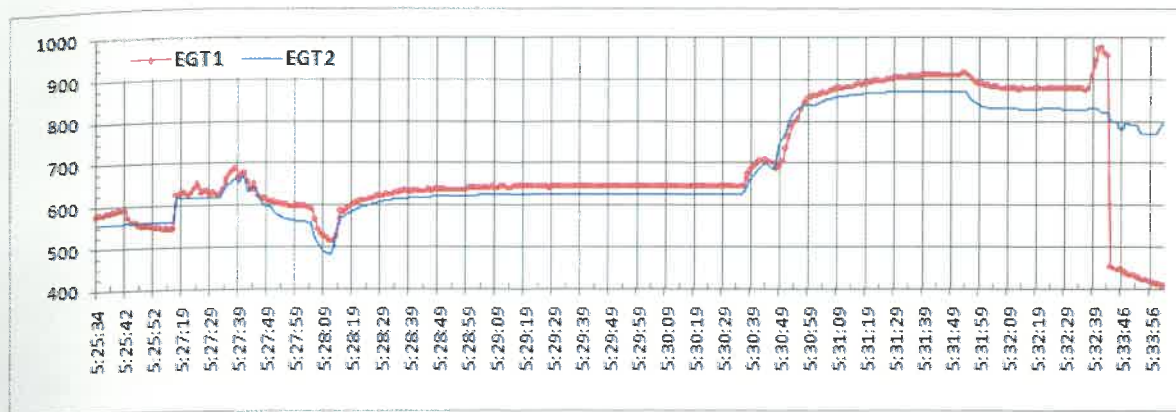
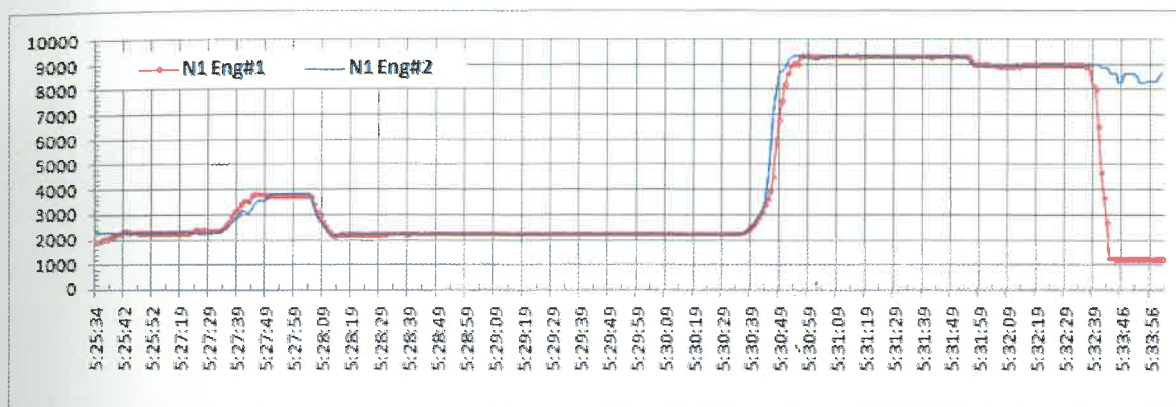
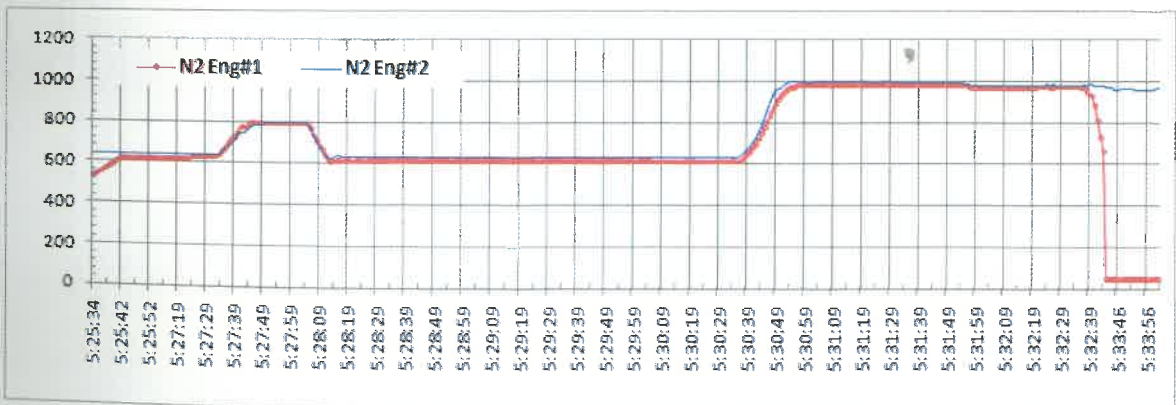
Engine Parameters FDR Plots-1 Vs FDR Time

- 2.6 The FDR data plots indicate that Engine No.1 EGT was higher than Engine No.2 at maximum throttle angle setting and it continued with the same trend till it peaked to 980°C at 5:32:42 FDR time and then throttle was retarded. During Engine No. 1 EGT rise time the throttle angle of the Engine No.1 was slightly lower than Engine No.2 which indicated that crew tried to control the rising EGT by retarding throttle. The fuel flow of Engine No.1 followed the throttle angle setting but its value remained slightly higher than respective value of other engine.

- 2.7 The oil temperature of Engine No.1 remained lower than Engine No. 2. Similarly oil pressure did not show significant variation, indicating that there was no engine oil system anomaly which led to higher than normal EGT.

- 2.8 In the middle of EGT rise period, vibrations peaks of HPC, LPT and HPT of Engine No.1 were recorded at FDR time 5:31:25, 5:31:29 and 5:31:33 respectively. Based on recorded vibration parameter, the component which experienced the problem first could not be isolated with certainty as the time of recorded parameter depends upon its sampling time / rate. However, the recorded parameter indicated an increase of vibrations of HPC, LPT and HPT during the EGT rise period. The absence of oil and fuel system anomaly and vibration parameter suggested performance anomaly initiated in either of HPC, LPT or HPT. The vibration parameters and BSI report supported the fact that HPC was the first component which experienced performance anomaly.
