# AIRCRAFT INCIDENT INVESTIGATION

A-300 AP-BBM

26TH SEPTEMBER, 1993

**TYRE TREAD PEELED-OFF INCIDENT DURING TAKE-OFF  
OF PIAC AIRBUS ON 26TH SEPTEMBER, 1993 WHILE  
OPERATING PK-321 AT QUETTA AIRPORT**

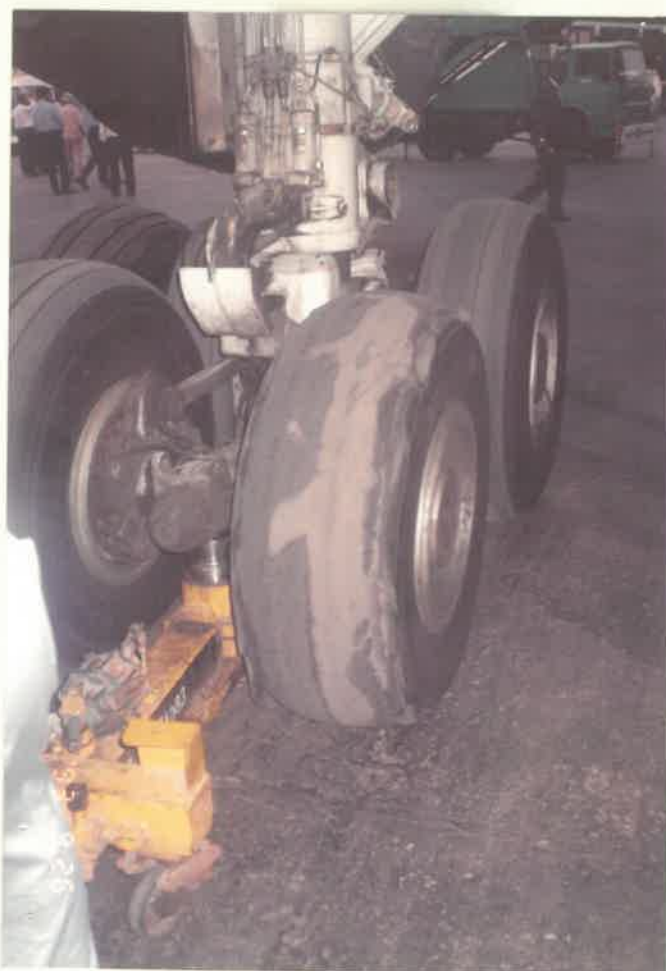
FRONT VIEW : NO.6 TYRE

18.1. PIAC Airbus A-300B4 registration No. AP-BBM was operating scheduled domestic flight PK-321 (Lahore - Quetta - Karachi). During take-off roll at Quetta at about 1640 PST the Air Traffic Controller informed the Captain of the aircraft that some tyre pieces were reported on the runway by the ground staff. As such, prior to landing at Karachi a low pass was executed for tyres security check by the ground staff and subsequently the aircraft landed safely. During post flight inspection No.6 tyre tread was found completely peeled-off as shown in Appendix 'A' to this report.

NOTE: TREAD PEELED-OFF SURFACE

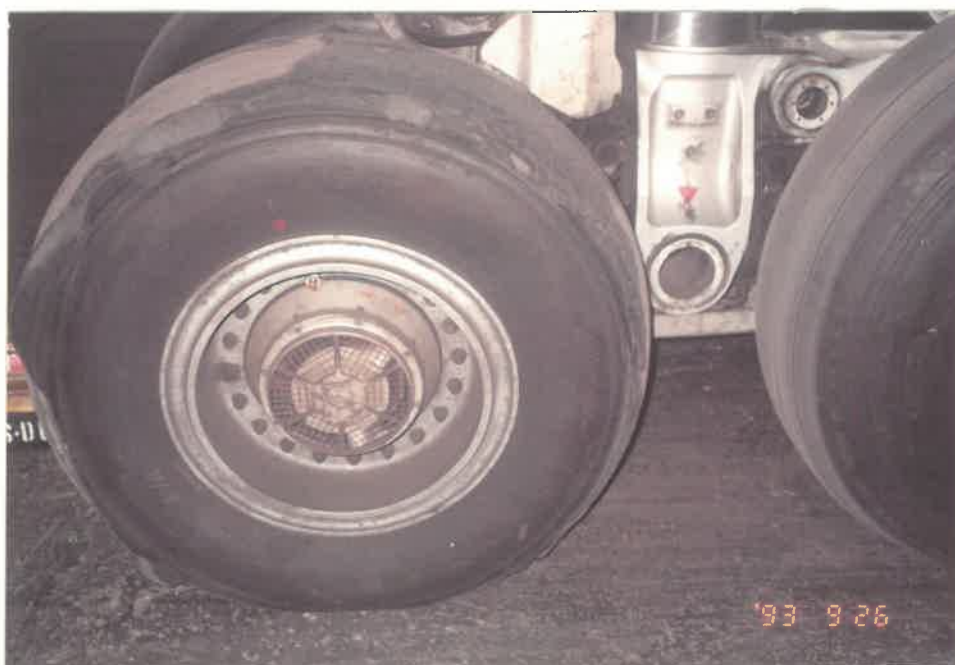
SIDE VIEW : NO.6 TYRE

NOTE : TREAD PEELED-OFF SURFACE
