**BELLEY LANDING OF CESSNA 172RG AIRCRAFT**  
**REGISTRATION MARK AP-BDY ON 3-2-1992**  
**AT FAISALABAD**

**Authority:** Director General of Civil Aviation Authority  
Memorandum No. HQCAA/1901/143/AIB dated 3-2-1992.

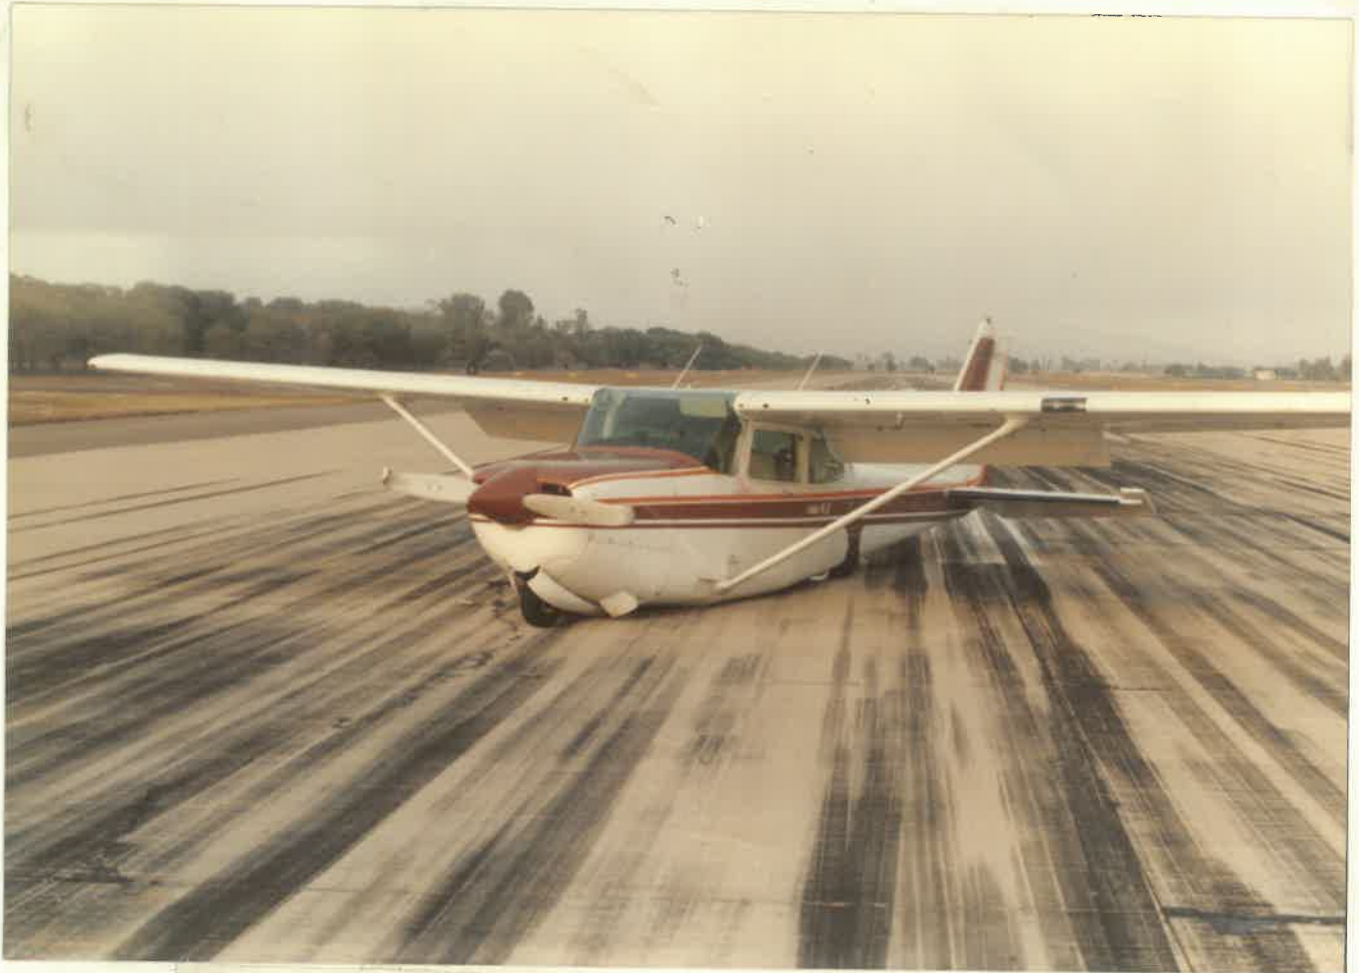
Pilot landed without lowering the landing gears. Rubbing marks of propeller and fuselage were visible on the runway for about 500 ft (i.e. between 1500 ft and 2000 ft of runway 21R). Sketch of scene of incident is attached as Appendix 'E'. One blade of the propeller bent approx: 4" rearward from the tip and similarly the other blade bent approx: 4" forward. There were scratches on the lower portion of fuselage and radio antennas installed there were damaged.

1. Aircraft with gears up = on the R/W  
at Faisalabad Airports

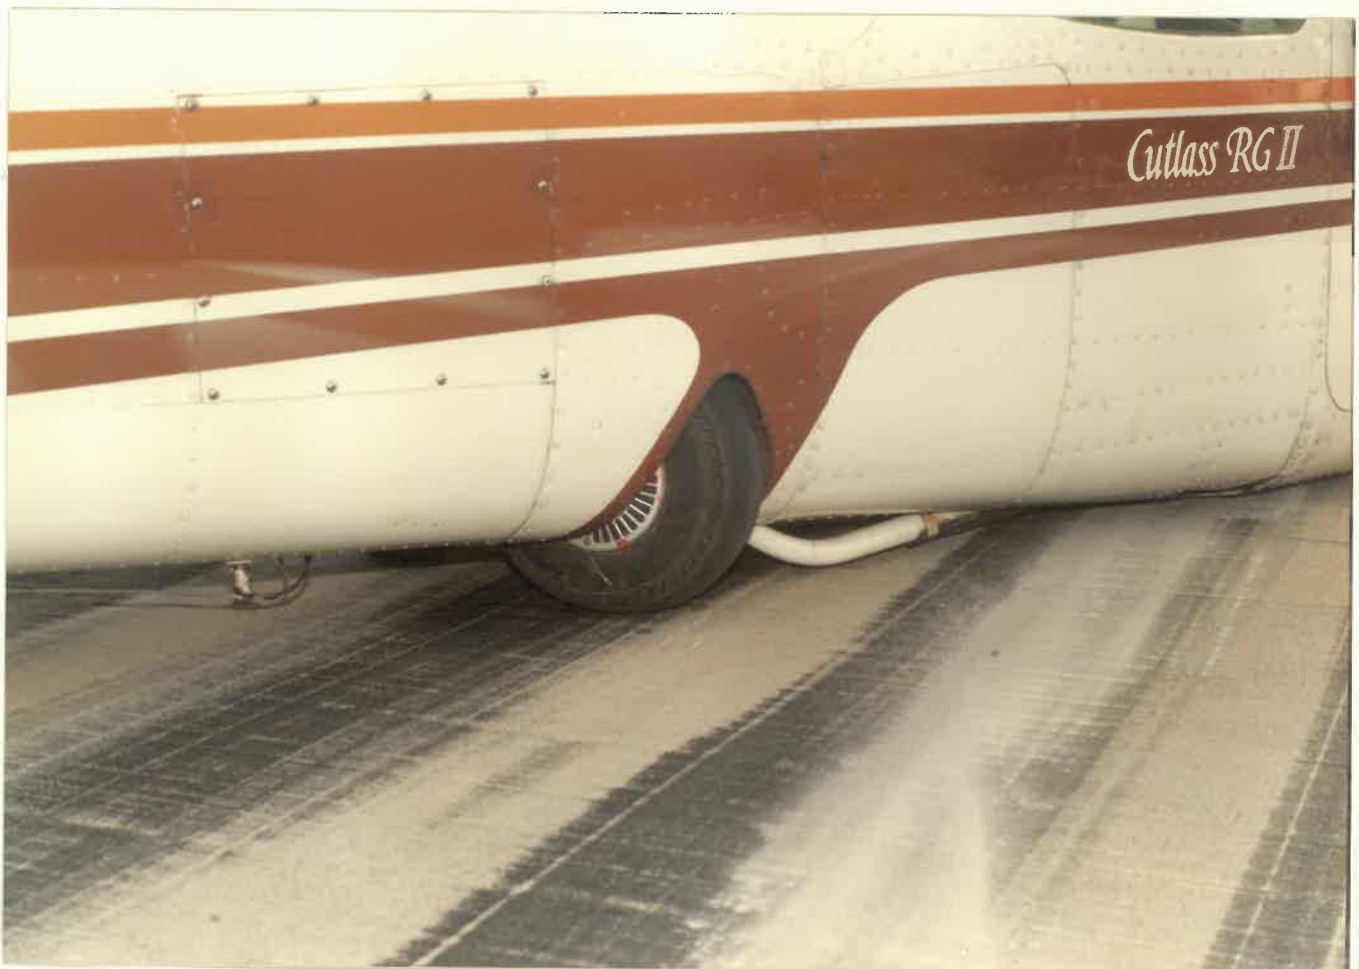
2. Right main gear about 4" out of the

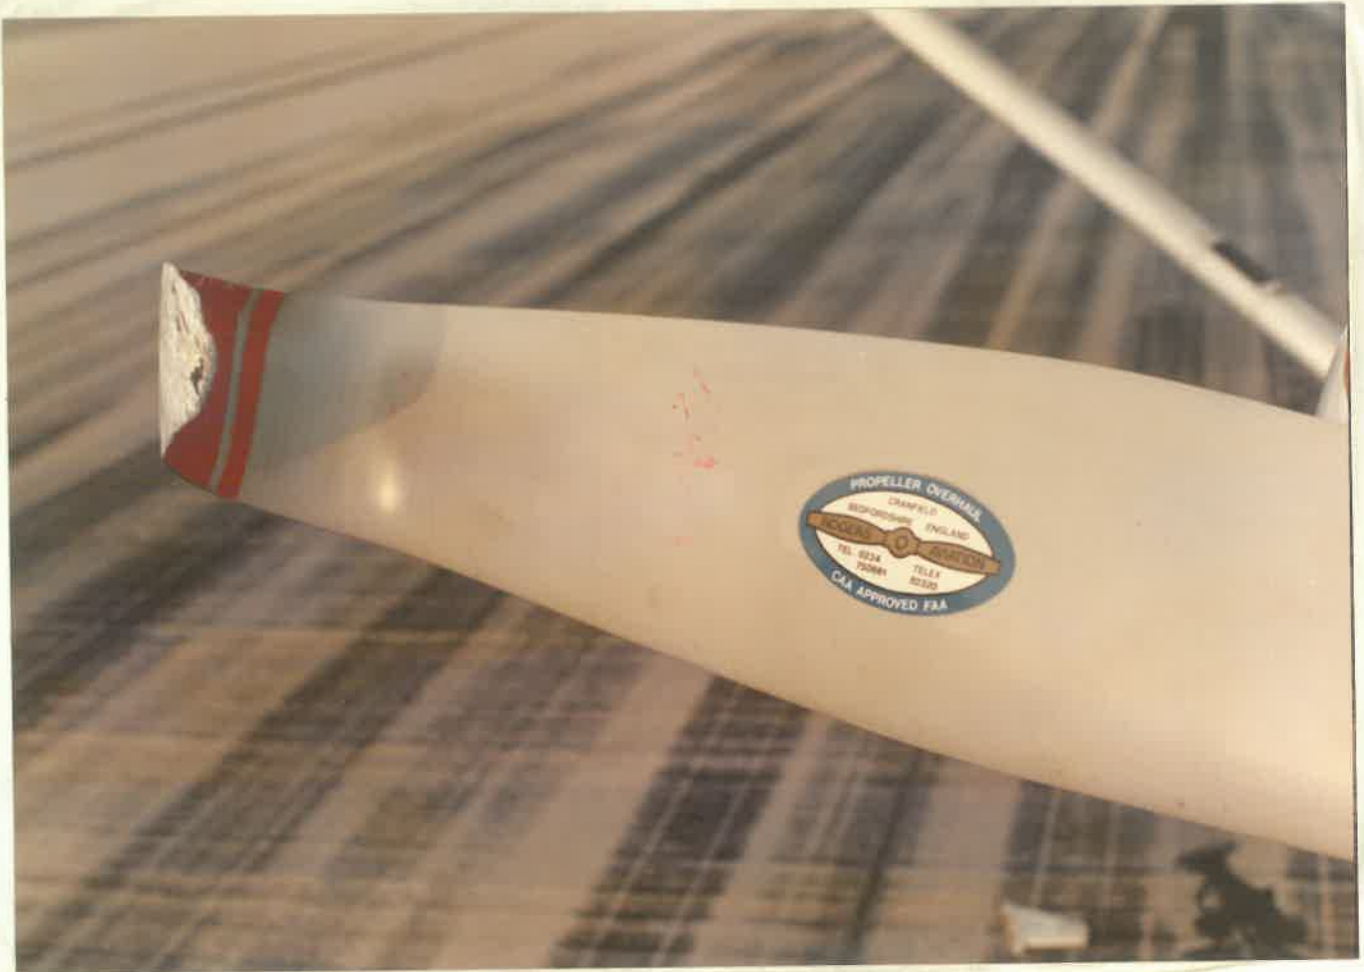
3. Damaged Prop TIP

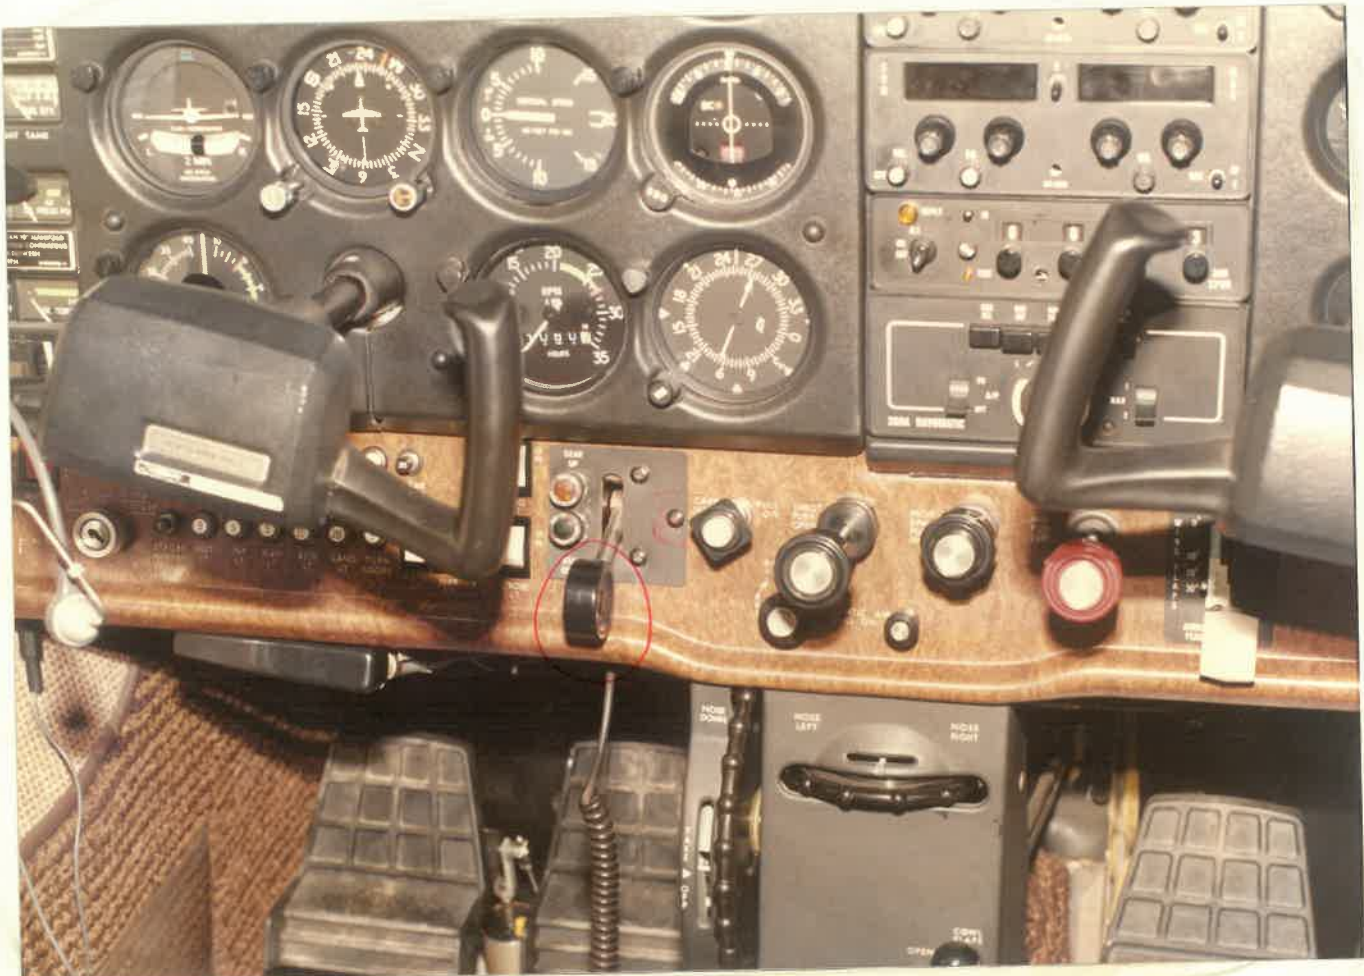
4. Cockpit Panel - indicating Gear-Lever Position "DOWN"

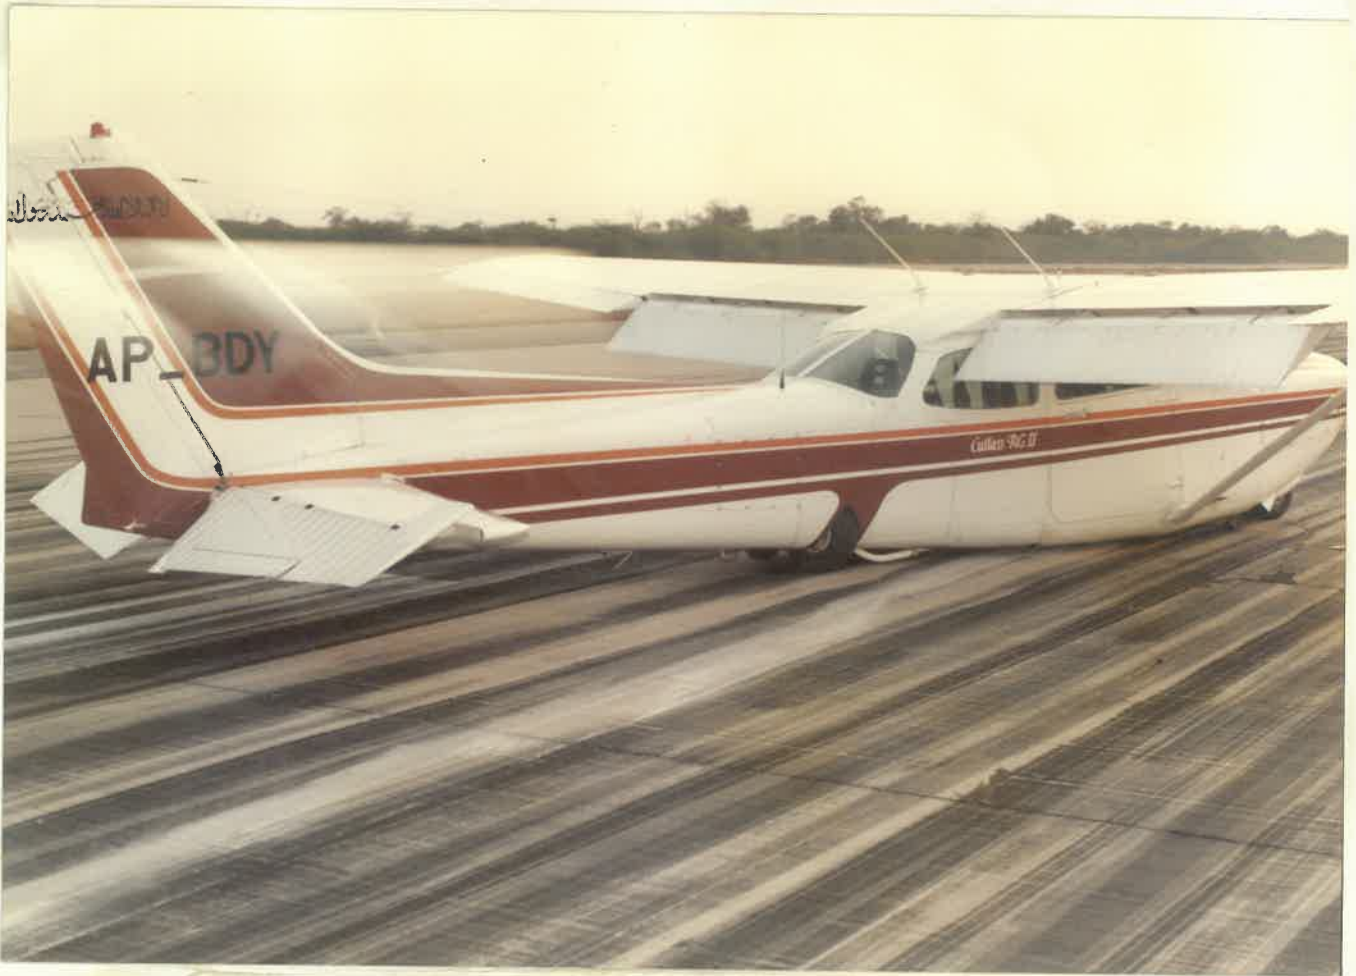
5

5. Main Wheels and Nose Gear in the process of coming "DOWN" - Flaps selected down about 30°.

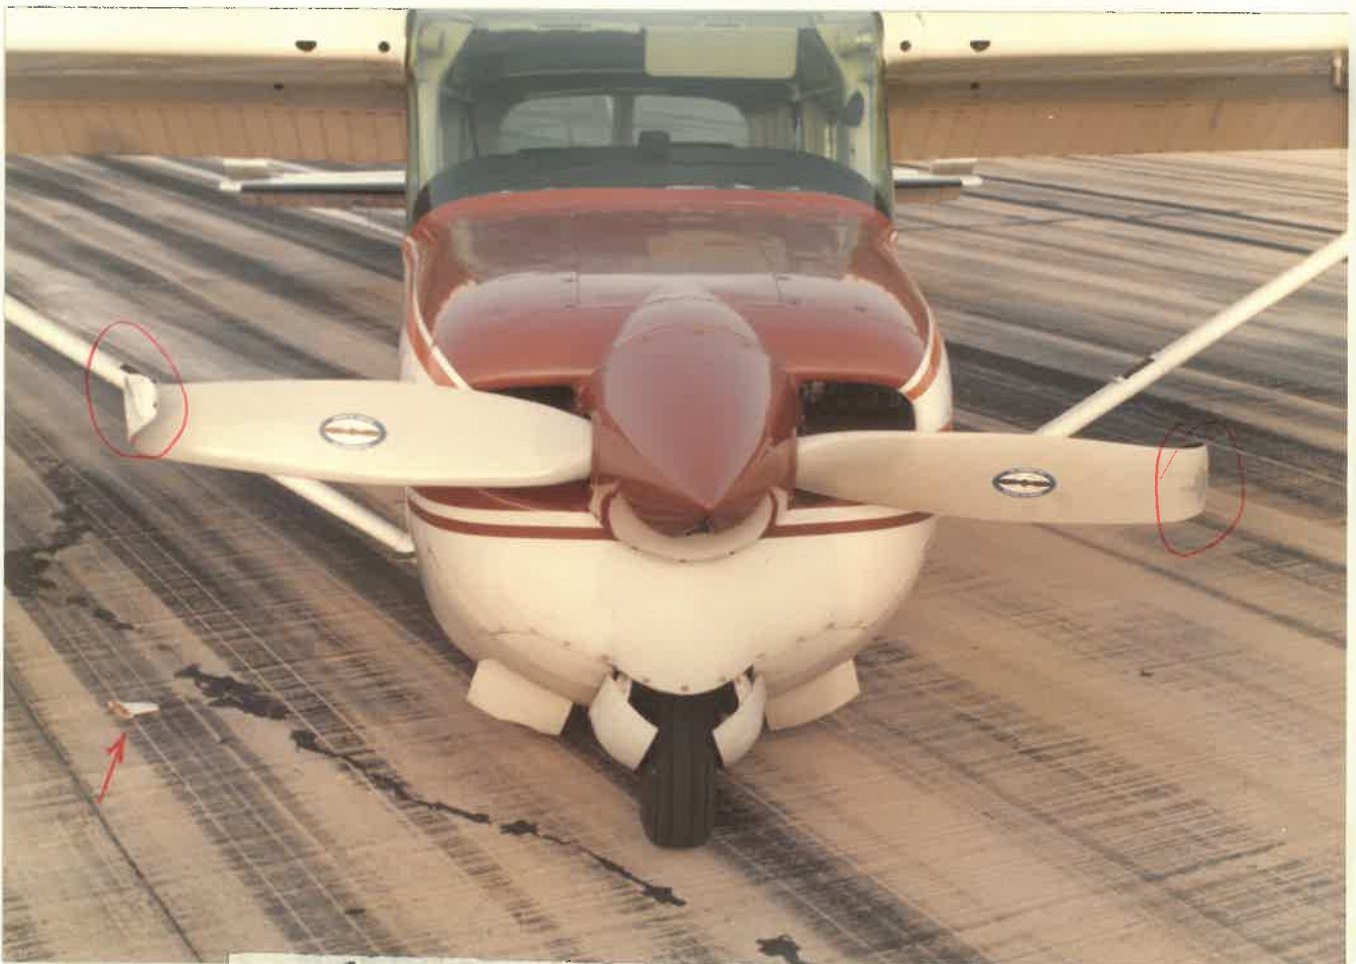
6

6. Damaged Prop TIPS - Nose Wheel half way out - No Damage to
