**AIRCRAFT ACCIDENT INVESTIGATION**

**ISLANDER BN 2A-26 AP-BEM**

**7TH JUNE, 1994.**

**FORCE LANDING ACCIDENT TO PAKISTAN**  
**AVIATORS AND AVIATION (PVT) LTD ISLANDER**  
**BN-2A-26 AIRCRAFT AP-BEM ON 7TH JUNE, 1994**  
**AT VILLAGE BHAJIAN ON RAIWIND ROAD WHILE ON**  
**CHARTER FLIGHT ON MULTAN-LAHORE SECTOR**

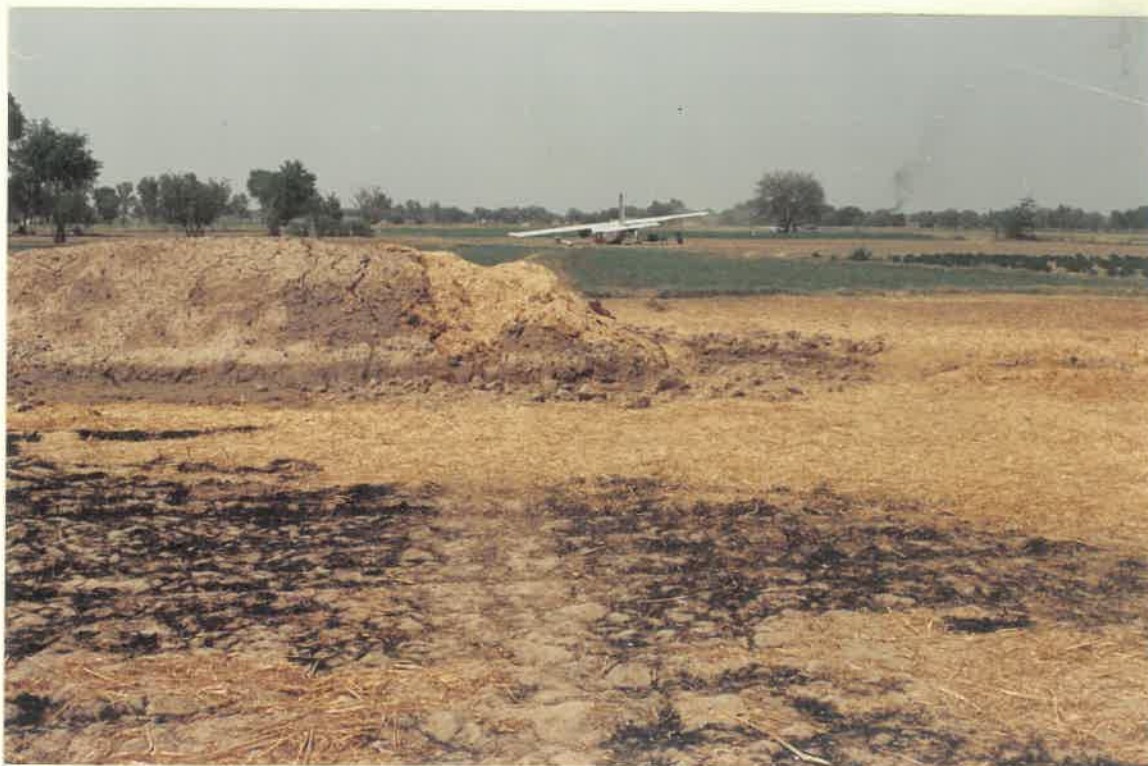
APP."C<sub>1</sub>"

AIRCRAFT TOUCH DOWN POINT AND FINAL STOP POSITION

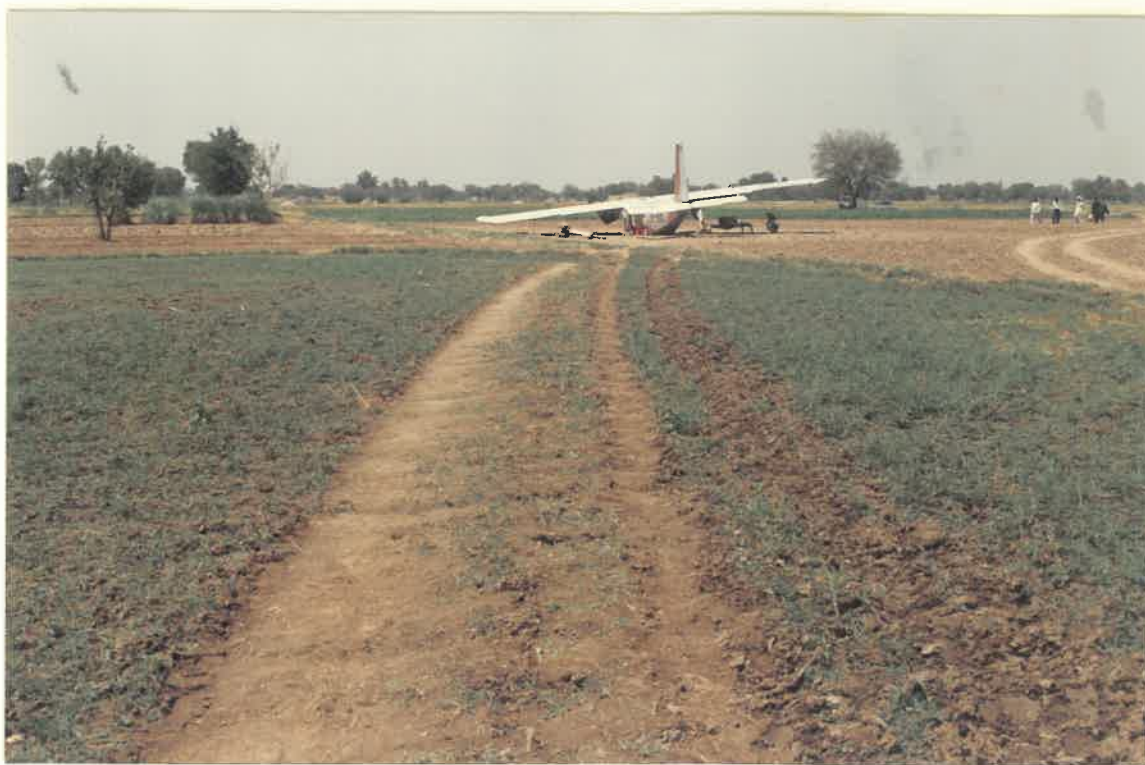
APP."C<sub>2</sub>"

PATH MADE BY A/C AFTER TOUCH DOWN

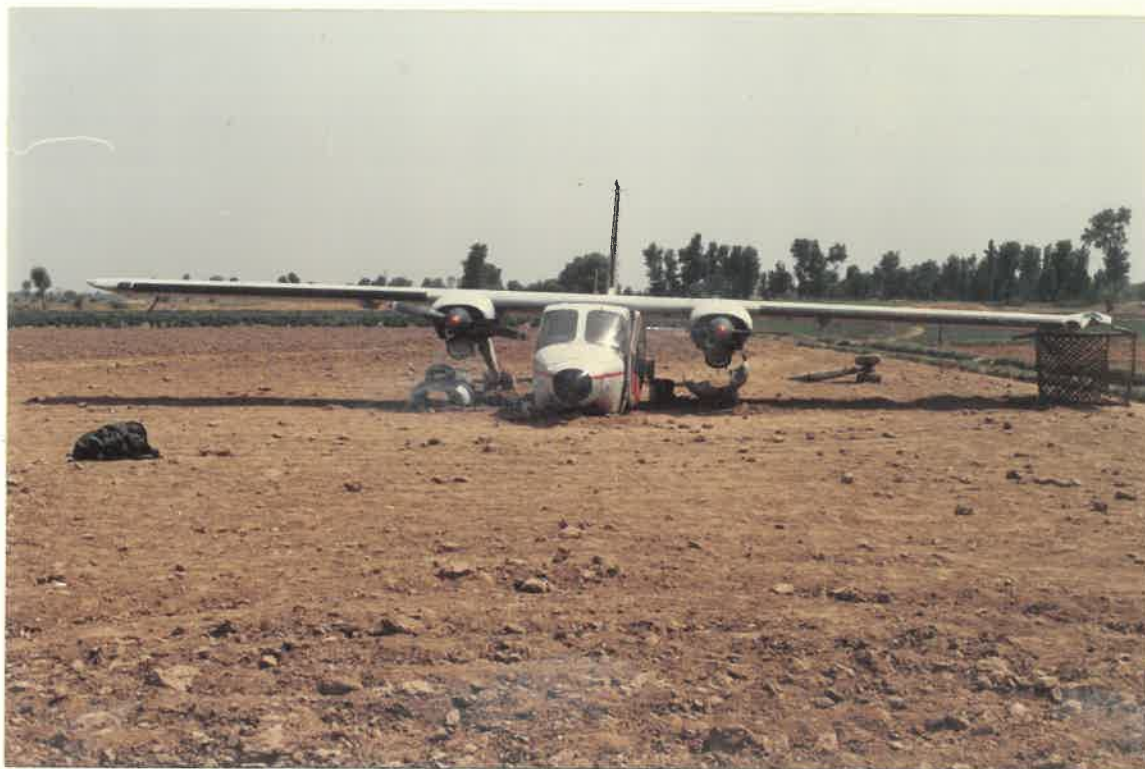
APP. "C"<sub>3</sub>

FRONT VIEW OF AIRCRAFT

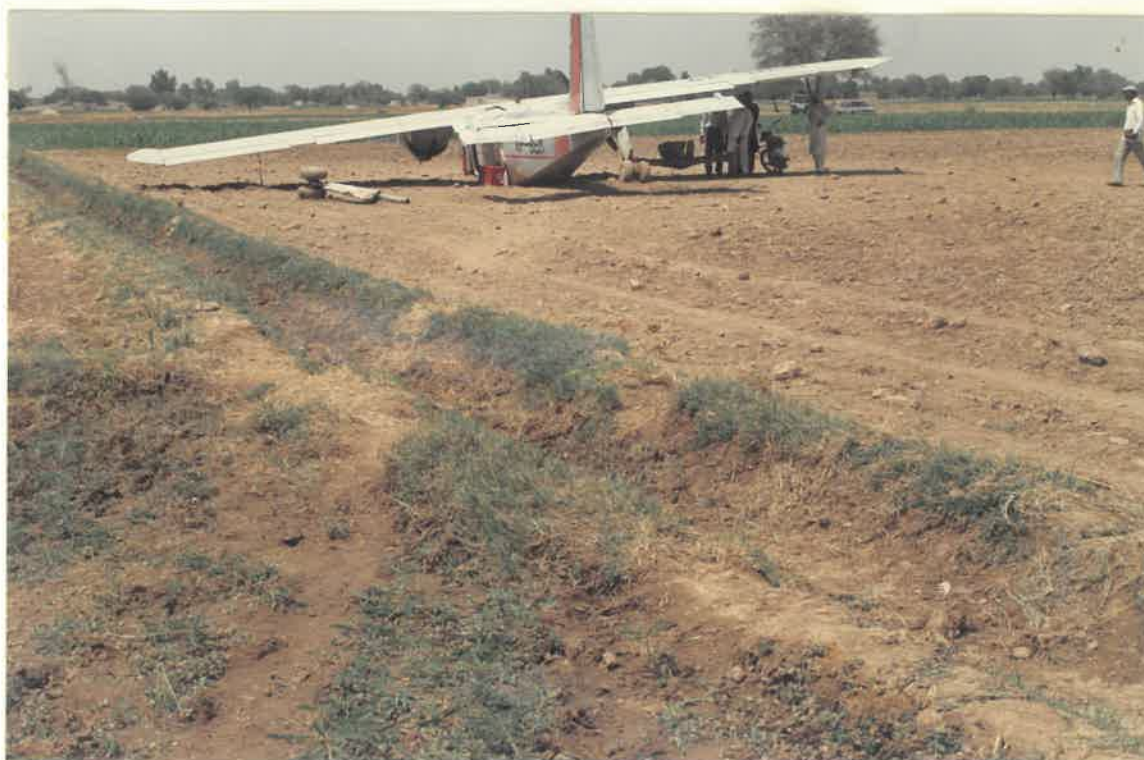
APP. "C"<sub>4</sub>

TRACK MADE BY LANDING GEAR

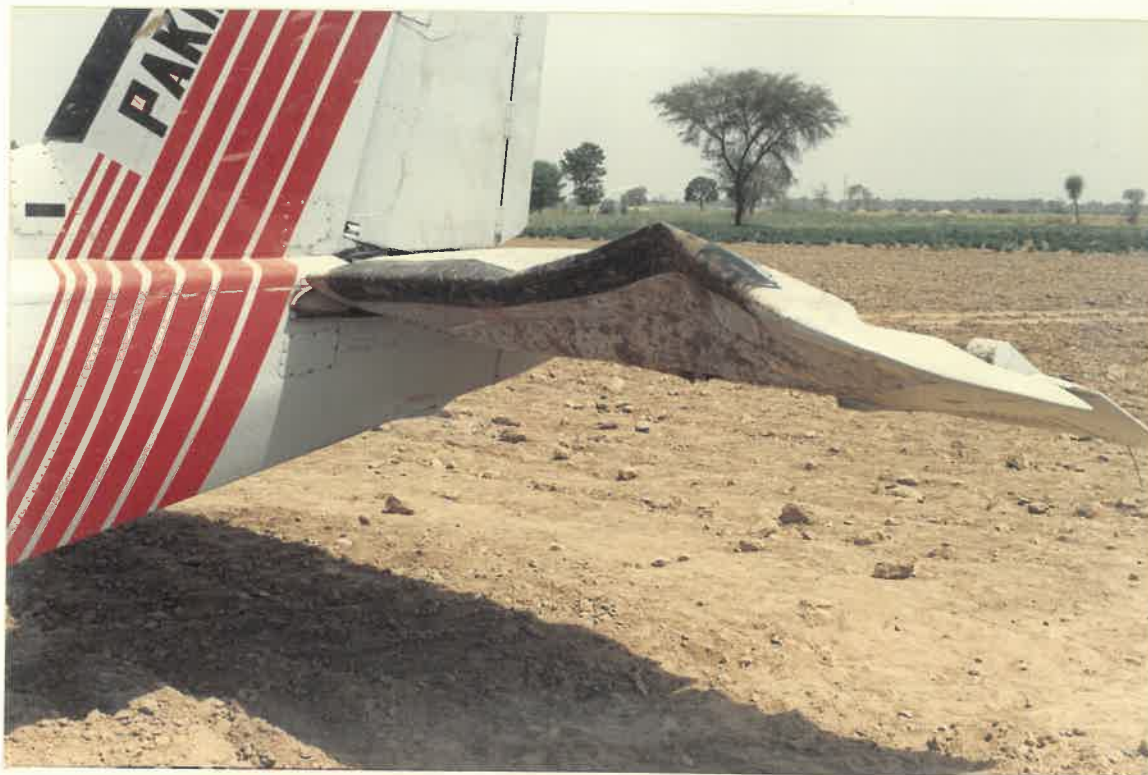
LEFT HORIZONTAL STABILIZER DAMAGED

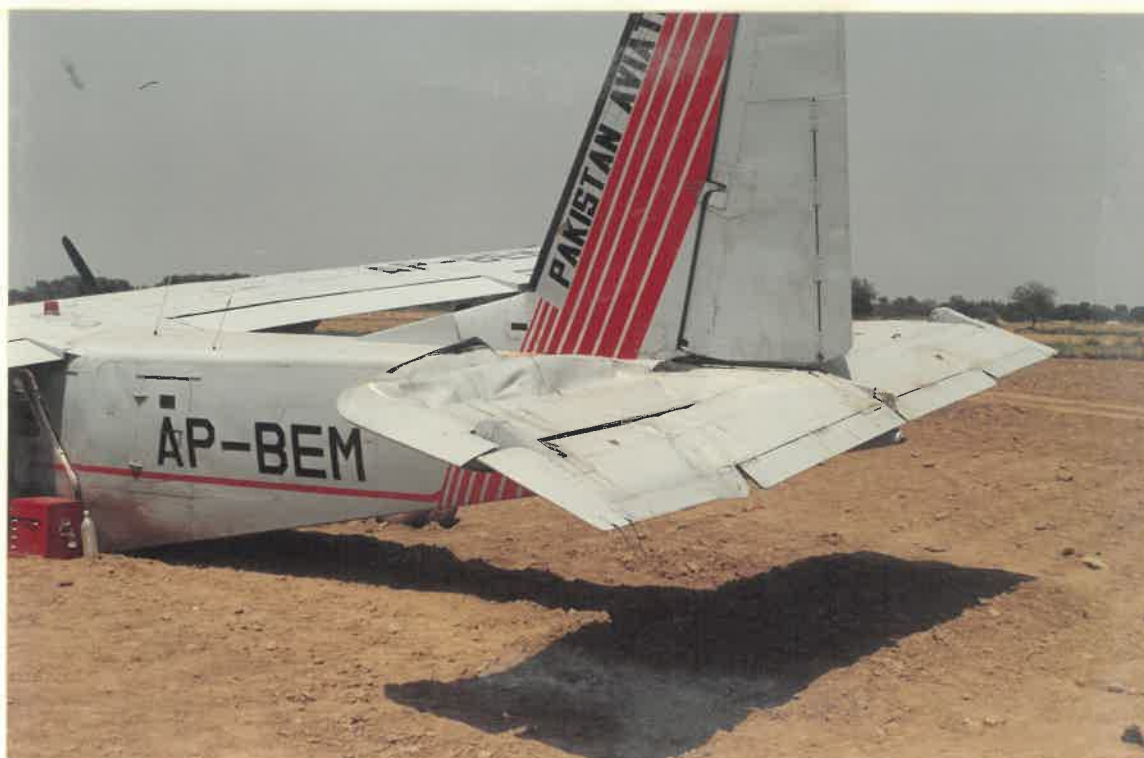
LEFT HORIZONTAL STABILIZER AND FLEVATOR DAMAGED

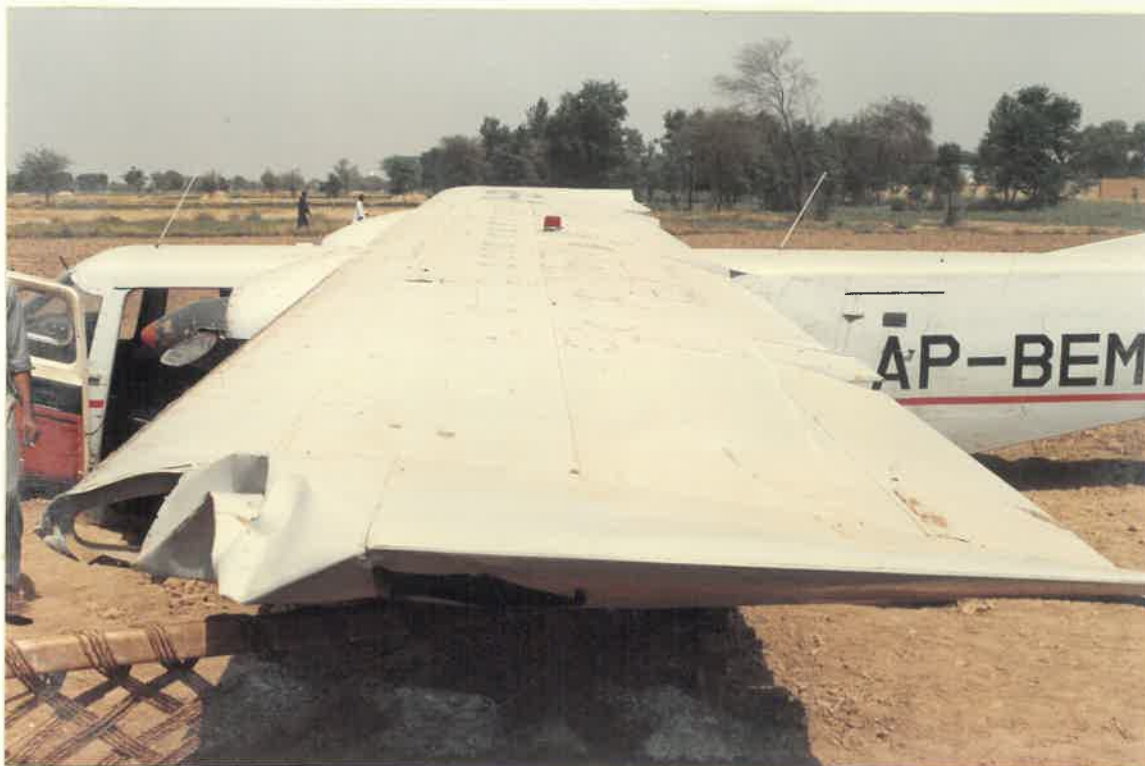
APP. "C" 7

LEFT WING TIP DAMAGED (SIDE VIEW)

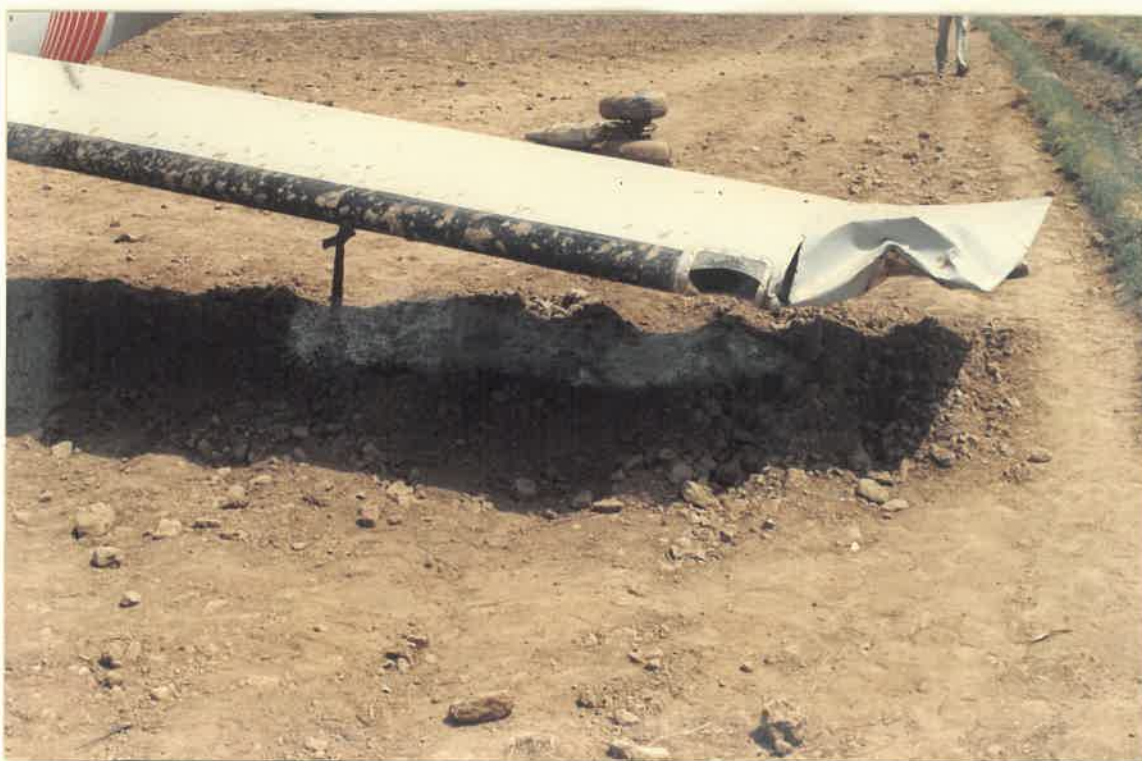
APP. "C" 8

LEFT WING TIP DAMAGED (FRONT VIEW)

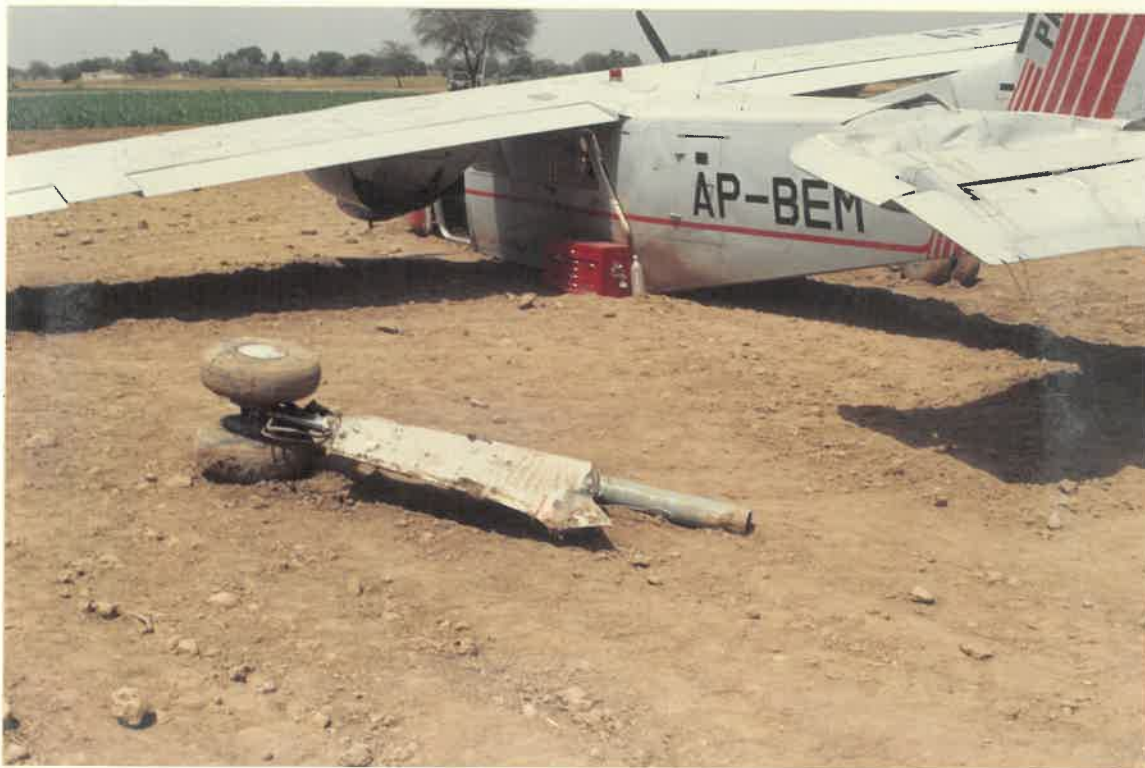
APP. "C" 9

LEFT UNDER CARIAGE BROKE FROM ITS MOUNTING BASE

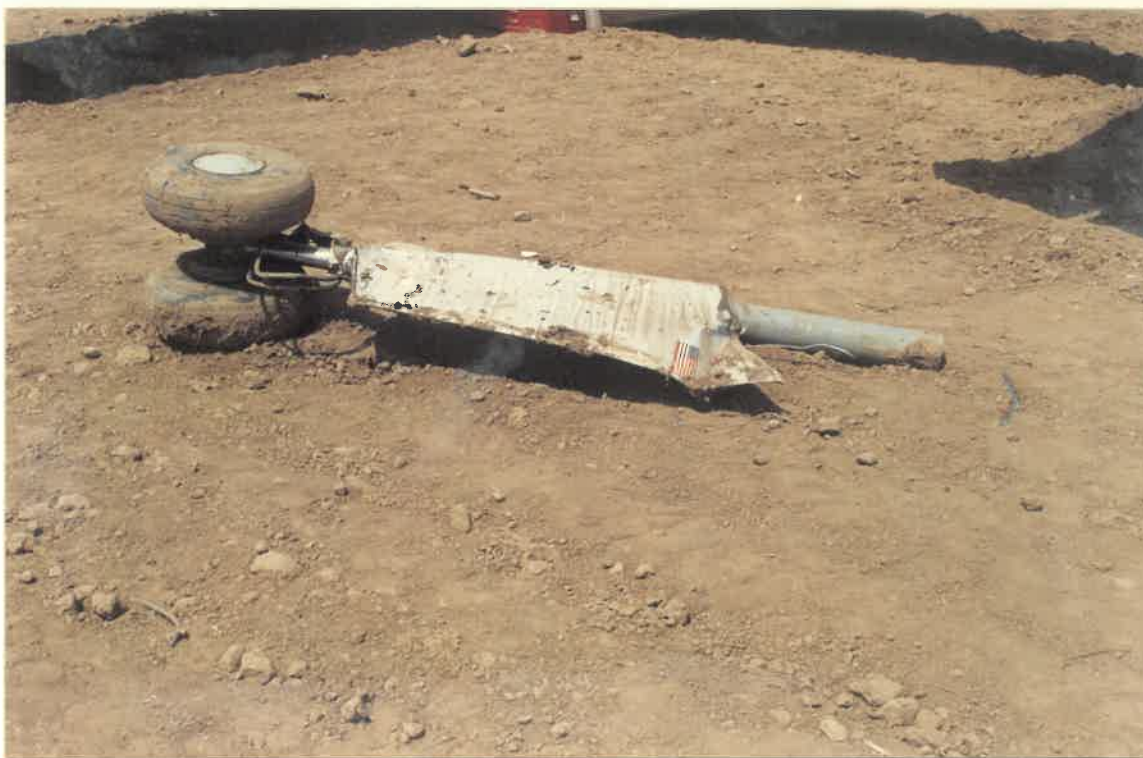
APP. "C" 10

LEFT UNDER CARIAGE

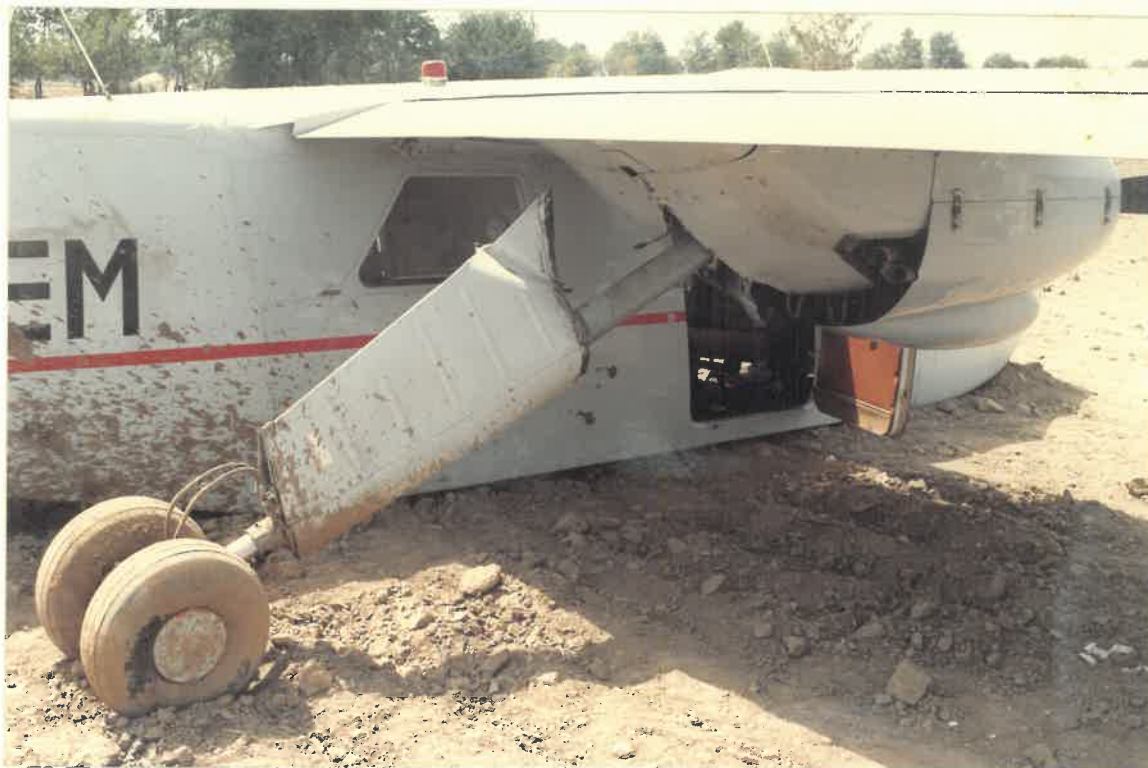
APP. "C"<sub>11</sub>

RIGHT UNDER CARIAGE BROKE FROM ITS MOUNTING BASE

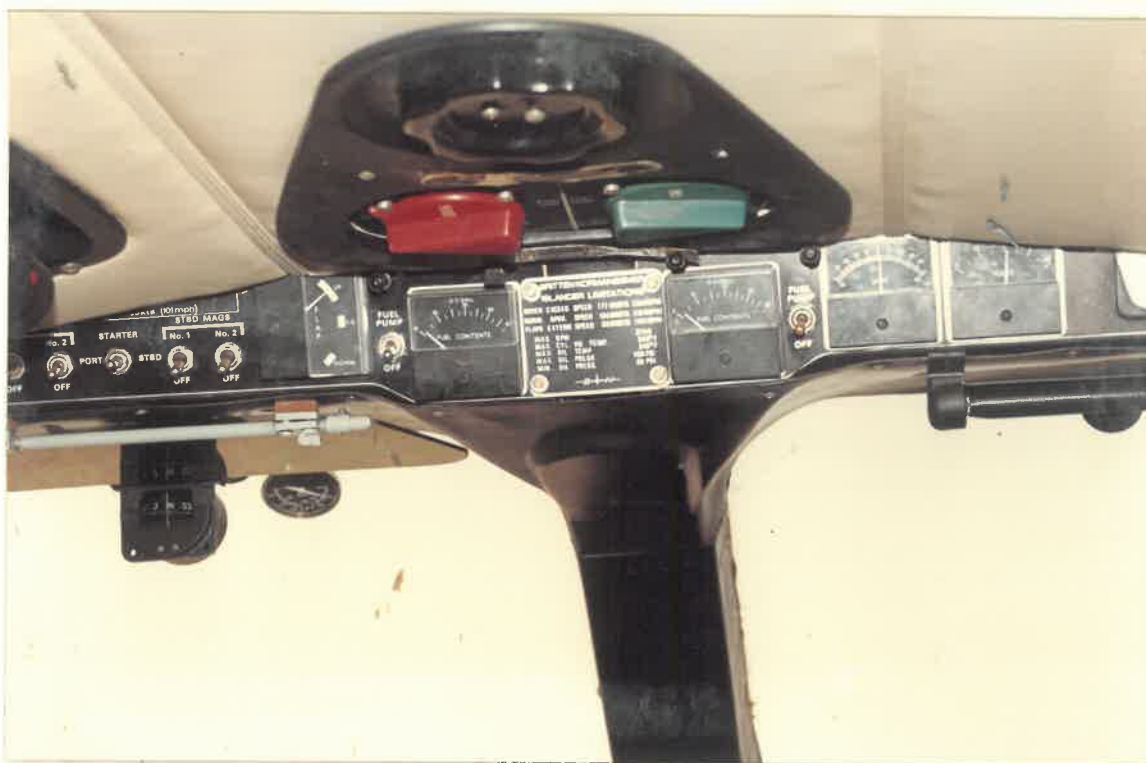
APP. "C"<sub>12</sub>

- 20.1. The cause of the accident was that pilot did not plan the charter flight with the help of relevant performance charts as per the mission profile, and the amount of fuel required was not calculated properly.
- 20.2. Both the Engines failed after 4:10 hours of flight time due to fuel starvation as no refuelling was carried out due to poor mission planning.

BOTH FUEL QUANTITY INDICATOR READING ZERO
