REPORT ON INCIDENT TO M/s.PIAC's BOEING-707  
A/C AP-AXA ON 19-4-88 AT KARACHI AIRPORT WHILE  
PUSH BACK FOR PK-266 KARACHI - DHAKA FLIGHT

**MEMORANDUM NO.HQ.CAA/1901/85/AIB DT 19-4-88**

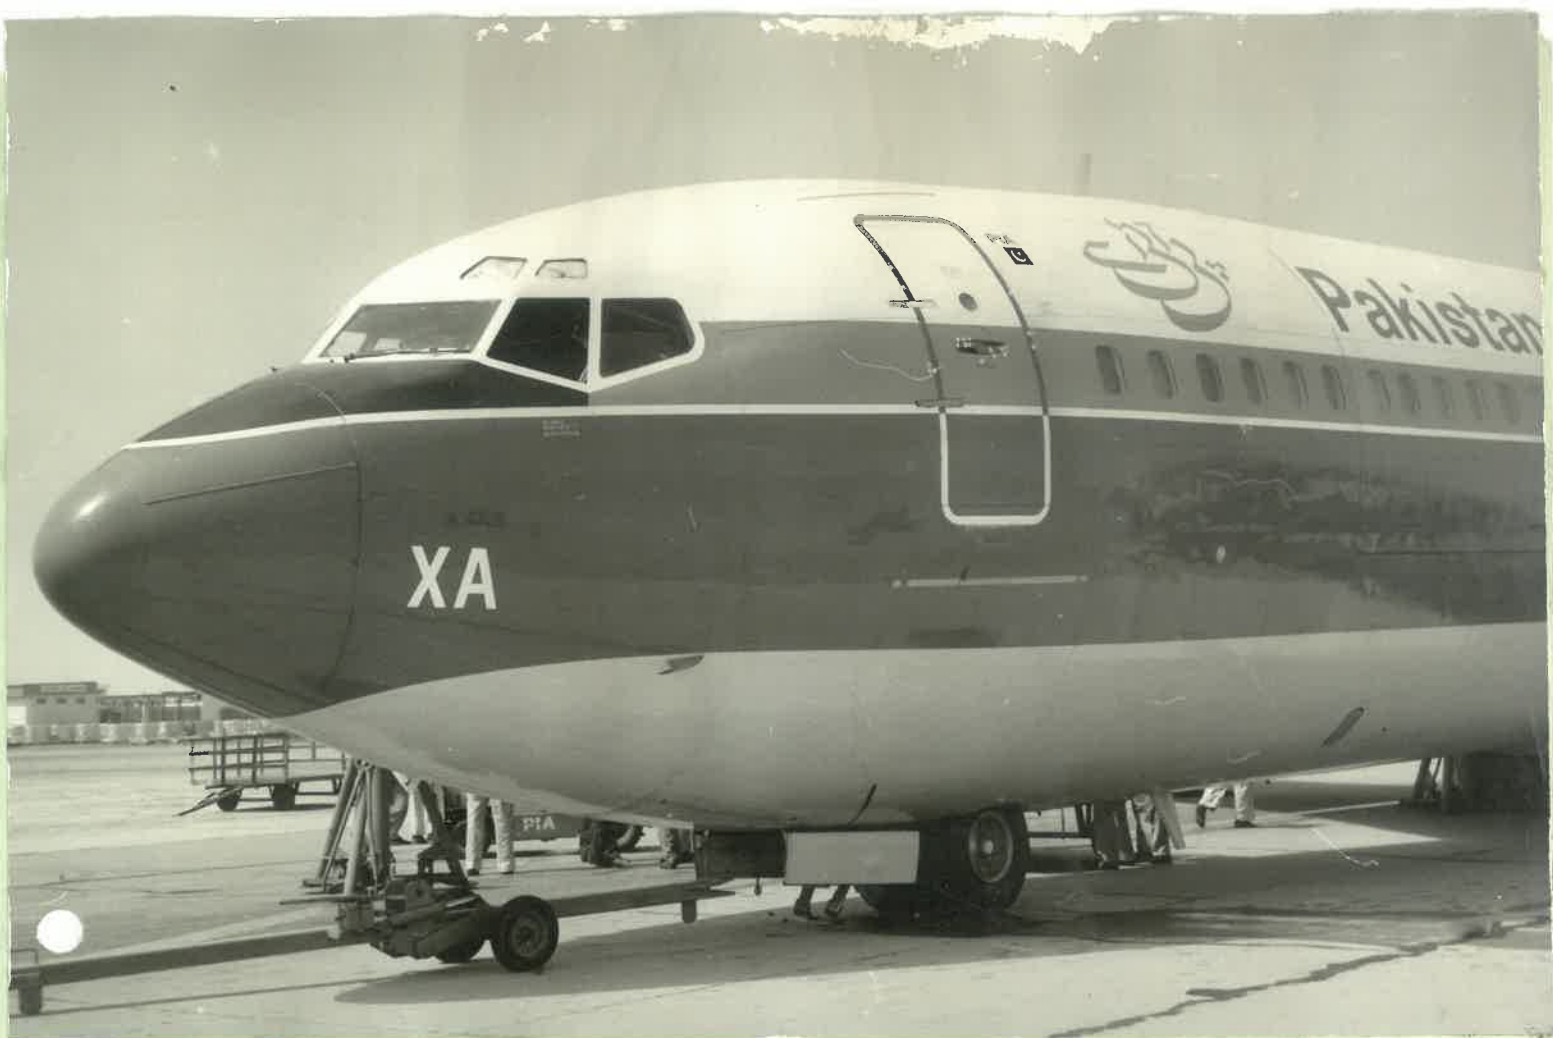
APP. 'D',

- 15.1. Fractured steeple was hand carried to Seattle for metallurgical examination. Results conducted in the lab at Boeing confirms two cracks propagated by intergranular stress corrosion.
- 15.2. The cracks initiated at corrosion pit in the bore of hole drilled for heat treatment process during manufacture.
- 15.3. The fracture basically occurred as a result of this corrosion.
- 15.4. This failure is new to Boeing and Boeing will have to update to have this area inspected.

- 17.5. The Investigation Team examined nose gear area while it was resting on the taxiway. The examination revealed that the outer cylinder steeple fitting had fractured and completely separated from the outer cylinder. The aircraft front fuselage had settled on nose gear tyres.

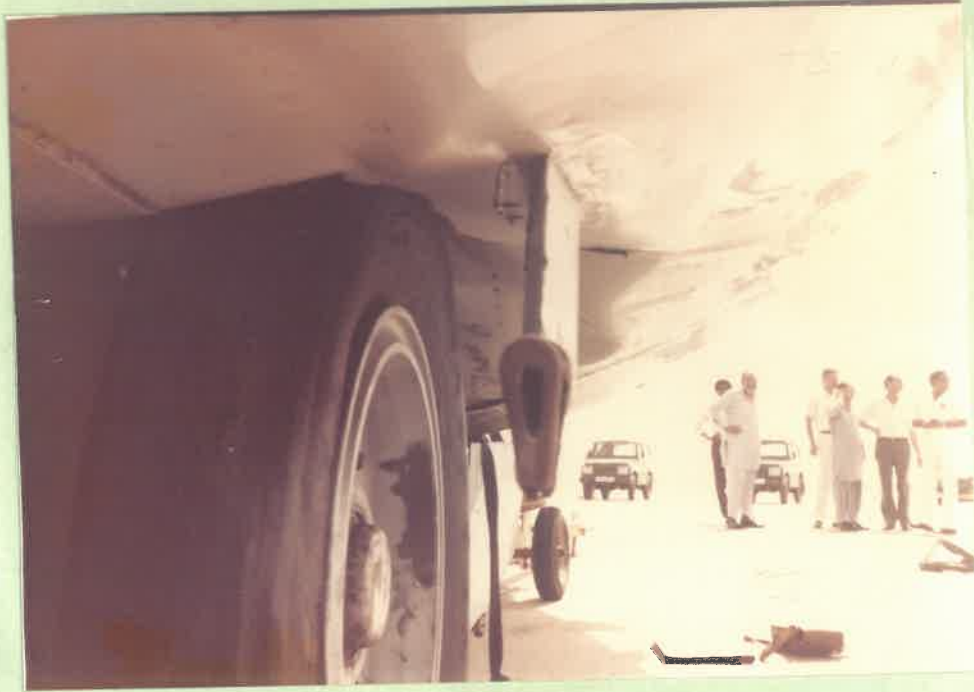
APP "E<sub>2</sub>"

- 17.6. It was seen that secondary damage had occurred from frame station 360 to frame station 460 and between stringers 25L and 25R, clam shell door, L-41 door, nose area pressure and return hydraulic tubings, all were damaged.
