## AIRCRAFT ACCIDENT INVESTIGATION REPORT

### RUNWAY EXCURSION ON LANDING AT PESHAWAR

PK-7302 AP-BAY B-4 ON 21 JANUARY 2005

*Safety & Investigation Board  
Headquarters Civil Aviation Authority*

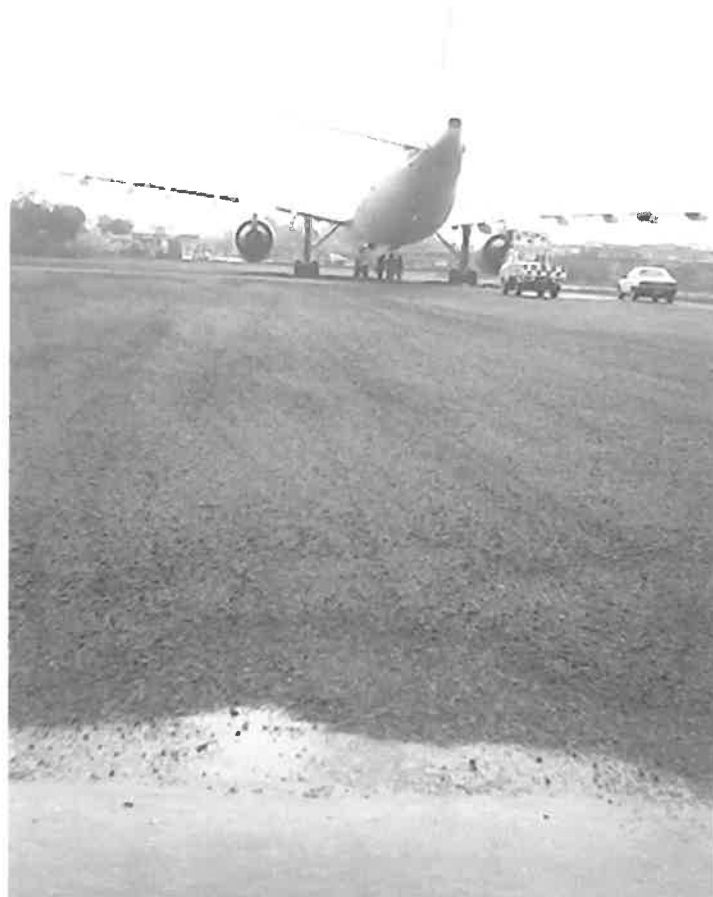
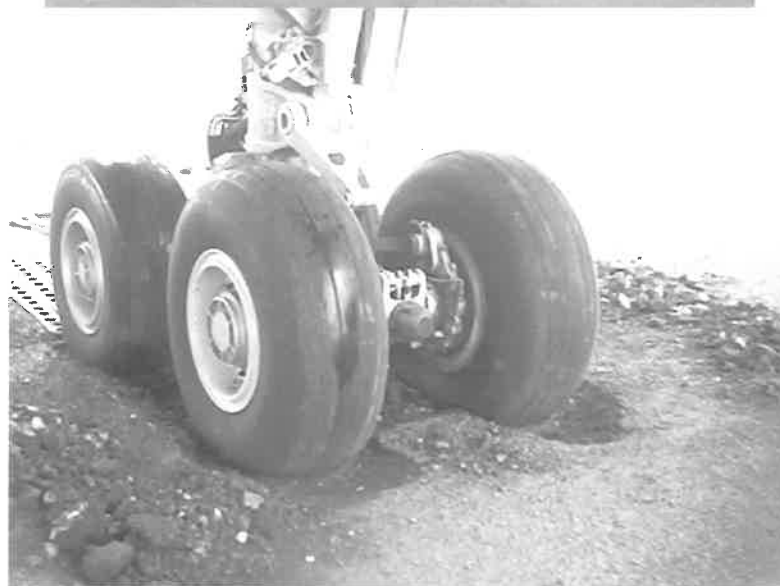
low PCN. During the intended turn about main wheels ploughed the stop way and at the place of stop the aircraft wheels sunk in by 3-4 inches.

6. **Damage.** There was no damage to the aircraft, however, the military aircraft arrester barrier net was damaged beyond repair and the stop way was ploughed by main wheel for about 200 feet.

- k. The stop way was ploughed in the overrun and area around halt position was damaged deeper by main wheels.
- l. The landing roll after brakes became effective corresponds to landing performance data given by the manufacturer.
