**INQUIRY INTO AIRCRAFT  
ACCIDENT IN WHICH AIRCRAFT  
CESSNA 310 AP-AVS WAS FIRED**

**UPON FROM THE GROUND  
ON 7<sup>TH</sup> OCTOBER 2002,  
RESULTING IN FATAL INJURIES  
TO AN ONBOARD AIRCREW**

**CIVIL AVIATION AUTHORITY**  
**PROCEEDINGS OF INQUIRY INTO AIRCRAFT ACCIDENT**  
**IN WHICH CESSNA-310 WAS FIRED UPON FROM THE**  
**GROUND ON 07-10-2002**

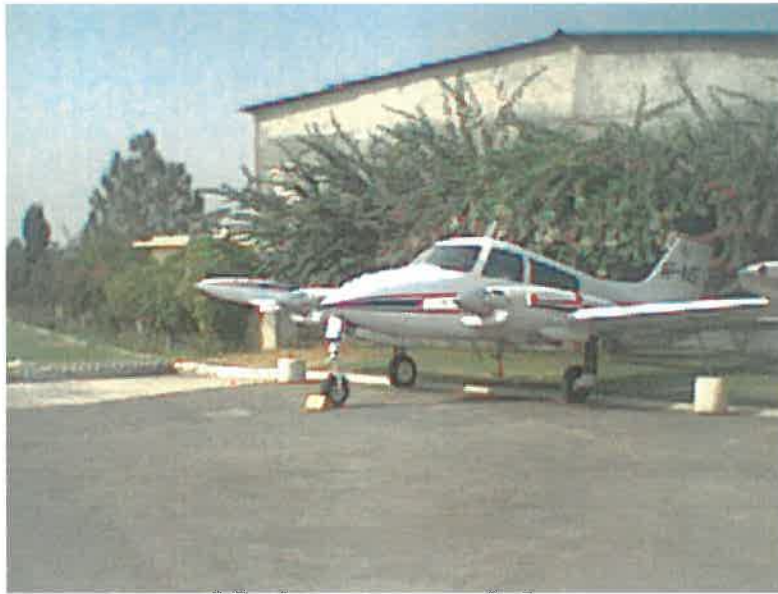
**EXHIBIT A-3**

Cessna 310P AP-AVS aircraft belonging to Hybrid Technics MCB parked at Peshawar Flying Club after the incident.

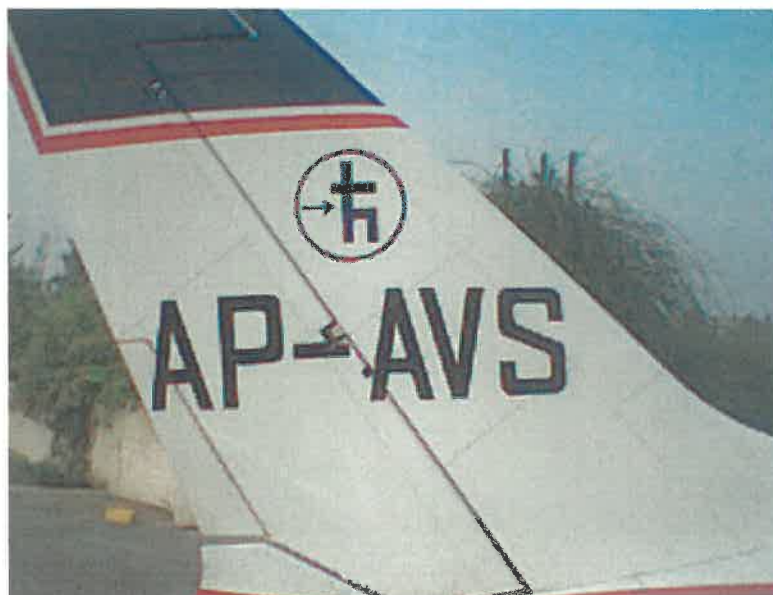
**EXHIBIT A-4**

Aircraft registration mark.

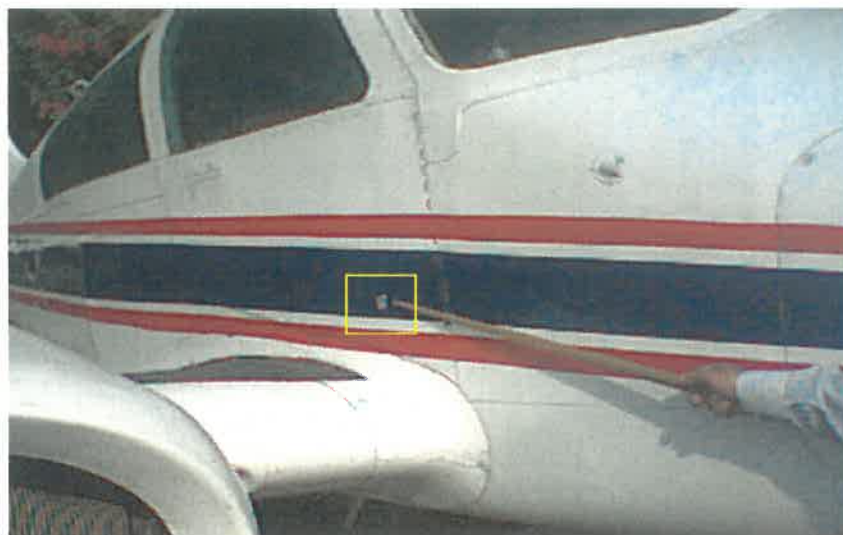
**EXHIBIT A-5**

Bullet hole created by bullet 'A' entering the right cockpit door approx 7 inches behind the door hinge (also see Exhibit A-6) and exited from the cockpit roof (also see exhibit A-7 and 8) after hitting the co-pilot. This was the fatal bullet that killed the co-pilot.

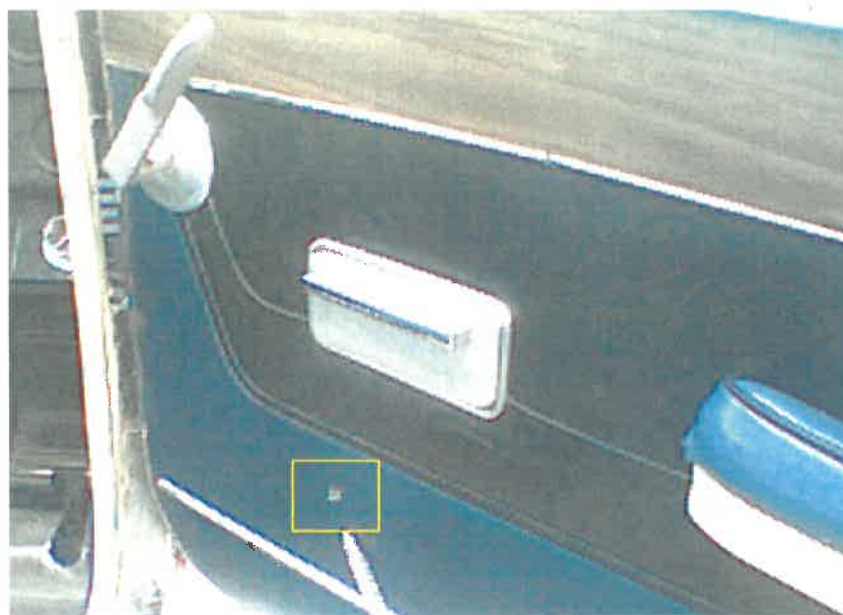
**EXHIBIT A-6**

Bullet hole on the inner side of the right cockpit door created by bullet 'A' entering the right cockpit door.

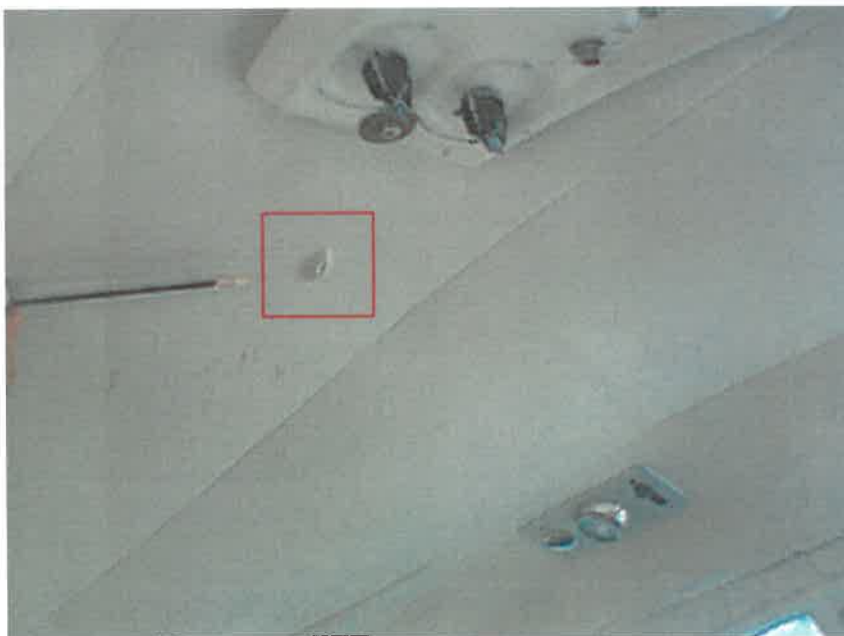
**EXHIBIT A-7**

Bullet hole on the inner side of cockpit roof created by bullet 'A' after entering the right cockpit door.

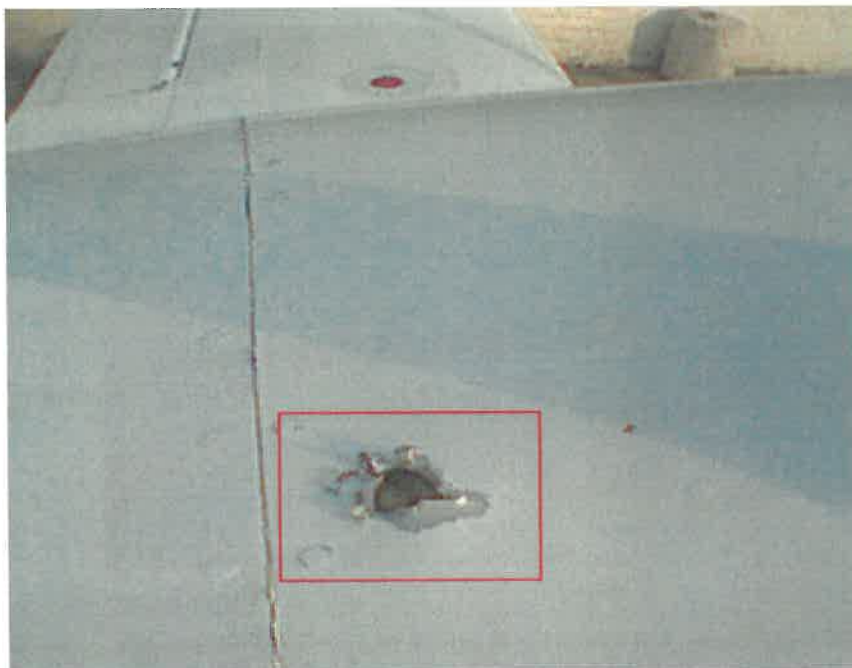
**EXHIBIT A-8**

Bullet hole on the outer side of the cockpit roof created by bullet 'A' that entered the right cockpit door.

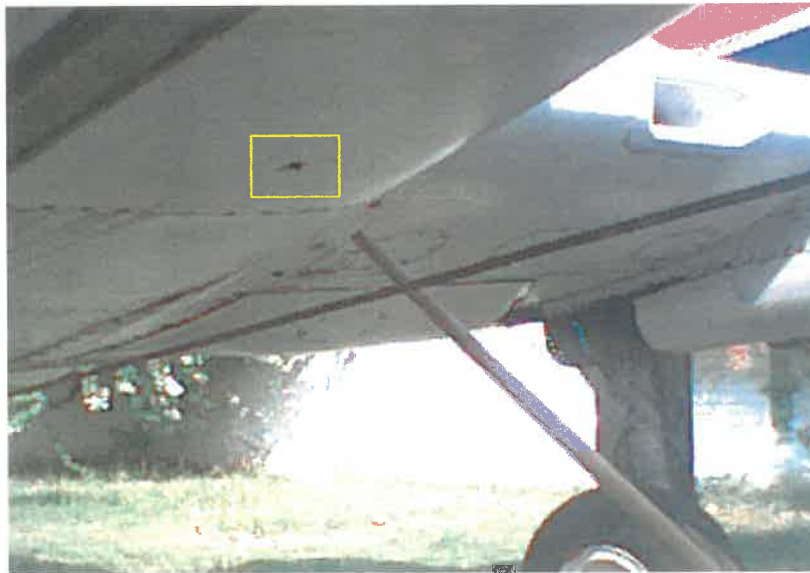
**EXHIBIT A-9**

Bullet hole created by bullet 'B' entering the cabin from the lower left portion of the fuselage 5 inches forward of the 3rd bulkhead and exited from left side of the fuselage behind the 3rd bulkhead damaging some electrical wires (also see exhibits A-10 and A-11).

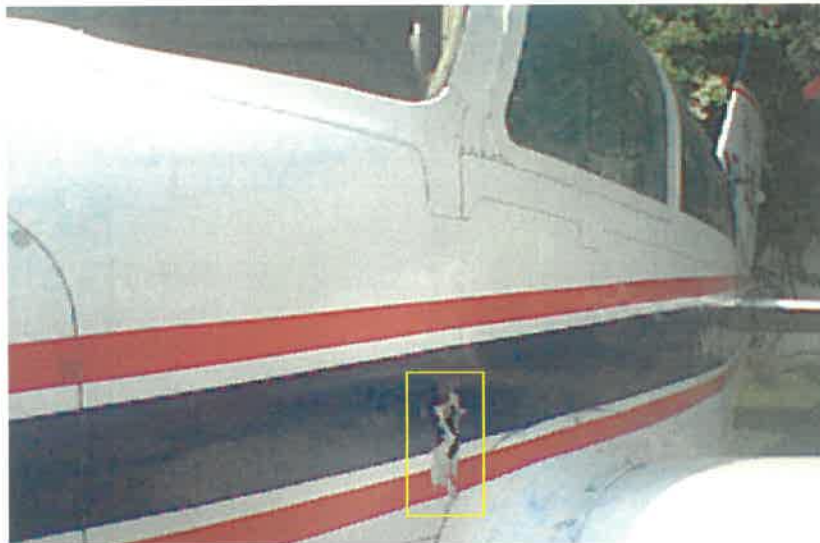
**EXHIBIT A-10**

Bullet hole created by bullet 'B' entering the cabin from the lower left side of fuselage and exited from left hand side of fuselage (refer to Exhibit A-9 and A11 also)

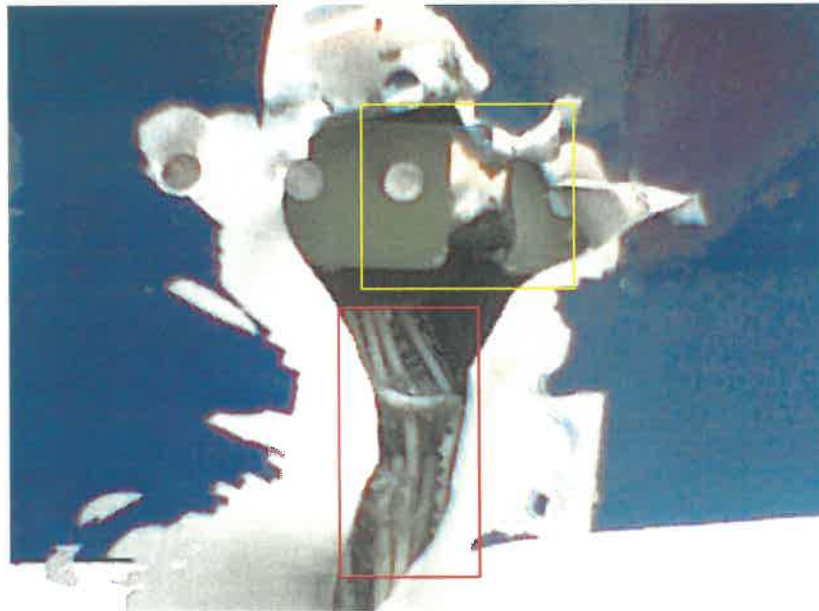
**EXHIBIT A-11**

- g) Exhibit A-11 shows electrical wires and internal structure damaged by the bullet 'B' entering from the lower left portion of the fuselage and exited from the left hand side of the fuselage (also see Exhibit A-9 and 10).

Electric wire and internal structure damaged by the bullet "B" entering from the lower left portion of the fuselage and exited from the left hand side of the fuselage (also see Exhibit A-9 and 10)

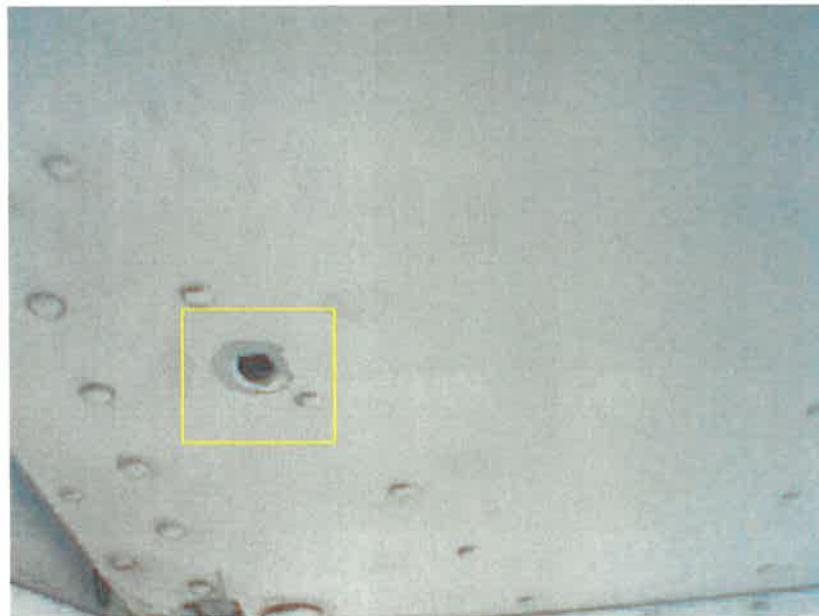
**EXHIBIT A-12**

Bullet hole created by bullet 'C' entering vertical from the lower portion of the right aileron and exiting the upper portion of the aileron only damaging the fuselage skin (refer exhibit A-13)

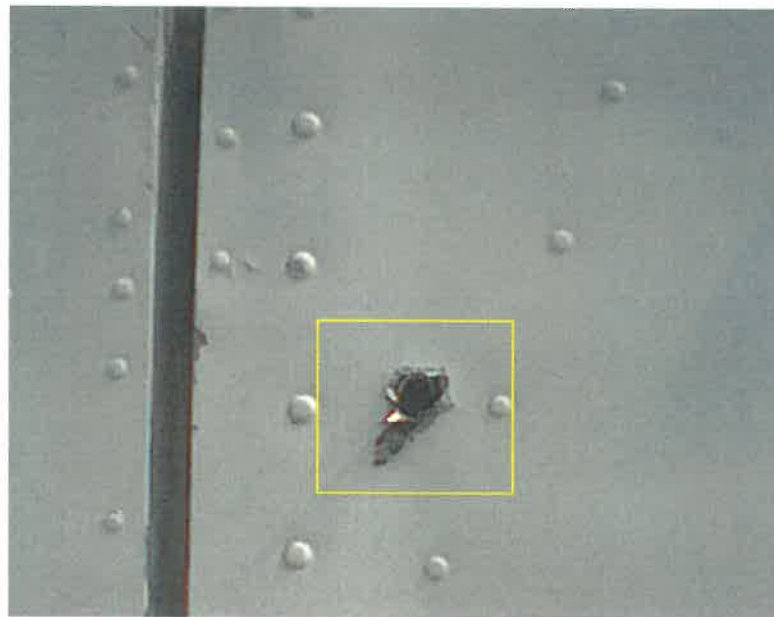
**EXHIBIT A-13**

Bullet hole created by bullet 'C' on the upper portion of the right aileron, entering vertical from the lower portion of the right aileron (also see exhibit A-12)

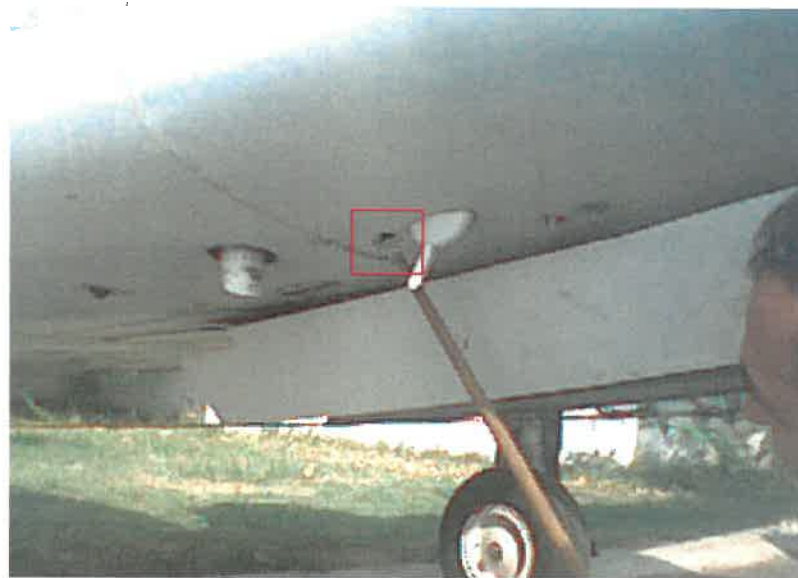
**EXHIBIT A-14**

- l) Exhibit A-14 shows a bullet hole created by bullet 'D' entering the nose wheel well from the right lower side of the fuselage. This bullet damaged the outer fuselage skin and a portion of the forward No.2 bulkhead channel (also see Exhibit A-15). The bullet continued by hitting the nose wheel well roof (refer Exhibit A-16), but did not penetrate the roof neither did it damage the nose landing gear which was retracted at the time. Only a small metal piece was found embedded in the nose tire.

Bullet hole created by bullet 'D' entering the nose wheel well from the right lower side of fuselage. This bullet damaged the outer fuselage skin and a portion of the forward No 2 bulkhead channel (refer to Exhibit A-15). The bullet continued by hitting the nose wheel well roof (Refer to Exhibit A-16), but did not penetrate the roof, neither did it damage the nose landing gear which was retracted at the time. Only a small metal piece was found embedded in nose tyre (refer to Exhibit A-17)

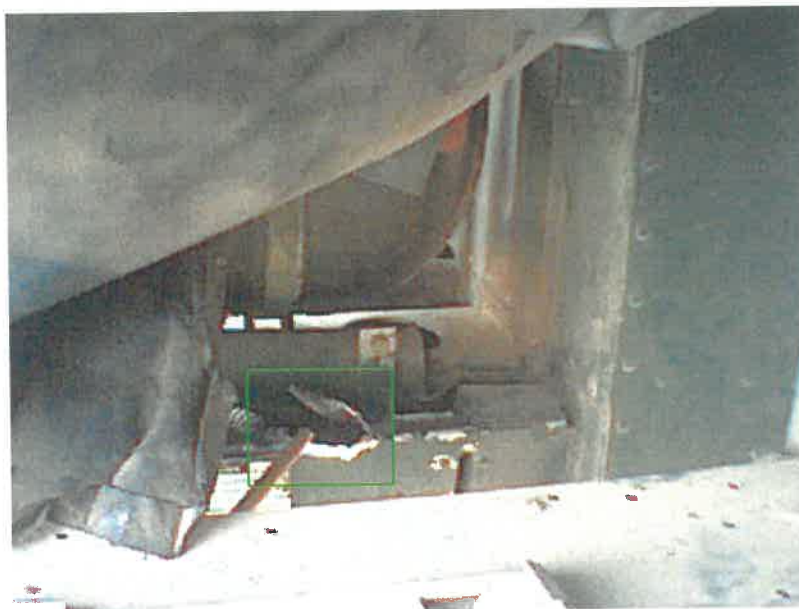
**EXHIBIT A-15**

- m) Exhibit A-15 shows bullet 'D' damaged a portion of the forward No.2 bulkhead channel.
- n) Exhibit A-16 – shows a small mark on the roof of the nose landing gear well created by the bullet 'D' that entered the nose wheel well from the left lower side of the fuselage.

Bullet 'D' damaged a portion of the forward No.2 bulkhead channel.

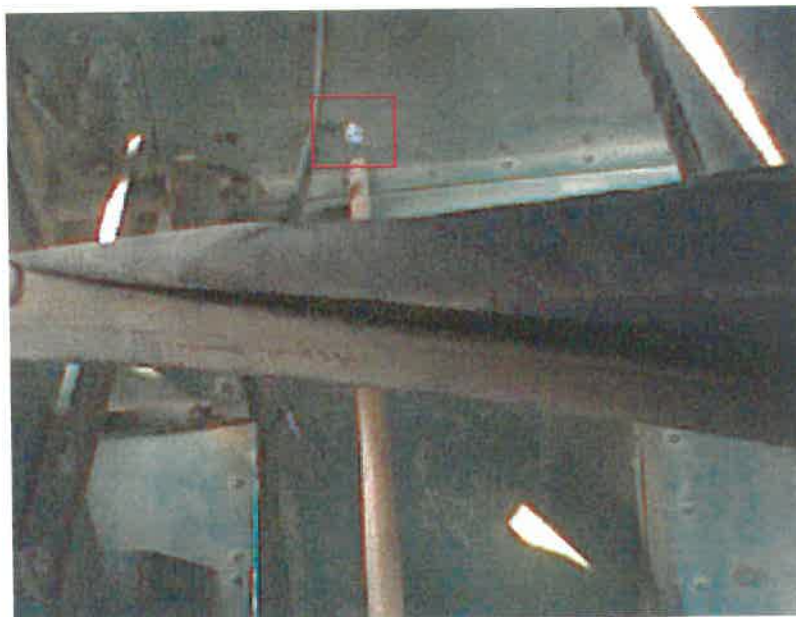
**EXHIBIT A-16**

A small mark on the roof of the nose landing gear well created by the bullet 'D' that entered the nose wheel well from the left lower side of the fuselage.

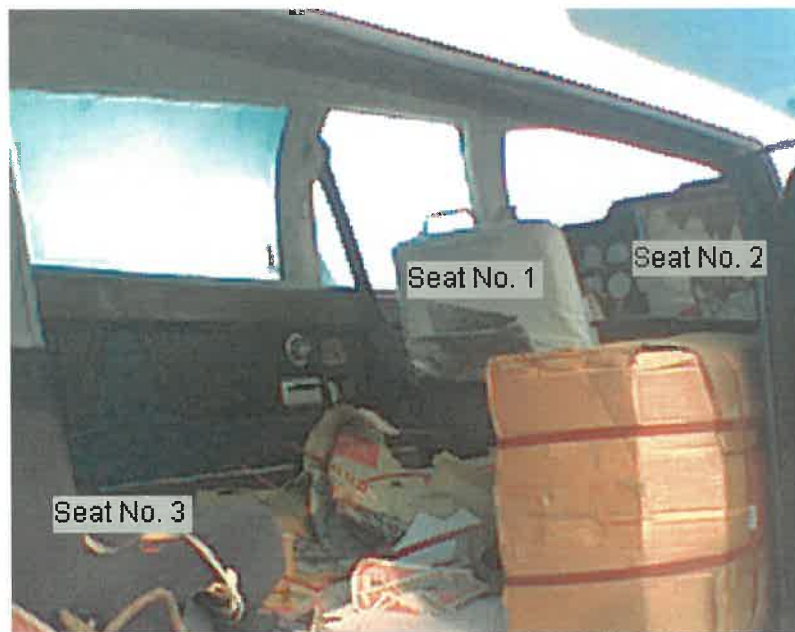
**EXHIBIT A-17**

- a) ANO 92.0007 Issue-2, 8<sup>th</sup> August 2000 requires an aircraft to have a seat for each person who is aged two years or more. The seats found installed in the aircraft were three whereas the total personnel on board were four.
- b) As required by ANO 92.0007 Issue-2, 8<sup>th</sup> August 2000 require an aircraft to carry adequate first aid kit appropriate to the number of passengers. The 1<sup>st</sup> aid kit was found missing.
- c) The certificate of radio installation as required by ANO 92.0007 Issue-2, 8<sup>th</sup> August 2000 was found missing. The remaining documents found on board were photocopies and not in original.
- d) The revised C of R bearing number 417 issued on 10<sup>th</sup> January 2001 was not kept on board. Further more ANO 92.0007 Issue-2, 8<sup>th</sup> August 2000 requires original documents to be placed on board, whereas photocopies were found.

- (a) Operations manual and passengers' manifest was not on board the aircraft, in violation of rule 253 of CAR 94.
- (b) One person was sitting on floor of the aircraft, in violation of rule 246 (c) of CAR 94 and ANO 92.007 dated 8<sup>th</sup> August 2000.

Three seats are shown whereas there were four passengers on board.

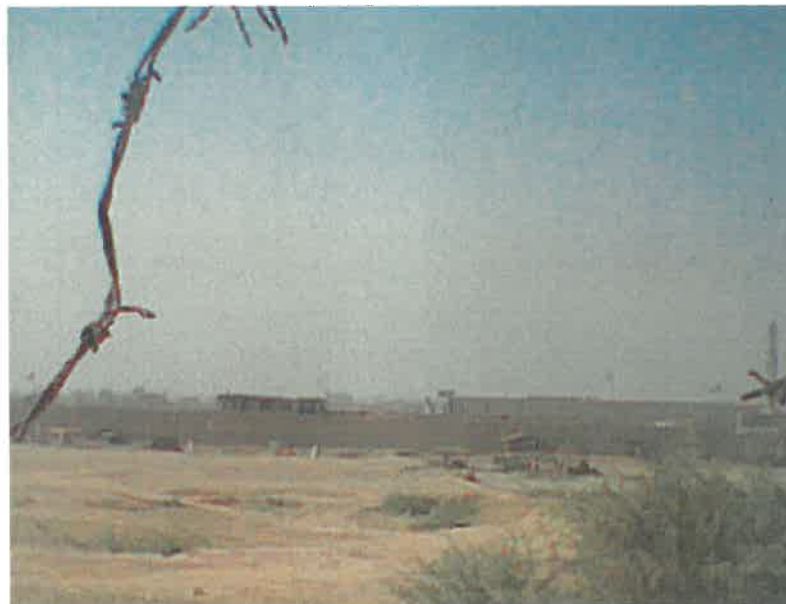
**EXHIBIT A-18**

Location from where the gun shoots were fired at the aircraft.

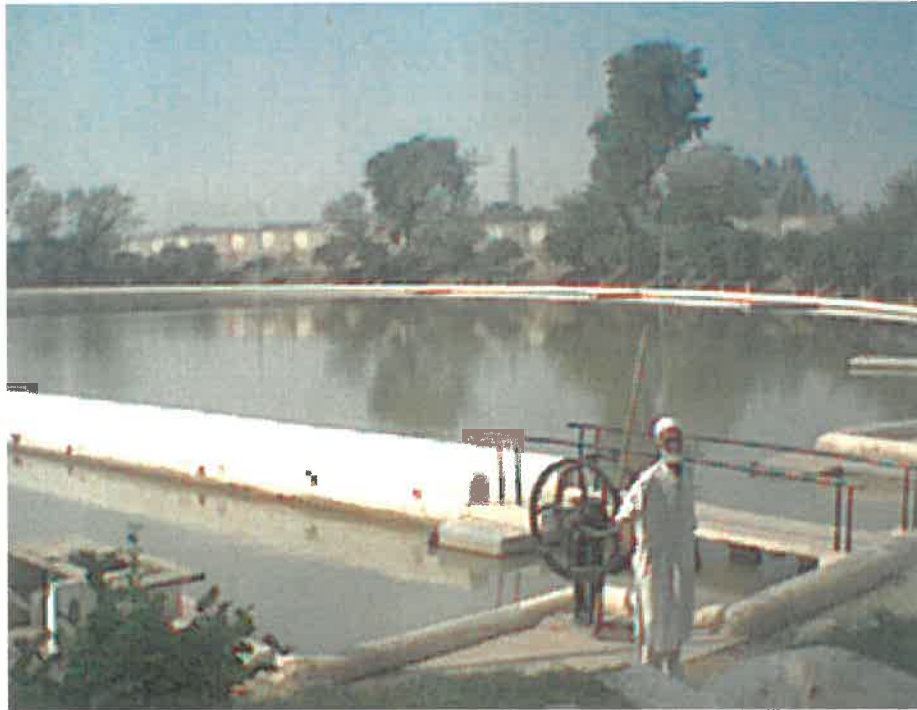
**EXHIBIT A-19**

10. **Accident Area Information.** The pilot in his statement has mentioned that there was a circular water pond in the area of accident. There is only one circular water pond in the vicinity and the water pond referred by PIC (Answer to Q No 22 by witness No 1) is a PAF M.E.S. water supply pond that is located in Bara. Therefore it is confirmed that the aircraft was over Bara at the time of accident. Bara area is lightly populated area and general elevation is 1500 feet. At the time of accident there was a political rally being conducted in Bara area. This gathering, from where most probably firing took place, was being held next to the water pond boundary wall (Refer to Exhibit A-19). The location of water pond is approximately 213<sup>0</sup> and 4.6 NM from beginning of runway 35 of Peshawar airfield.

PAF circular water reservoir at Bara.
