**INVESTIGATION REPORT ON THE ACCIDENT INVOLVING**  
**AIR FRANCE BOEING-747 UNITED STATES REGISTRATION**  
**N-1252E WHICH OCCURRED ON 18TH JANUARY, 1984**  
**NEAR KARACHI**

Authority: D.G.C.A.A. M E M O R A N D U M (APP.A)

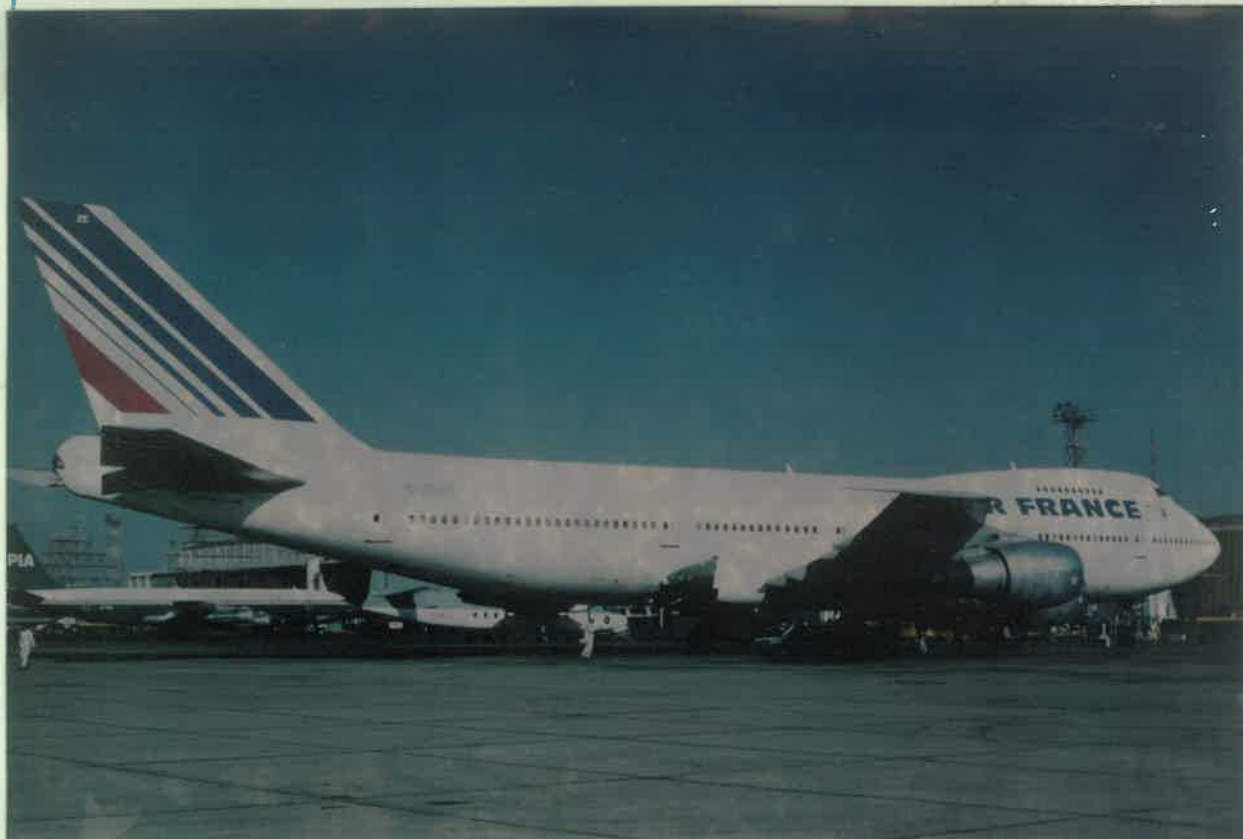
APP. B-1

5.1. Due to explosion inside the cargo hold, a hole was caused on the right side of the fuselage aft of the right landing gear. ( See Appendix B1 ) the explosive forces assisted by the pressure differential, between the inside of the fuselage and outside, caused additional tearing of fuselage skin.

1. Photographs showing damage to the aircraft on the right side of the fuselage aft of the right landing gear.

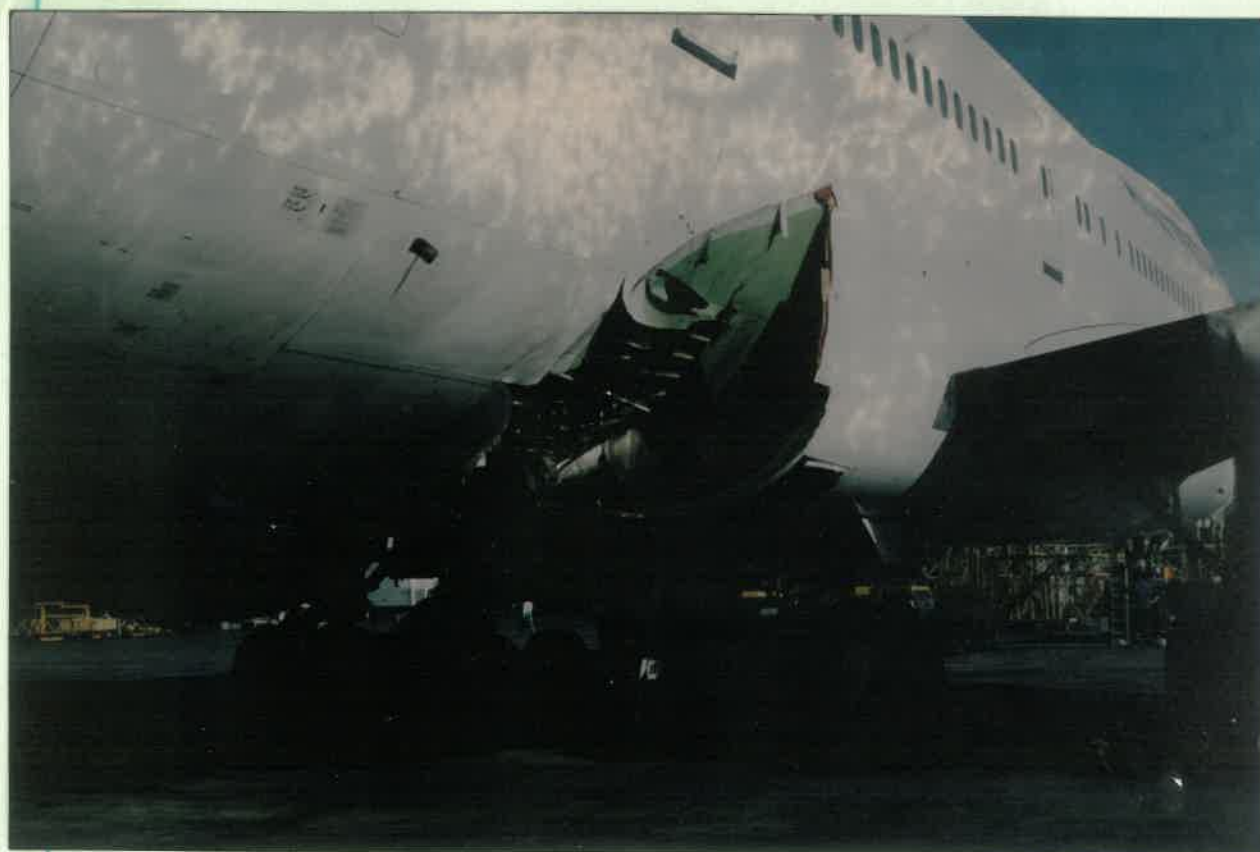
APP. B-2

12.1. This aircraft, parked on bay No.6, was identified as B-747 bearing Nationality and Registration Marks N 1252E, operating in Air France liveries. It was inspected at its parked position before off-loading of cargo. Only one hole was noticed in the aircraft fuselage aft of the right landing gear opposite the rear cargo hold. There was no other damage. (Appendix B 2,3 )

2. Close up view of the damage.

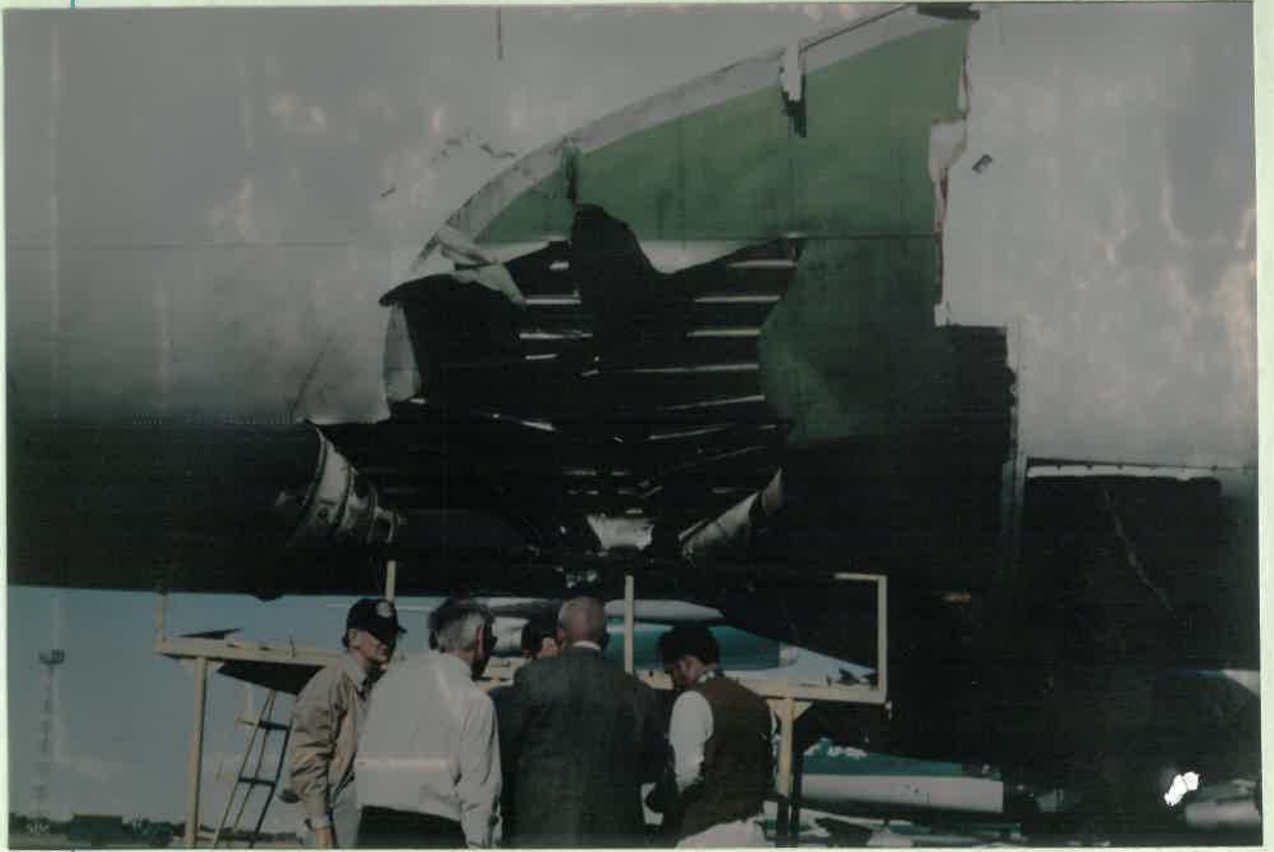
APP. B-3

3. Another close up view of the damage.

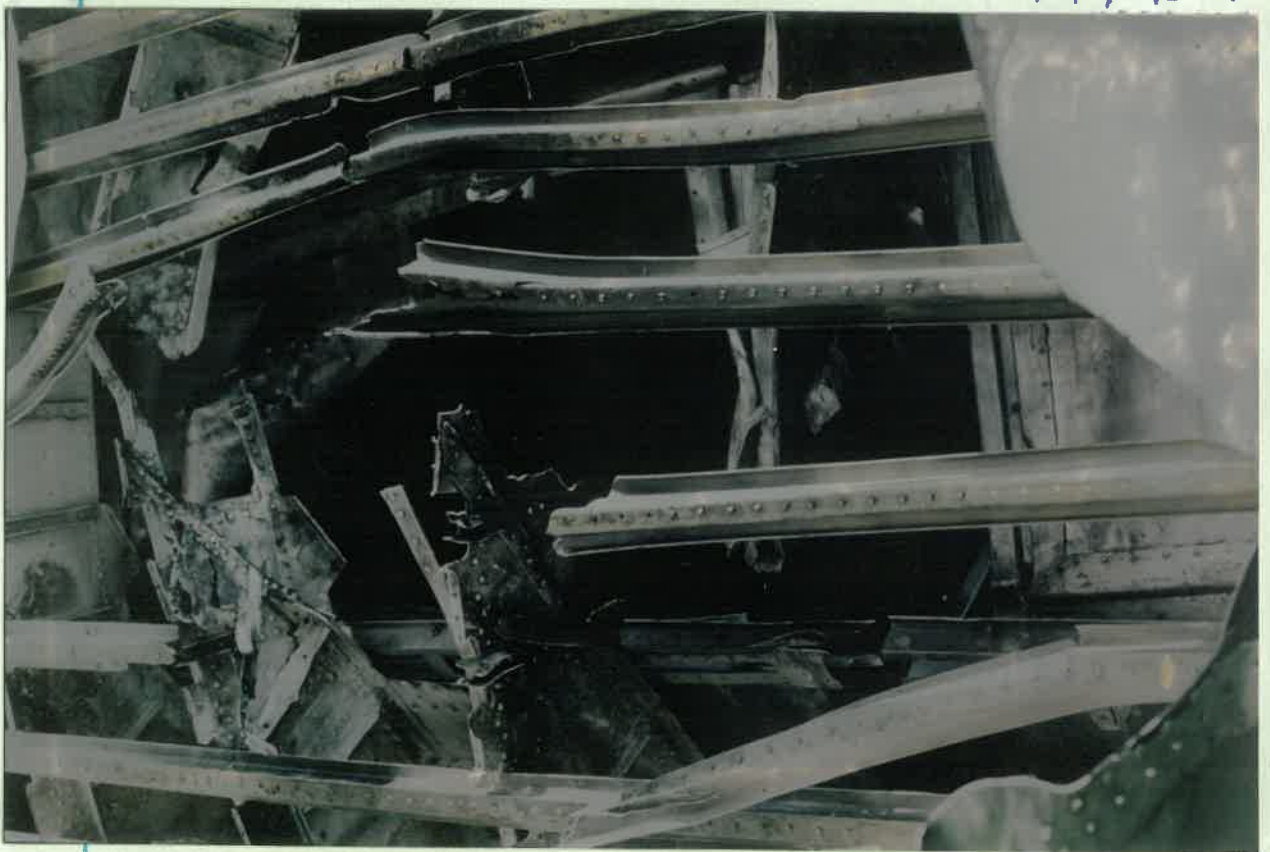
APP. B-4

4. Photographs showing the factured ribs of the aircraft.

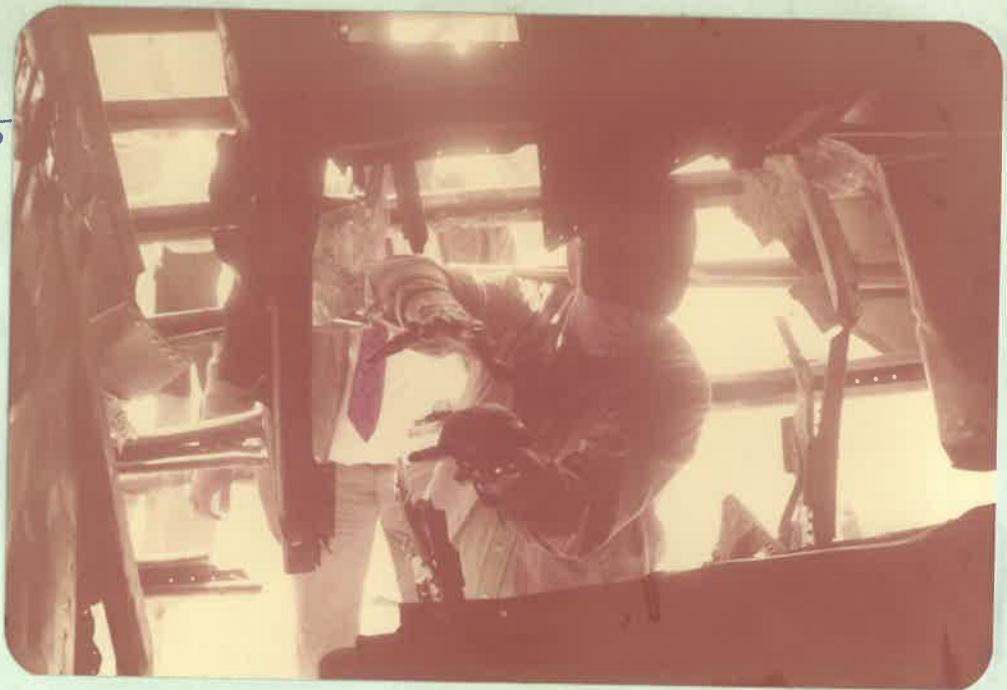
APP-B-5  
1

Photo showing possible location of explosive charge

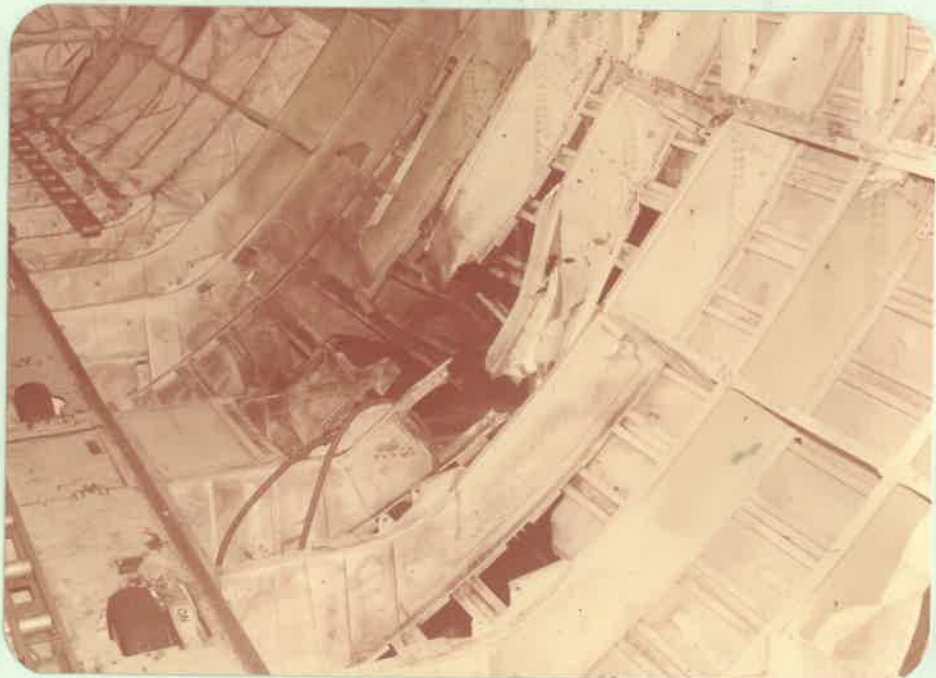
APP-B-5  
2

Damaged fuselage from inside.

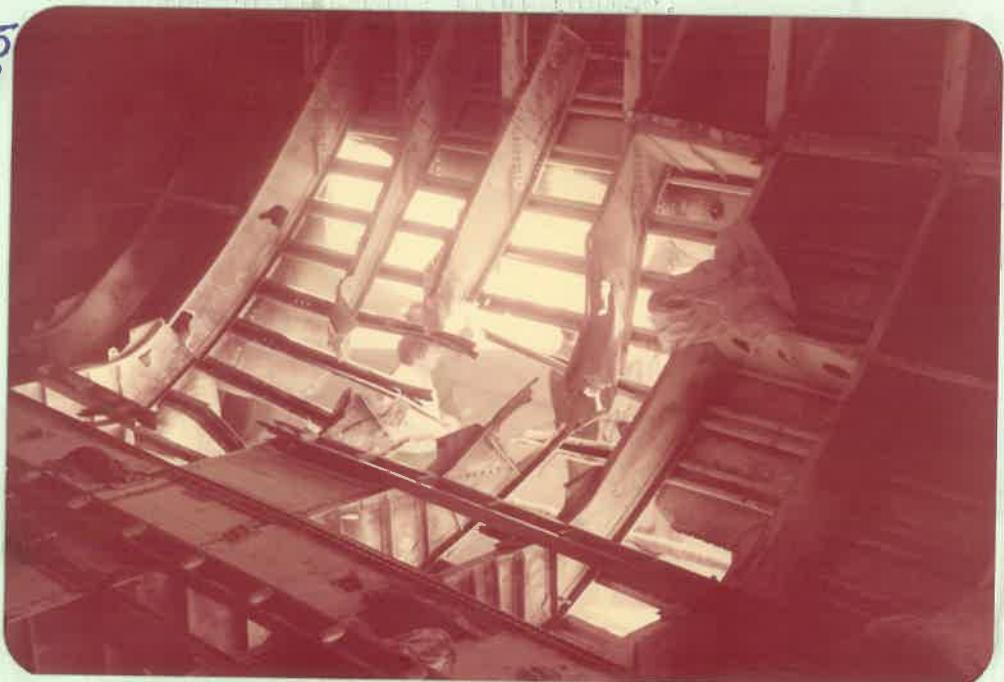
APP-B-5  
3

Damaged fuselage seen from inside.

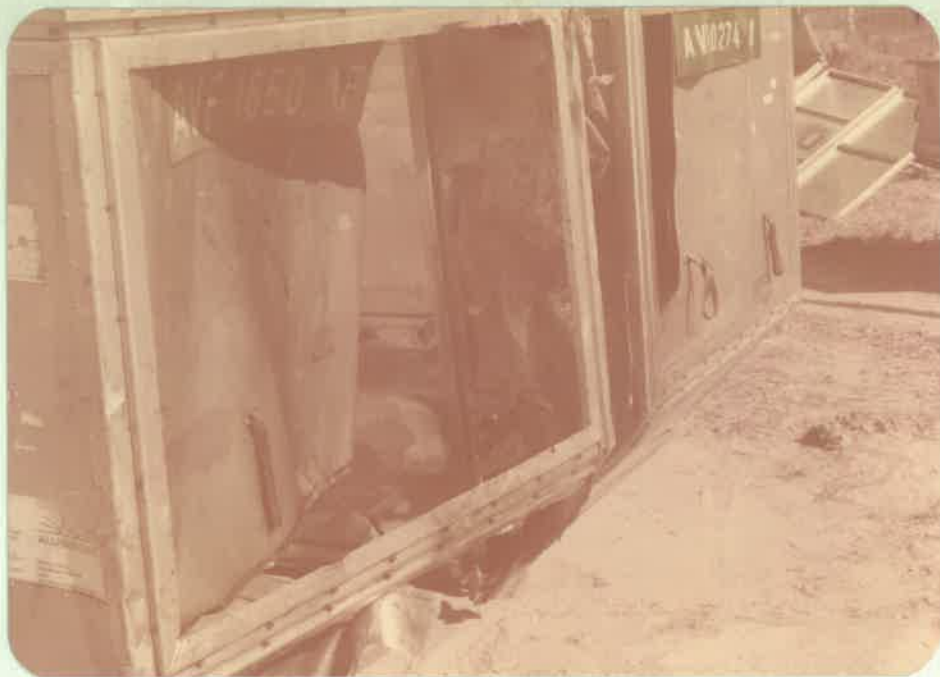
APP B-5<sub>4</sub>

Damaged containers No AVE0274AF & AVE 1650 AF

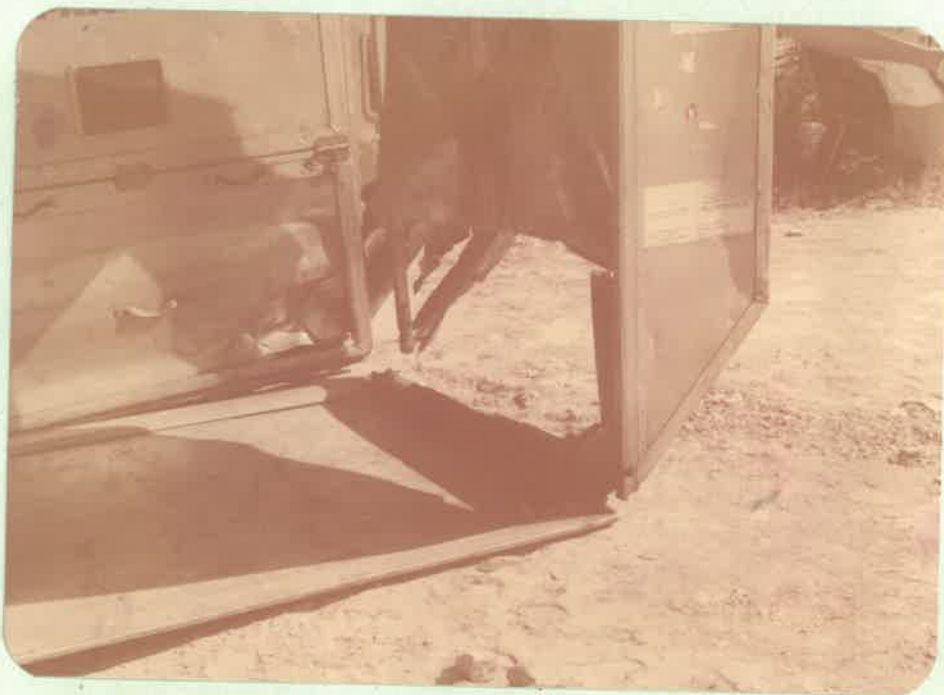
APP B-5<sub>5</sub>

Another view of container AVE 1650 AF

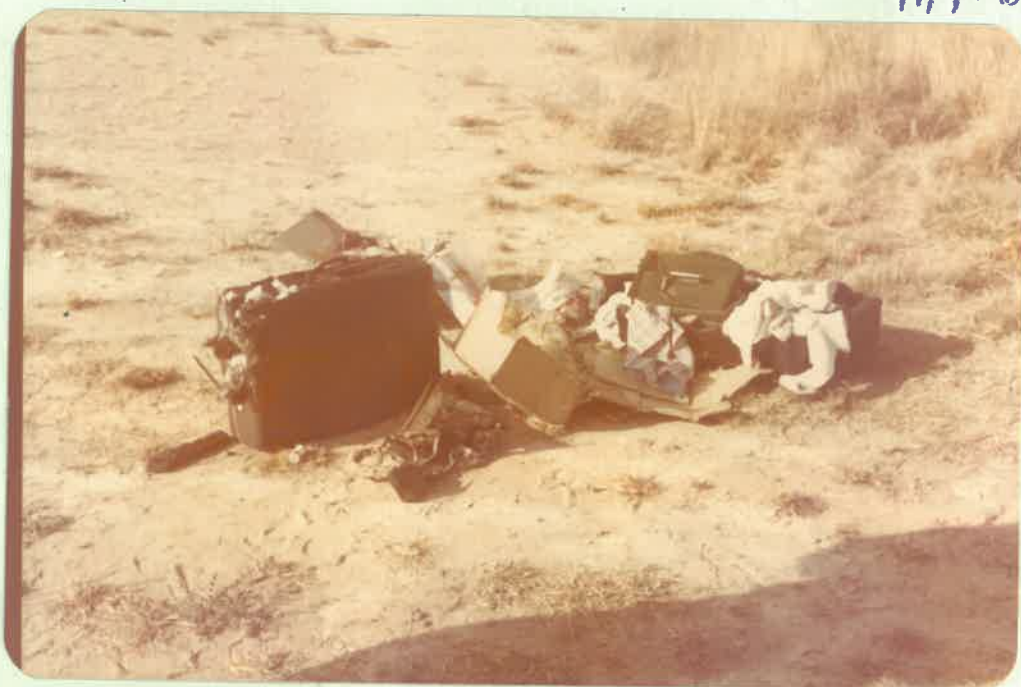
APP B-5<sub>6</sub>

Damaged baggage removed from container AVE 1650 AF

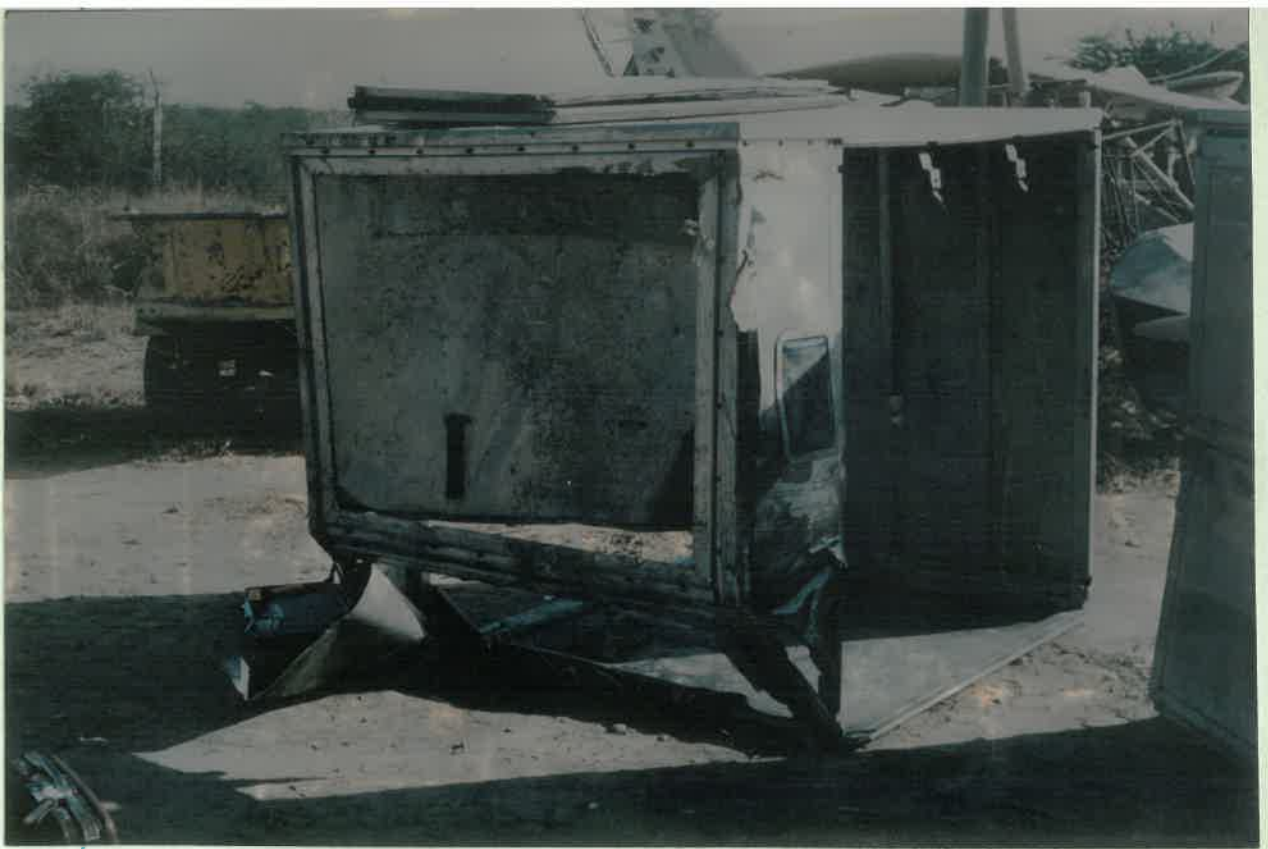
APP. B-6

- 21.1. Fuselage sustained damage due to explosion of industrial type of dynamite in the baggage container No.AVE-1650 AF. The explosive device was most probably in the bag which was the property of Mr.Monreal Agusti luis.

6. Photograph of the damaged container No. AVE 1650AF in which the explosion occurred.

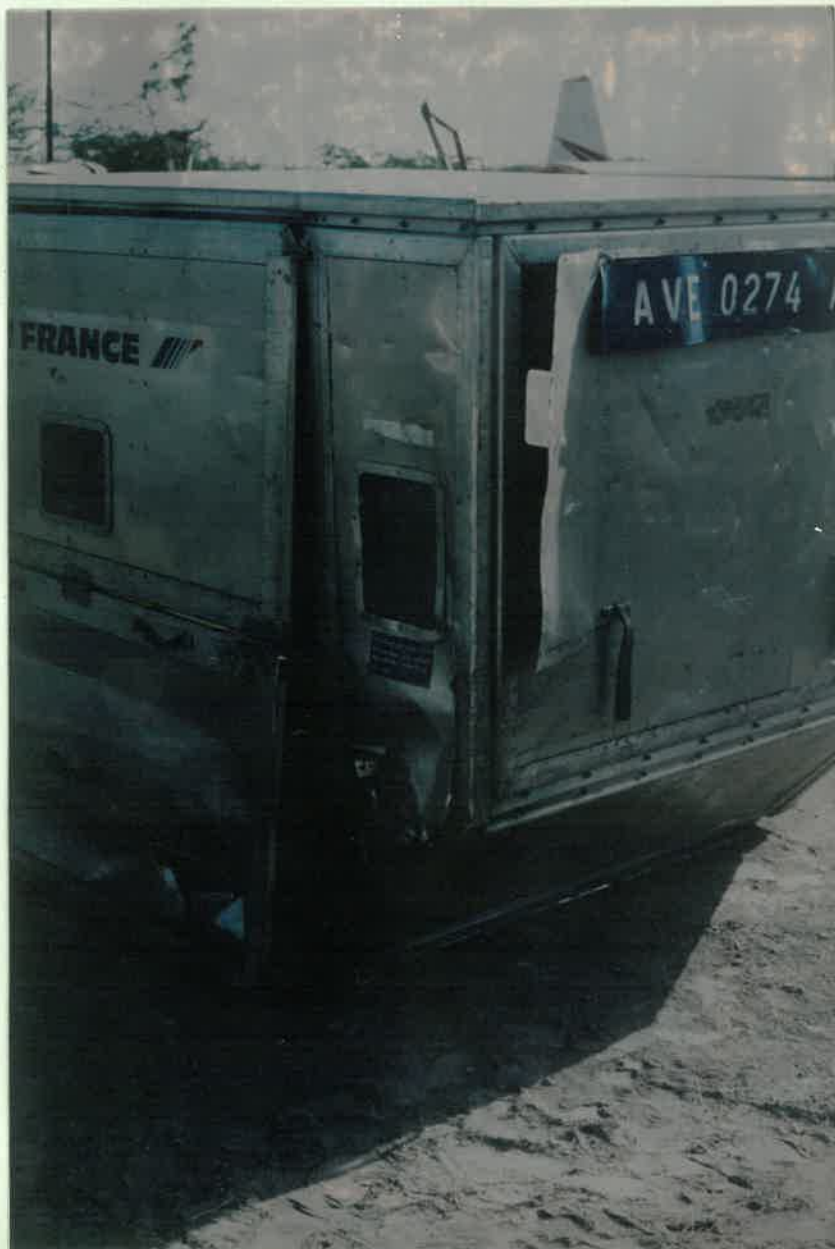
APP. B-7

7. Photograph of the container No. AVE 0274 AF which was placed next to container AVE 1650 AF and which was also damaged due to the explosion.
