**PAKISTAN CIVIL AVIATION AUTHORITY**  
**(SAFETY & INVESTIGATION BOARD)**

**SERIOUS INCIDENT TO GULF STREAM-1 OF  
M/S. KING AIR SERVICES (SOUTH AFRICA) REG. NO.  
ZS-NHW ON 14 MARCH 2007  
AT  
ISLAMABAD INTERNATIONAL AIRPORT**

## FINAL REPORT

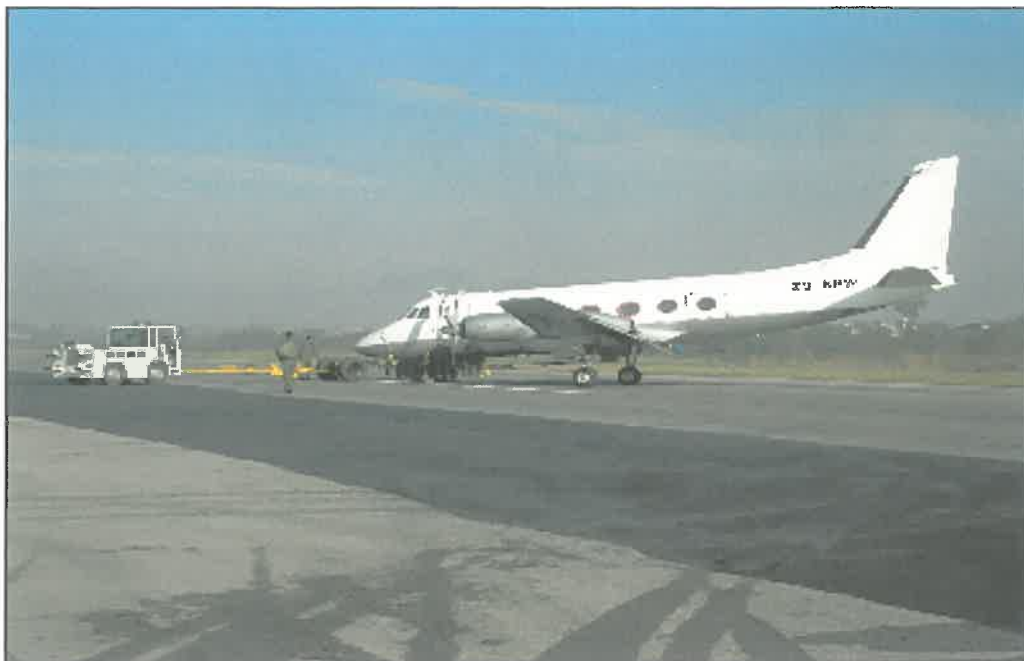
APPENDIX K1

**SYNOPSIS:** On 14 March 2007 a non scheduled cargo flight, aircraft Gulf Stream-I, operated by Air King South Africa landed on Islamabad runway with nose landing gear (NLG) in retracted position. The aircraft was on a chartered flight from Muscat to Islamabad (**Appendix 'B'**). The notification of serious incident as per ICAO Annexure 13 was issued (**Appendix 'C'**). The NLG could not be extended despite of all efforts by aircrew and was confirmed in retracted position by ATC. Aircraft sustained damage to its both propellers and nose dome. However, no injury to any person or damage to ground equipment occurred. CAA and PAF authorities extended emergency and rescue facilities in excellent manner. The investigations revealed damages to NLG doors and control rods due to vibrations and rubbing during nose gear up landing. The exact cause of failure of normal NLG could not be determined due to non availability of hydraulic components facility in Pakistan. The emergency handle was also found jammed in its position. The aircraft operator M/s. King Air Services is not responding to extend any help either for component testing or for aircraft recovery. In these circumstances the aircraft will be auctioned to recover the charges to be paid to PAF for parking and recovery from runway. (**See Photograph K-1**).

GENERAL VIEW OF THE AIRCRAFT BEFORE  
RECOVERY FROM RUNWAY

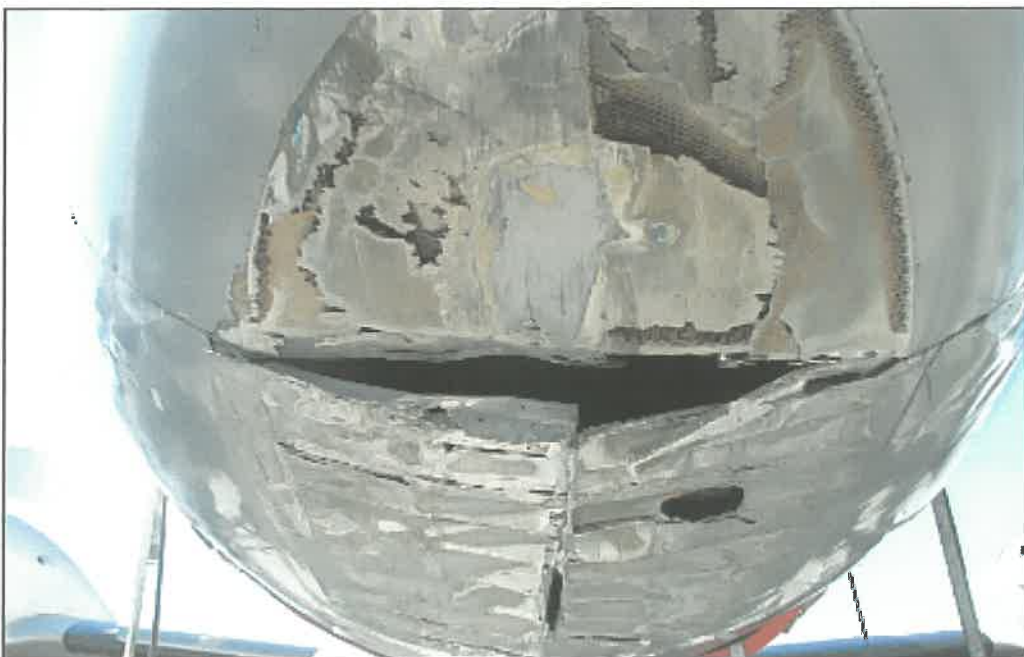
APPENDIX K2

1.3. **Damage to Aircraft:** Nose area structure and propellers were bent due to ground rubbing while in rotation (**See Photographs K-2 and K-10**). The movie of aircraft while landing is attached to the report in electronic version.

DAMAGE TO NOSE DOME AND NLG DOORS

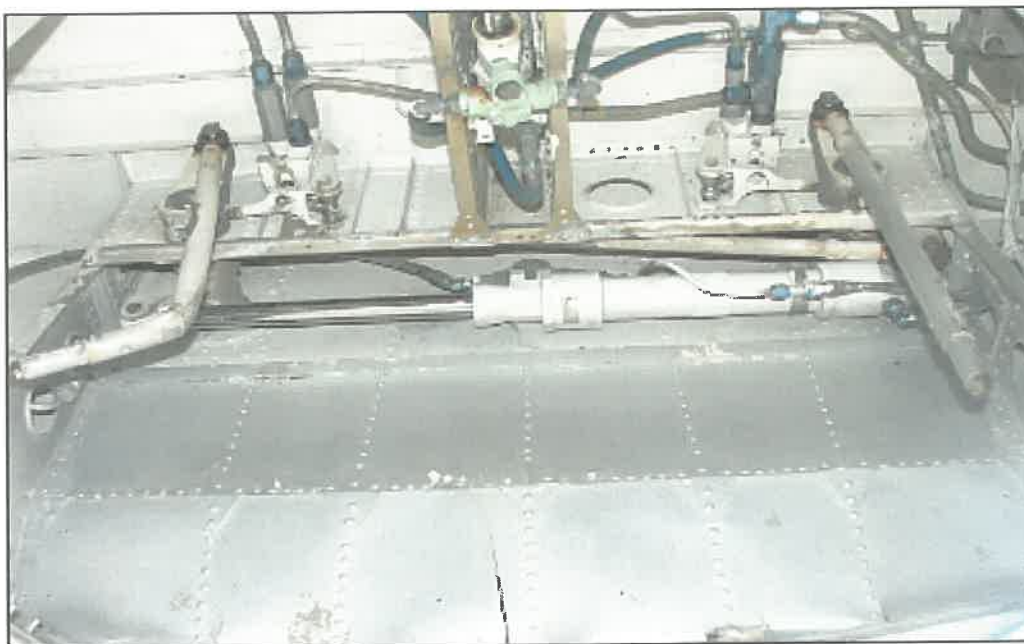
**APPENDIX  
K3**

2.3 The landing gear system of Gulfstream is all mechanical supported with hydraulic power. There is a sequencing valve, a hydraulic actuator which controls the movement of link rods for both doors for NLG; the last mechanical linkage between side doors and hydraulic actuator **(See Appendix 'G' & Photograph K-3)**. In addition to normal NLG retraction and extension system there is a emergency system which operates with the help of 1800 psi pneumatic bottle. Apparently both systems failed to extend the nose landing gears, whereas the main landing gears were extended successfully. Hence it can be concluded that the hydraulic power was available but either the control valve, door actuator or the sequence valve malfunctioned. The malfunction of either of these components would hinder the opening of the nose landing gears doors; and as long as nose landing gears doors are not open the NLG can not extend. That is why when on ground once the doors were opened mechanically, the NLG came down automatically.

**A GENERAL VIEW SHOWING NOSE LANDING GEAR BAY,  
NLG ACTUATOR, CONTROL VALVES, EMERGENCY PNEUMATIC  
CONNECTIONS AND DOOR LINK RODS ARE VISIBLE**

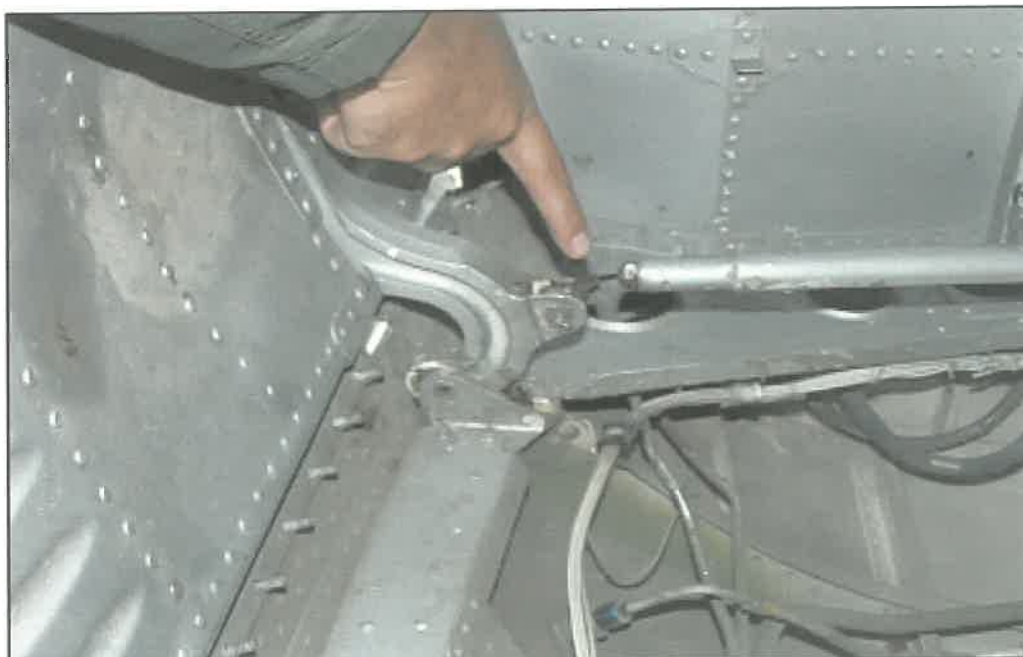
**APPENDIX K4**

2.4 The analysis of the damages to the doors and door links; that is bent on left door control rod and breakage of right door control rod indicates that these damages are post occurrence and are not the cause of the incident **(See Photographs K2 – K10)**. There are two distinct areas of investigation. Firstly the failure of NLG under normal hydraulic system and secondly and an area of serious concern, why did the emergency system failed to bring the NLD down.

**RIGHT DOOR LINK OF NLG FOUND BROKEN  
DUE TO GROUND IMPACT**

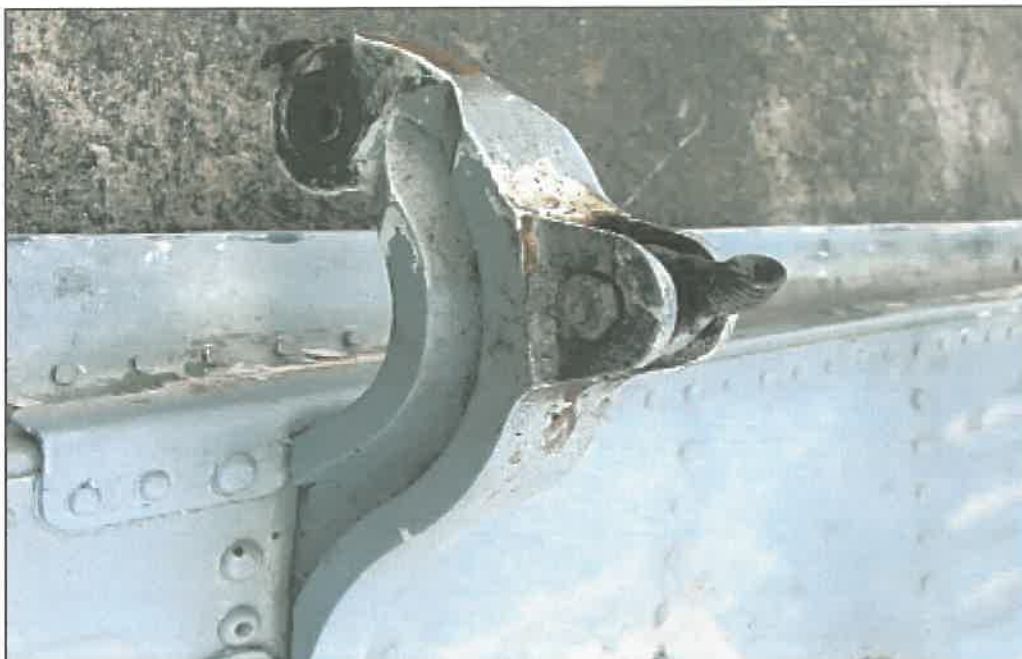
**APPENDIX K5 RIGHT NOSE LANDING GEAR LINK ROD BROKEN END  
SHOWING BENDING AT THREADED END BEFORE FAILURE  
DURING IMPACT**

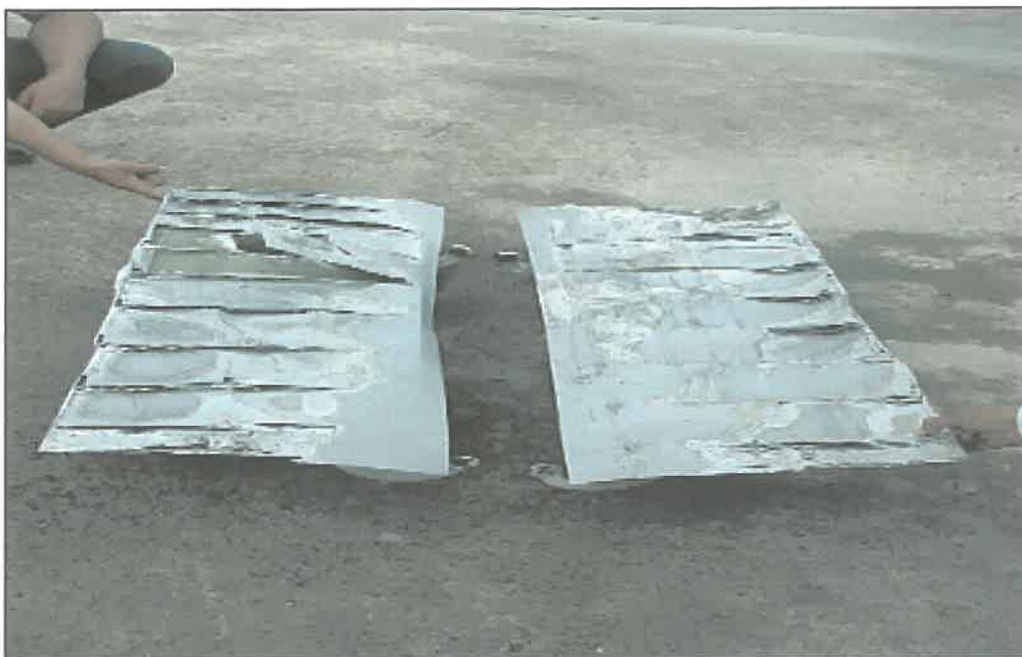
**APPENDIX K6 LANDING GEAR DOORS – EXTERNAL DAMAGE –  
DUE TO CONTINUOUS GROUND RUBBING**

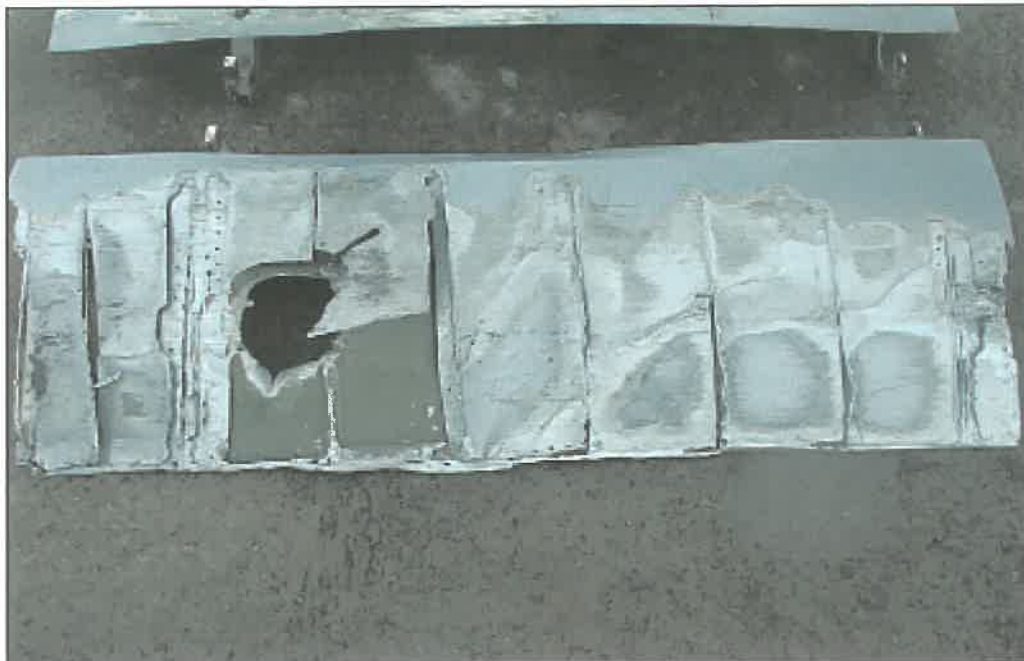
**APPENDIX K7 LEFT NOSE LANDING GEAR DOWN –  
EXTENT OF DAMAGE DUE TO GROUND RUBBING**

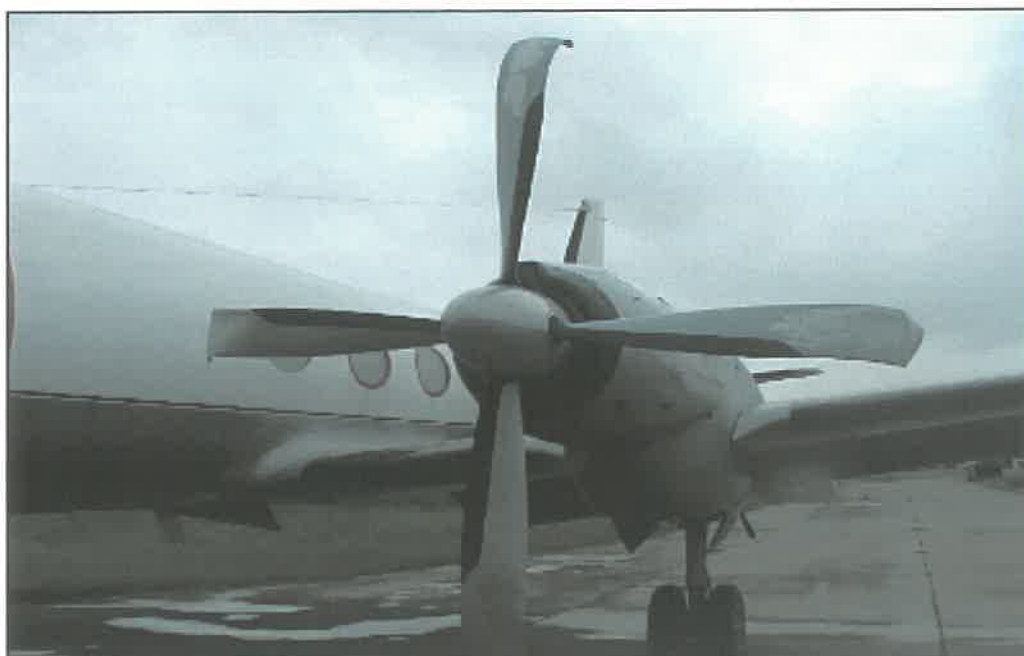
**APPENDIX K8 PROPELLER TIP DAMAGE – A CONSEQUENCE OF HIGH RPM  
DURING LANDING**

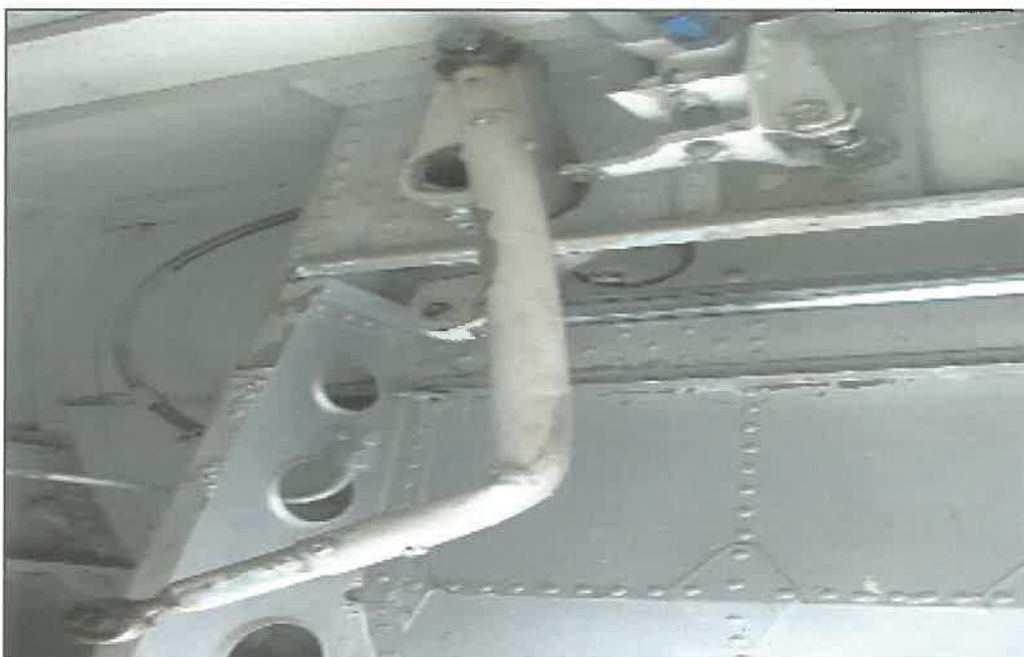
**APPENDIX K9 NOSE LANDING GEAR LEFT DOOR LINK ROD BENT DUE TO CONTINUOUS IMPACTS OF DOORS WITH GROUND**

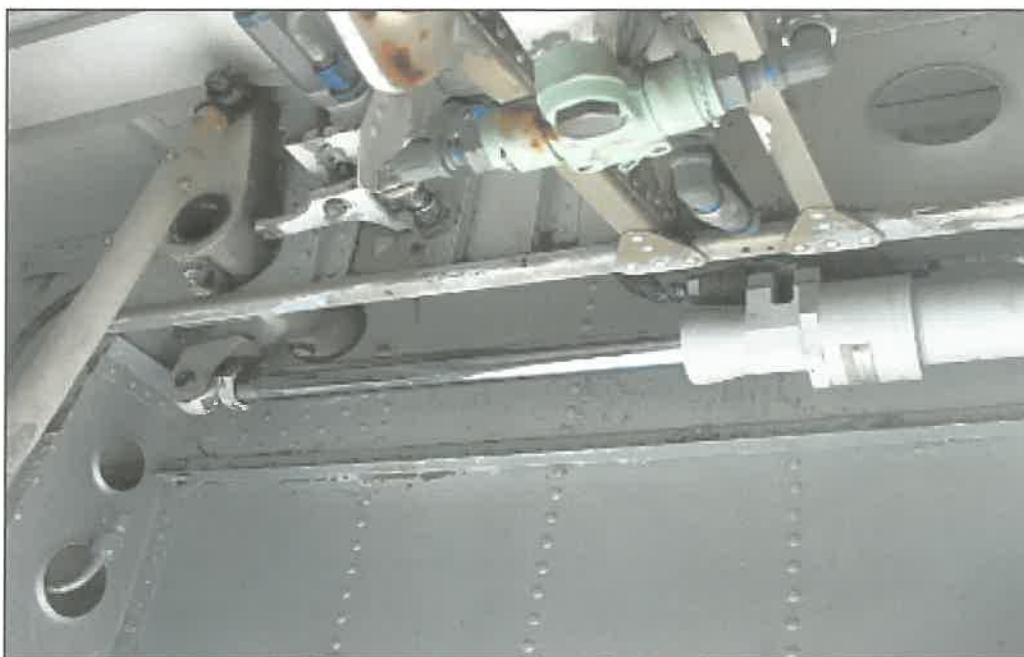
**APPENDIX K10 NOSE LANDING GEAR ACTUATOR IN FULLY EXTENDED POSITION – NO EVIDENCE OF HYDRAULIC LEAK**
