INVESTIGATION REPORT ON COLLISION BETWEEN  
SAUDIA AND PIA AIRCRAFT ON 5TH DEC., 1984.  
AT KARACHI AIRPORT.

| PIA Aircraft | Airbus - 300<br>Reg.MK.AP-BBA |
| Saudia Aircraft | Boeing 747<br>Reg.Mk.HZ-AIB |
| Date & Time of Collision | 5-12-1984 at<br>0700 hrs. P.S.T. |

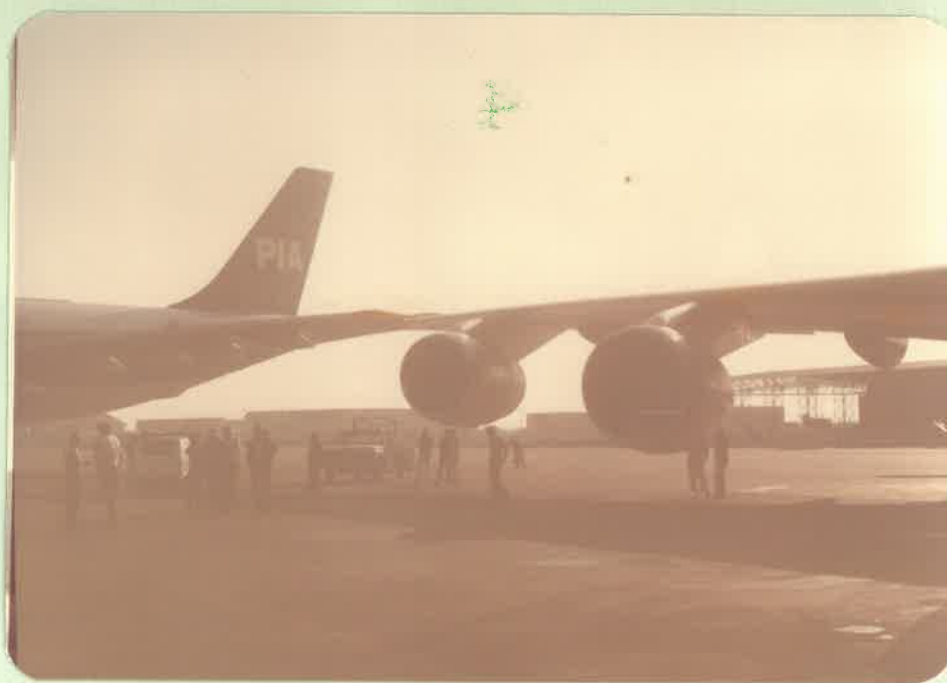
APP. N1

- 2.4. President, Accident Investigation Board and the Pilot Chief Investigator after arrival at the scene of incident, carried out initial survey of the location. It was noted that the right hand wing tip of the B-747 was stuck in the left hand wing tip at the out board aileron of the A-300 (App. "N" ). The wing tip of B-747 had engaged in an opening at outer trailing edge of the wing of A-300 which had been created due to down-ward movement of the aileron of the A-300. It was also noted that No.1 engine of the B-747 had scrape marks on the outer side of its cowling. It was discovered that this engine had come in contact with a baggage container, parked at the edge of the tarmac off the hard standing, whilst the B-747 was manoeuvring for parking.

RIGHT WING TIP OF SAUDI AIRLINES 747 ENGAGED WITH  
LEFT WING TIP OF M/s P.I.A.C., A-300.

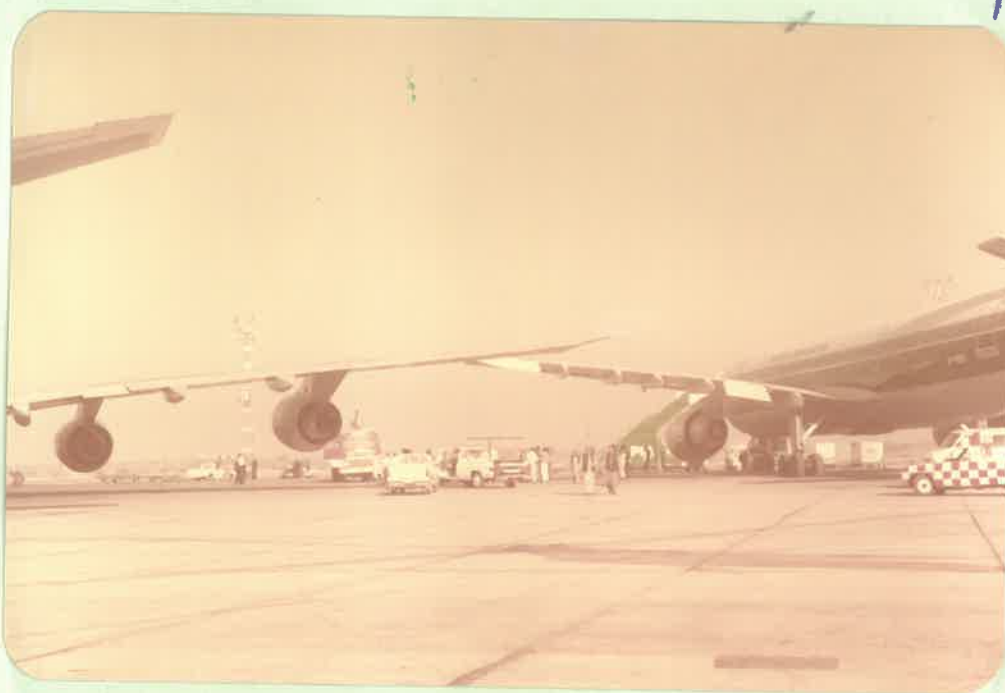
APP. N2

WING TIP SEEN AFTER DISENGAGEMENT.

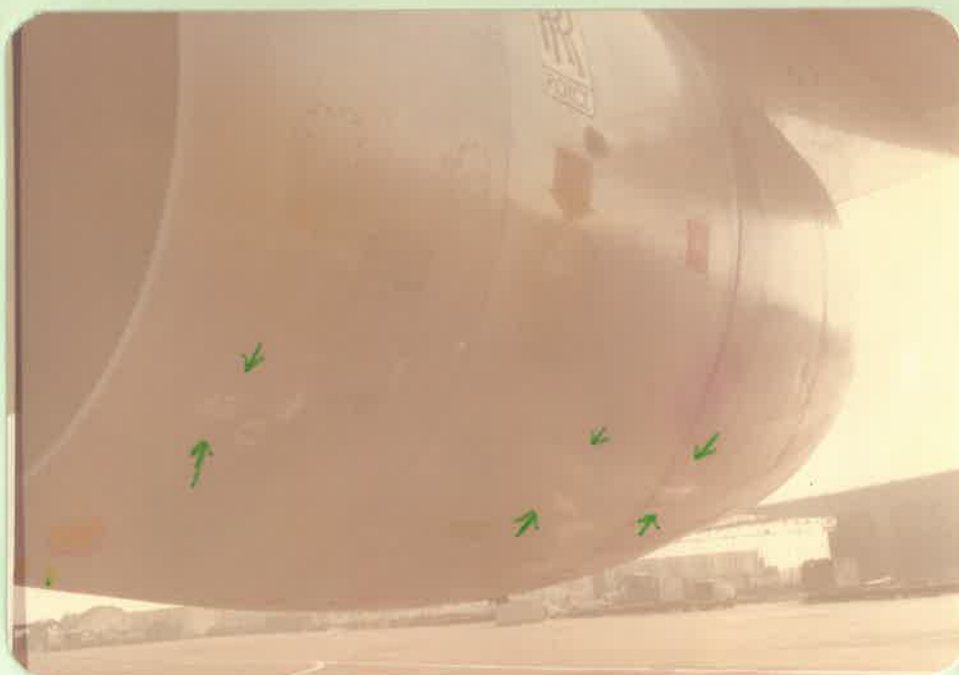
APP N3

SCRAPE MARKS SEEN ON THE COWLING OF # 1 ENGINE  
OF SAUDI AIRLINE's 747

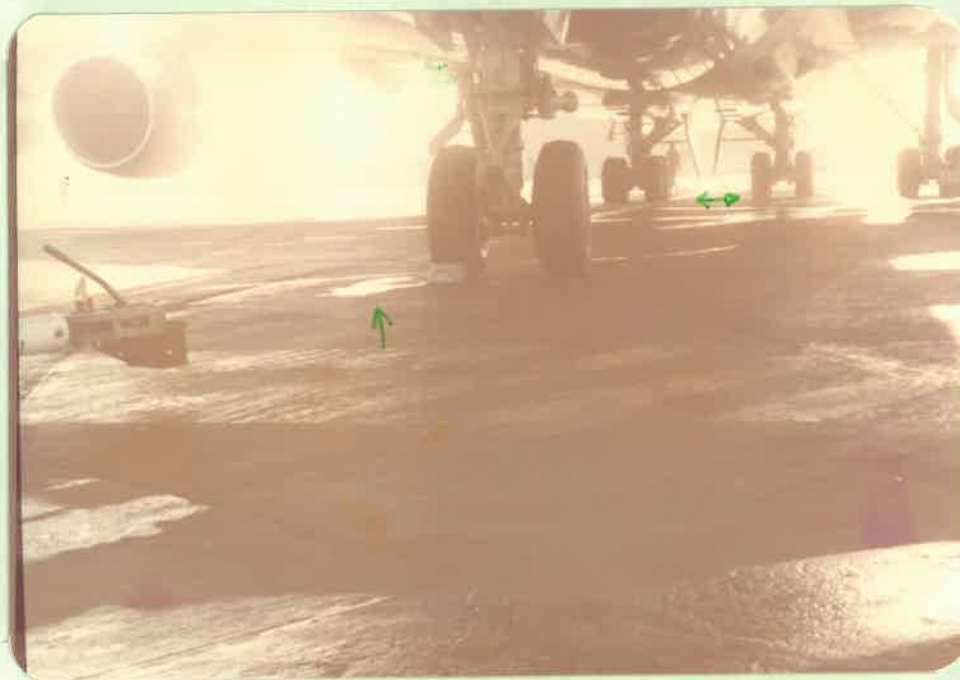
APP N4

- 3.3. After the landing of Saudia Boeing 747, the pilot of this aircraft was instructed to park the aircraft on bay No.13. He proceeded under the guidance of follow-me vehicle. When he arrived close to bay No.14, it appears that he noticed that he could not manoeuvre the aircraft to be parked on bay No.13 in case he made normal turn. He therefore made a wider turn. This is proved by the fact that cowling of his left outer engine (No.1), scraped against empty cargo containers placed on trollies parked near the edge of the apron off the hard standing. When the pilot made wider turn, he must have disregarded the yellow lead-in line. However the pilot continued to taxi till his Co-pilot advised him to stop. It was done when the later had received signal from the wing marshallers to this effect. By this time the wing tip of the taxiing aircraft had come in contact with the wing tip of the parked aircraft.

- 4.3. The ATC failed to take follow-up action when the parking bay was changed.
- 4.4. When the pilot realised that he had to deviate from yellow lead-in line for parking on No.13, the pilot did not notify the A.T.C.

NOSE WHEEL AND LEFT BODY GEAR CAN BE SEEN WELL  
LEFT OF YELLOW LINE. NOTE AIRCRAFT PARKS SHORT  
OF ITS NORMAL POSITION.

- 5.1.9. Copies of all circulars issued in respect of aircraft operation be circulated to all the airlines operating through Karachi Airport.
- ✓ 5.1.10. Whenever a pilot feels that he is to deviate from the laid down procedure, in this case following the yellow lead-in line, he must not continue taxiing. Instead he must notify the appropriate A.T.S. unit and obtain guidance. Suitable instructions be issued to all airlines operating through Karachi Airport.
