# FINAL INVESTIGATION REPORT

**INCIDENT OF PIAC FLIGHT PK-755 (SIALKOT TO RIYADH) A320-200  
REG NO AP-BLU FIRE WX IN THE AFT CARGO COMPARTMENT  
DATED 11 OCTOBER 2017**

### INCIDENT OF PIAC FLIGHT PK-755 (SIALKOT TO RIYADH) A320-200 REG NO AP-BLU FIRE WX IN THE AFT CARGO COMPARTMENT DATED 11 OCTOBER 2017

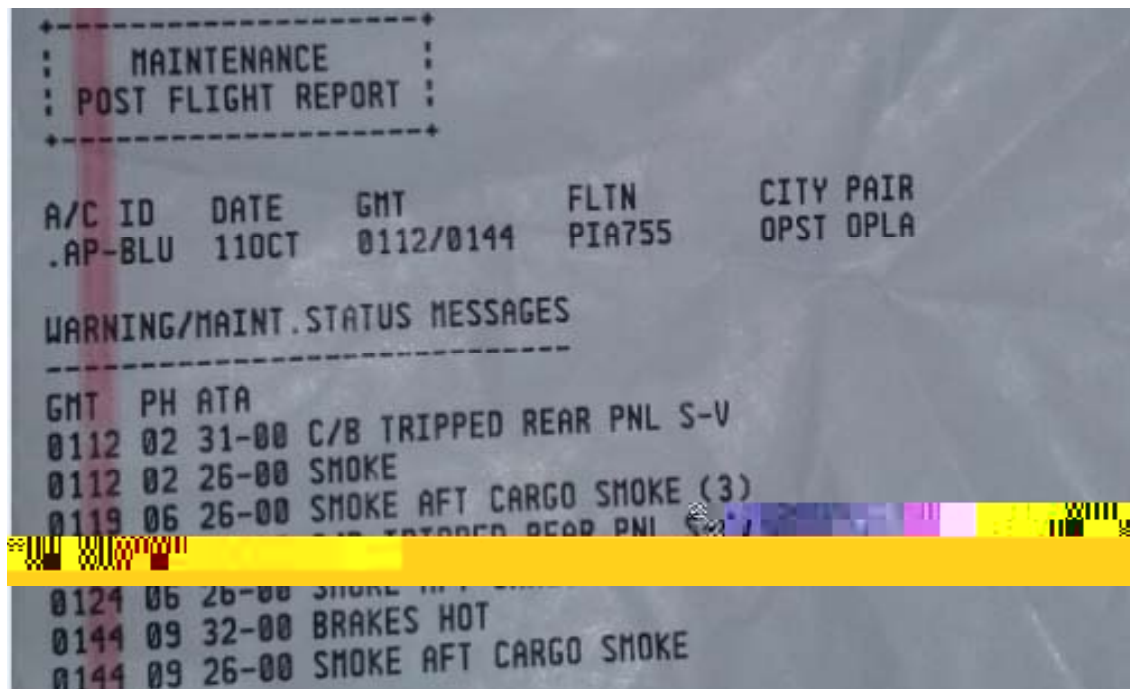
- 2.1. On arrival at Lahore no evidence of any fire, smoke or overheat was found inside the cargo area. Cargo fire bottle was found to be operated and discharged.
- 2.2. The Post Flight Report (PFR) generated by ECAM pertaining to this occurrence is as follows :-
