**PAKISTAN CIVIL AVIATION AUTHORITY**  
**(SAFETY & INVESTIGATION BOARD)**

**SERIOUS INCIDENT TO M/S PIAC, AIRCRAFT  
FLIGHT # PK-2226, B-747 , REG. # AP-BFY ON 23 NOV 2011  
AT ALLAMA IQBAL INTERNATIONAL AIRPORT, LAHORE**

**INVESTIGATION REPORT INTO SERIOUS INCIDENT TO M/S PIAC, PK-2226,  
B-747 AIRCRAFT, REG. NO. AP-BFY AT ALLAP, LAHORE ON 23 NOVEMBER 2011**

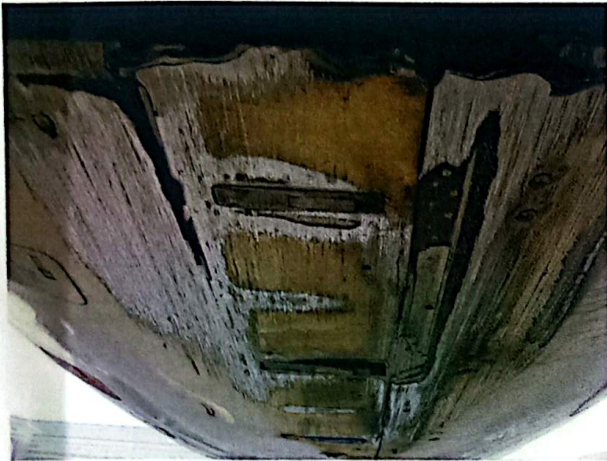
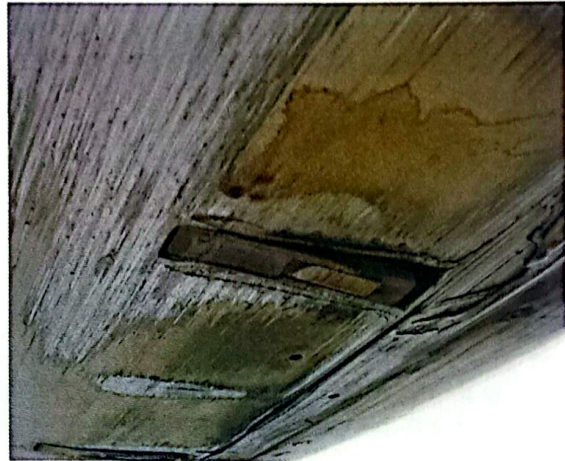
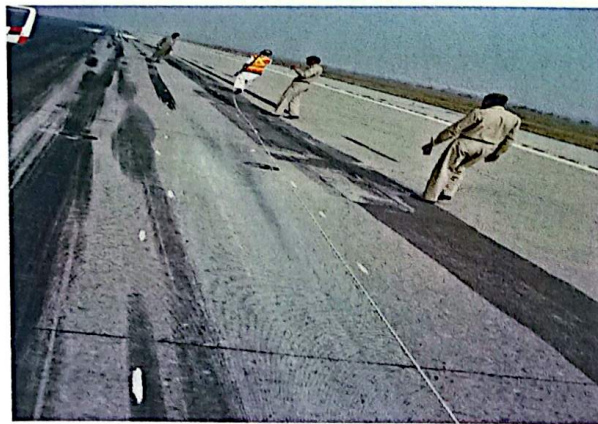
- a. Damage to both fan cowls of engine # 4.
- b. Damage of translating cowl (Reverser) of engine # 4.
- c. Oil leakage from IDG of engine # 4.
- d. Right rear wheel # 12 deflated.

2.2.3 The flight crew had reported "right body gear tyre No. 11 and 12 deflated" during walk around. However, later inspection revealed only right rear wheel # 12 deflated which was replaced.

- 5.1 Medical examination reports of flight crew did not reveal any abnormality.
- 5.2 Runway marks and the scratch marks observed on No:4 Engine pod are in correlation with each other, and hence caused by coming in contact with each other.

- a. All main landing gear oleo - No leak observed.
- b. Wheels hub tie bolt - No abnormality.
- c. Condition of Fuse Pins associated with Engine # 4 Found Sat.
- d. Engine # 4 mounts creep marking - Found Sat.
- e. Engine # 4 MCD - Found sat.
- f. Free rotation of engine # 4 - Found Sat.
- g. Complete BSI of engine # 4 - Found Sat.
- h. Engine # 4 IDG found leaking - Same removed and blanking plate installed.
- i. Fan cowls of Engine # 4 found damaged - Both fan cowls of replaced.

- j. Engine # 4 thrust reverser sleeve damaged. Thrust reverser de-activated. Interim repair carried out. Referred to Base Station Karachi as replacement not feasible at Lahore.
- k. Manufacturer recommended inspection after Shock Landing of engine # 4 and engine # 3, fuselage area, wing area including leading edge flaps, trailing edge flaps and cabin area - Found satisfactory.
- l. Ground run of engine # 4 - All engines parameters found normal.
