# FINAL INVESTIGATION REPORT

SERIOUS INCIDENT OF PIAC FLIGHT PK-363  
(SECTOR ISB – UET), B737-300 AIRCRAFT REG # AP-BFT  
AT QUETTA ON 08<sup>TH</sup> MARCH, 2013

### SERIOUS INCIDENT OF M/S. PIAC FLIGHT PK-363 (SECTOR ISB – UET) B737-300 AIRCRAFT REG # AP-BFT AT QUETTA ON 08<sup>TH</sup> MARCH, 2013

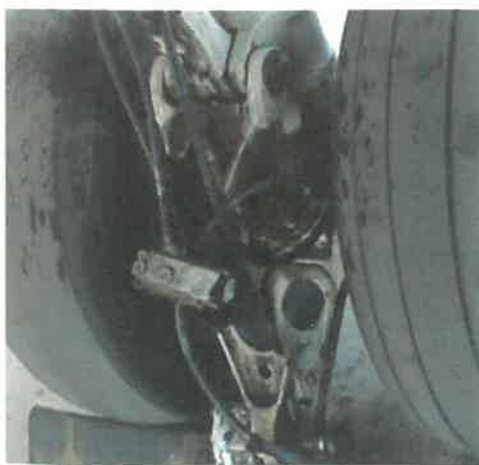
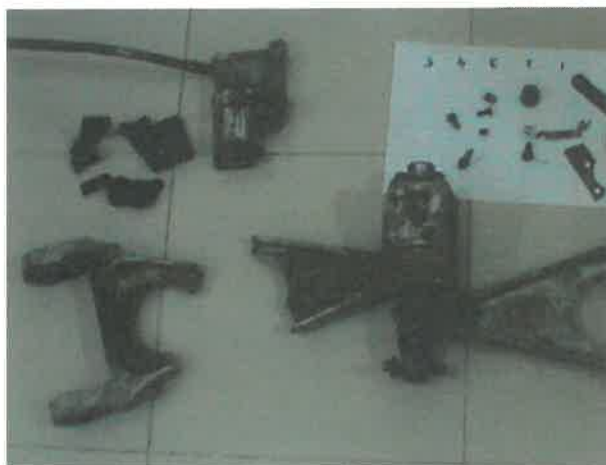
- 1.2 **Injuries to Persons.** No one onboard the mishap aircraft received any injury as a result of this occurrence.
- 1.3 **Damage to Aircraft.** The aircraft LMLG Upper Torsion Link was found fractured at larger lightening. Shimmy damper upper portion containing hydraulic lines and manifold got dislodged from shimmy damper actuator. The hydraulic fluid lines to the LMLG brake assembly were also found damaged.

Fractured Upper Torsion Link and damaged Shimmy Damper

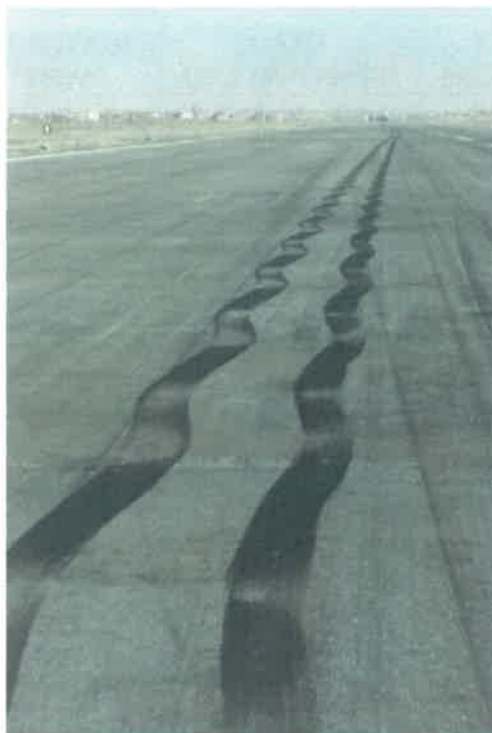
LMLG tire marks

- 2.24 In-effective shimmy damper mechanisms due to trapped air, internal leaks / failures of shimmy damper, over inflation of shock struts and more than specified clearance / play in the associated linkages results in torsional vibrations of the wheel assembly. If the vibrations approach the natural frequency of assembly then resonance phenomenon (large amplitude vibrations) is excited which is called Shimmy event. The zigzag tire marks on the runway are characteristic indication of the shimmy event.

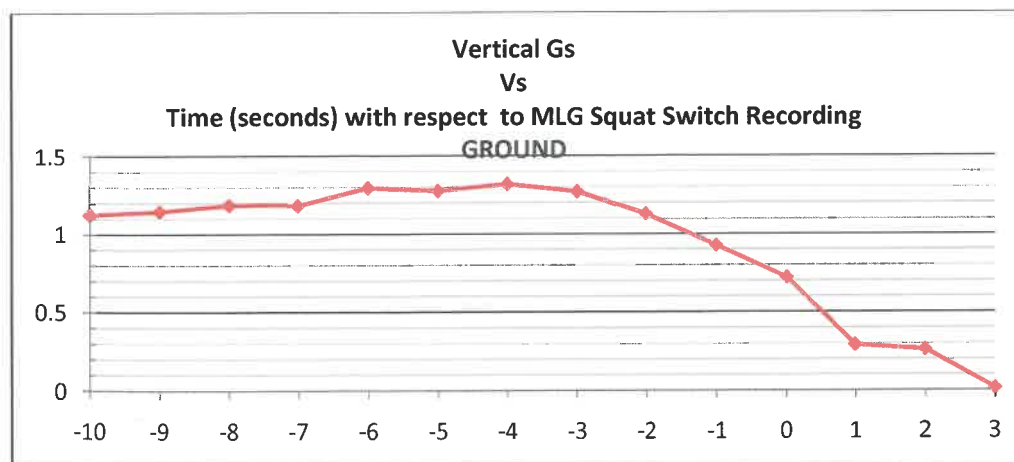
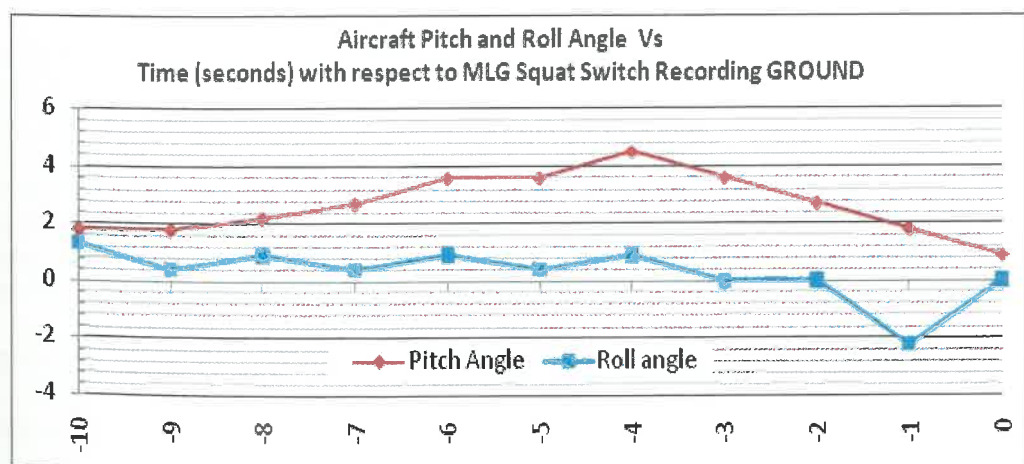
- 2.11 The peak in vertical acceleration roughly corresponds with the initial contact of the aircraft with runway surface. The roll angle at time of touchdown was very close to zero and pitch angle was approximately 4° pitch up. The aircraft made an almost wings level touch down on main wheels.

- 2.12 The transition of the landing gear squat switches to the GROUND was recorded approximately 3-4 seconds after peak vertical acceleration (touchdown). This implies that landing gear struts remained extended for approximately 3-4 seconds after the touchdown.

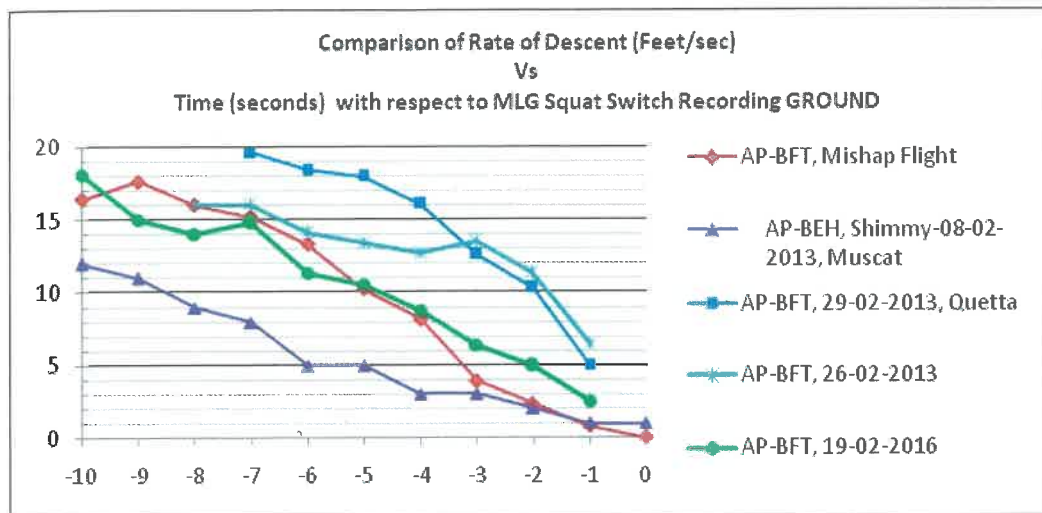
- 2.13 The sink rate of the aircraft was calculated using Radio Altitude. Though the calculated sink rate is not a direct measure of compression rate of the landing gear strut but it does provide a qualitative indication. The comparison plot shows that aircraft sink rate in case of both shimmy event flights before the compression of the landing gear struts (squat switch sensing GROUND) is showing similar pattern and was very low in comparison to normal flights.

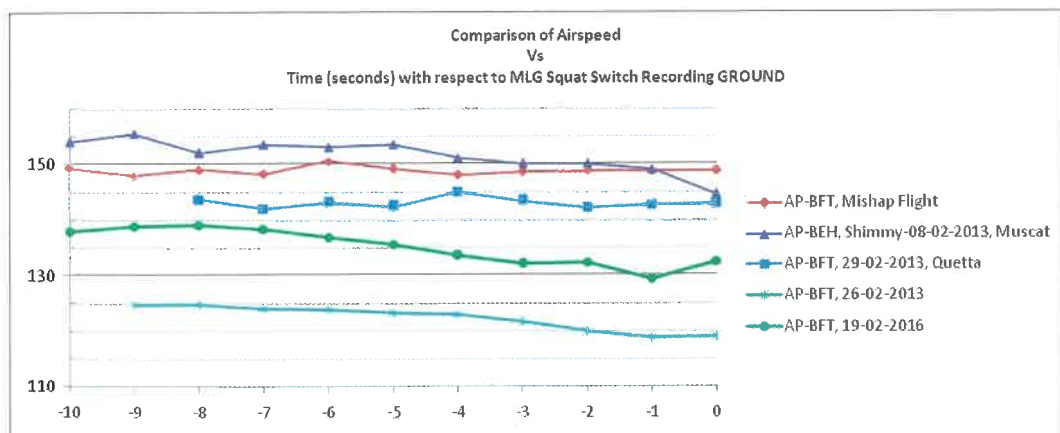
- 2.14 The Computed Air Speed (CAS) at the time of touchdown was approximately 149 knots which is a relatively high speed as evident from the comparison plot presented below:

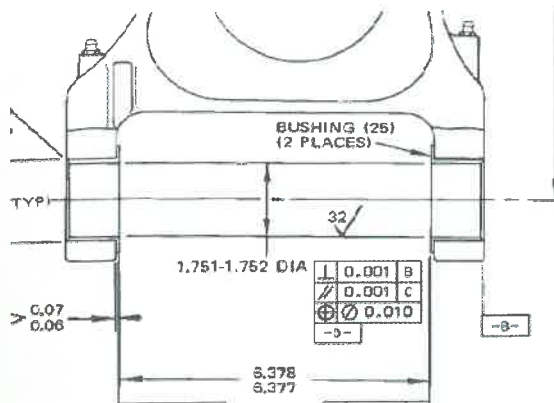
Upper Torsion Link Drawing

- 2.17 Design wear limit of Upper torsion link assembly inner flange (with bushes) is 6.377 to 6.378 inches and service wear limit (max) is 6.382 inches as per Component Maintenance Manual (CMM) 65-73761. The actual measurement of the damaged

Upper Torsion link assembly inner flange (with bushes) was found as 6.383 inches, which would result into relatively more play.

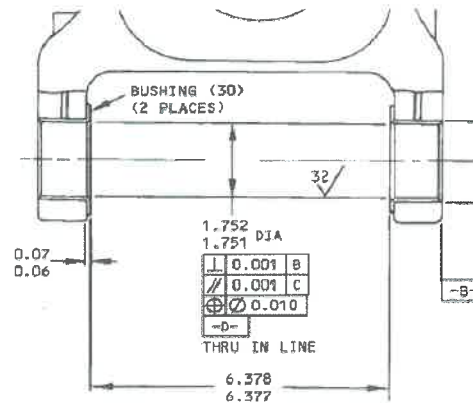
Lower Torsion Link Drawing

- 2.18 Design wear limit of Lower Torsion Link assembly inner flange (with bushes) is 6.377 to 6.378 inches and service wear limit (max) is 6.382 inches as per CMM 65-73761. The actual measurement of Lower Torsion Link assembly inner flange (with bushes) was found as 6.379 inches.

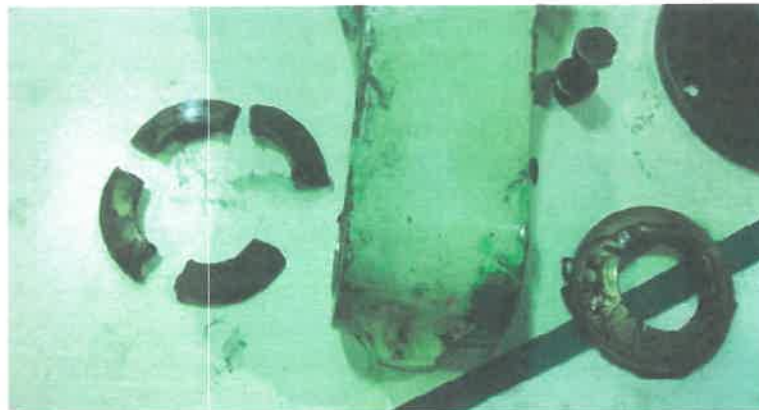
- 2.19 Lower Torsion Link upper lug outer flange's inboard side bush was found broken into four pieces, whereas outboard side bush was intact. Inner diameter (Average) of Spherical bush in lower torsion link upper lug was measured as 0.998 inches which is also within design limits (0.99 to 1.01) inches as per applicable CMM. The damage pattern of the bush indicated failure under compressive loads, which most probably were encountered during shimmy event.

Lower Torsion Link upper lug damaged and intact bush

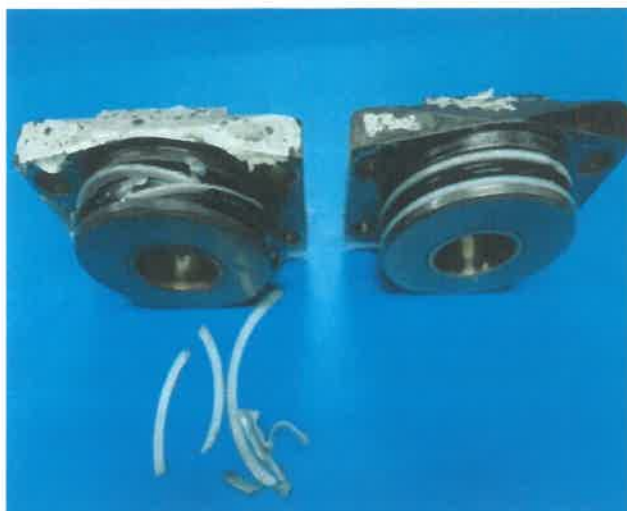
- 2.20 The failure mode analysis of the Upper Torsion Link was performed at Institute of Space Technology (IST), Failure Analysis Center (FAC). The FAC analysis report (**Appendix 'E'**) concluded that part failed due to bending overload and no evidence of fatigue failure was found.
- 2.21 Shimmy damper assembly Part No. 65-44771-4, Serial No. 1821-91 was disassembled and checked as per CMM 65-44771-4. During this examination one out of two Ring Backup (Teflon seal), one was found missing and the available Ring Backup (Teflon seal) and Packing (O-ring) was found damaged.

Damaged vs Intact Ring Backup

- 2.22 The mishap Shimmy Damper was released from PIAC Hydraulic shop on 2<sup>nd</sup> August, 2011 by re-using Rings Backup (Teflon seals) as Boeing maintenance instructions do not specify to replace the Ring Backup (Teflon seal). Shop release maintenance records were reviewed and found that PIAC shop staff also assumes Packing (O-ring) as "On-Condition" item rather than once use consumable in contrast to applicable Boeing maintenance instructions. The re-use of the Packing increases the chances of it getting damaged during subsequent operation. Similarly if one of the Ring backup is missing then Packing (O-ring) would not be fully supported and is likely to get extruded and damaged during operation.

- 4.1 The operator (PIAC) to perform One Time Check / Inspection on Boeing 737-300 fleet to ensure following as per applicable AMM / Publications:
  - 4.1.1 Removal and disassembly of all Shimmy Dampers and 100% replacement of all consumables.
  - 4.1.2 Check / Adjustment of gap of Apex Joint of Main Landing Gear Torsion Link.
  - 4.1.3 Check / Adjustment of Torsional Free Play.
  - 4.1.4 Bleeding of installed Shimmy Damper.
- 4.2 The operator (PIAC) to brief all Boeing 737-300 operating cockpit crews to adhere to Boeing recommended procedures & techniques of landing especially at higher elevation airports so as to ensure maximum efficiency of shimmy damper mechanism.
