**CRASHED LANDING OF FLETCHER FU 24-950**  
**AIRCRAFT REG. MARK AP-BAD ON 19-9-1992**  
**AT PASRUR**

**Authority: Director General CAA letter No. HQCAA/1901/147/SIB dated 24-9-1992.**

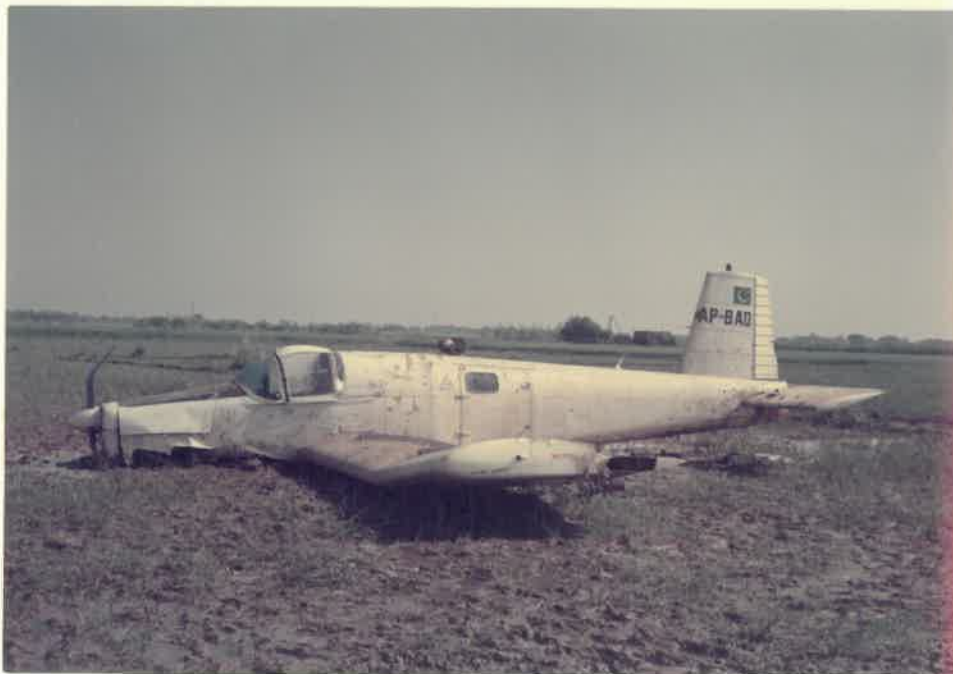
Sketch of the aircraft at crash site is attached as Appendix 'B'. Location of broken parts are also shown in the sketch. The aircraft first impacted on kachcha field about 950 ft from edge of runway end 13 and about 300 ft left of central line. After initial impact the aircraft bounced up and then crashed landed at a distance of about 50 ft. During these impacts all the three landing gears separated from the fuselage and were found lying separately from the fuselage.

Photograph showing the aircraft lying in  
kachcha field.

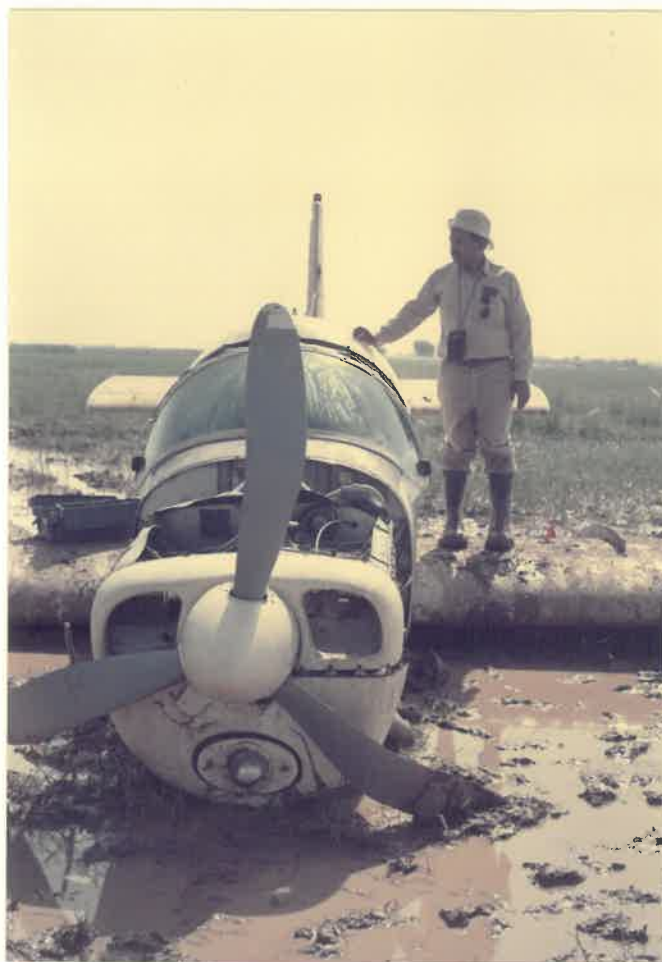
17.4 The type of damage to the propeller blades and the statements of the pilot as well as the evidence from the eye witnesses proves beyond doubt that the engine appeared to have suddenly failed immediately after take off and the pilot had no choice except to crash land straight ahead in the paddy field. The height at which the engine cut is estimated to be about 50 feet A.G.L. and the speed of the aircraft about 120 KPH. Thus the pilot virtually had no time to attempt to restart and did better in concentrating to put the aircraft back on ground safely.

Photograph showing the aircraft with prop  
bent rearward.

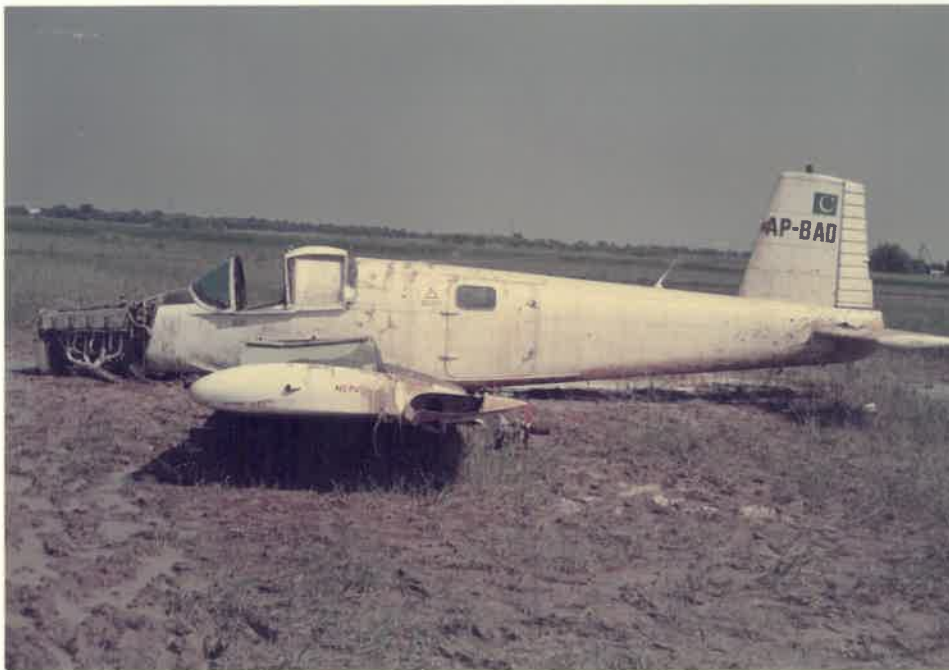
Photograph showing the aircraft in partially disassembled condition

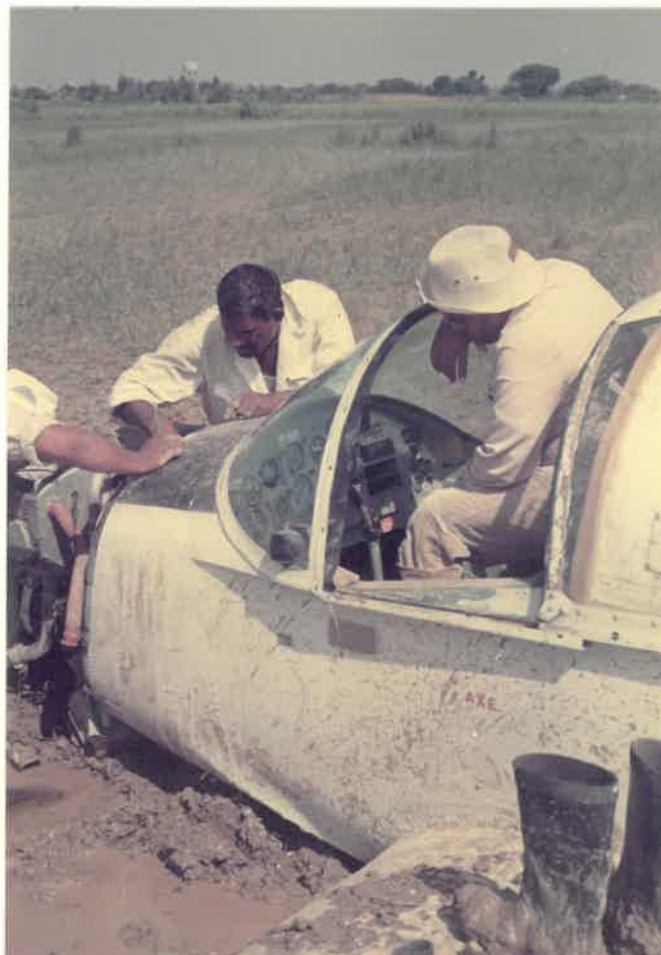
Photograph showing close up of the aircraft in partially disassembled condition.
