**PAKISTAN CIVIL AVIATION AUTHORITY**  
**(SAFETY & INVESTIGATION BOARD)**

**INVESTIGATION REPORT**  
**SERIOUS INCIDENT – M/S. SHAHEEN AIR**  
**AIRCRAFT BOEING – 737-200, REG. NO. AP-BIK**  
**ON 8 FEBRUARY 2010**  
**PESHAWAR INTERNATIONAL AIRPORT, PESHAWAR**

### SERIOUS INCIDENT TO M/S SHAHEEN AIR BOEING-737-200 FLIGHT NO. NL-757, REG. AP-BIK AT PESHAWAR AIRPORT ON 8 FEB 2010

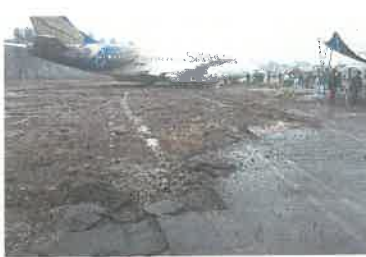
1.3.1 Wheel # 2 and 3 completely ruptured.

1.3.2 Traces of Mud insertion in both the engines and all the three wheel wells.

1.3.3 Apparent stresses on main landing gears due to side-ways skidding and then sudden stop in un-prepared soft / wet ground.

1.4 **Other Damages:** Left edge of overrun surface was scrapped / damaged. Additionally, aircraft arresting net assembly of BAK-12 Barrier installed at Rwy-17 end got damaged beyond recovery.
