**CIVIL AVIATION AUTHORITY**

**TYRE BURST INCIDENT INVESTIGATION IN RESPECT**

**TO M/S PIAC F-27 AIRCRAFT REG. NO.AP-ALW**

**OCCURRED ON 23RD OCTOBER, 1998**

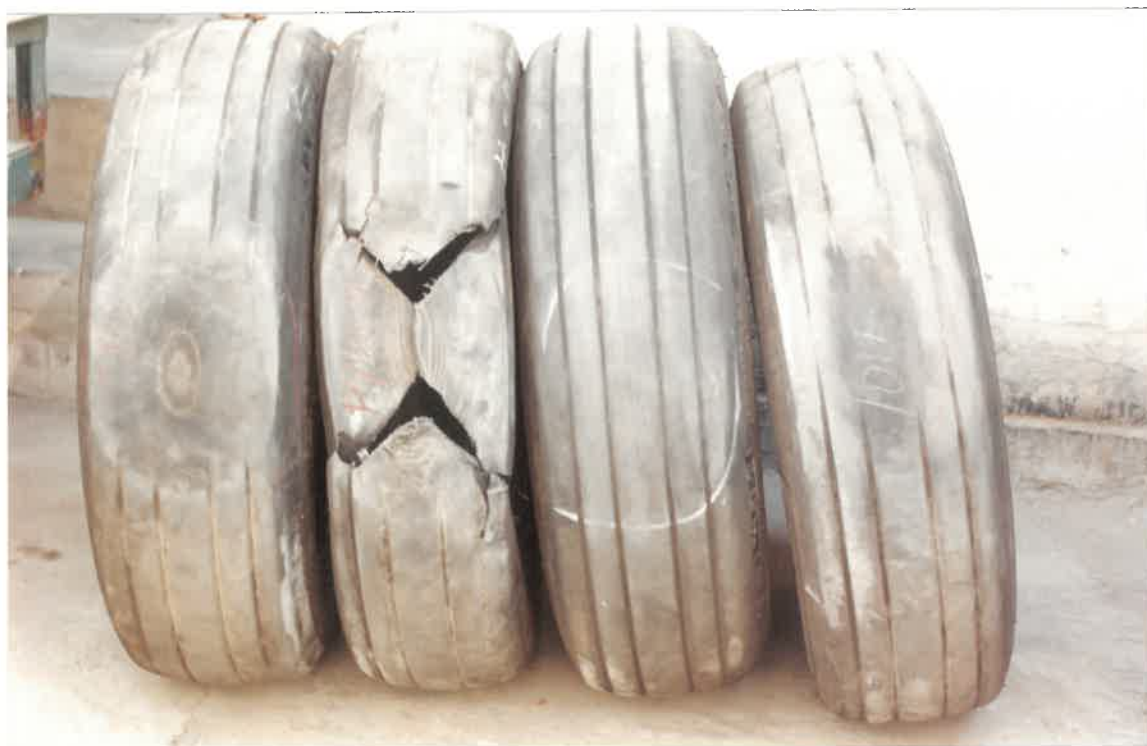
5.1 One tyre had burst while the other three tyres of the main landing gears had flat spots. All four tyres were rendered beyond repairs.

- 22.8. The aircraft remained on the runway after landing.
- 22.9. Due to rubbing action of the tyres on the runway all four tyres of the main landing gears had one flat spot each.

TYRES AS VIEWED FROM THE AIRCRAFT REAR  
LEFT OUTER, LEFT INNER, RIGHT INNER, RIGHT OUTER.

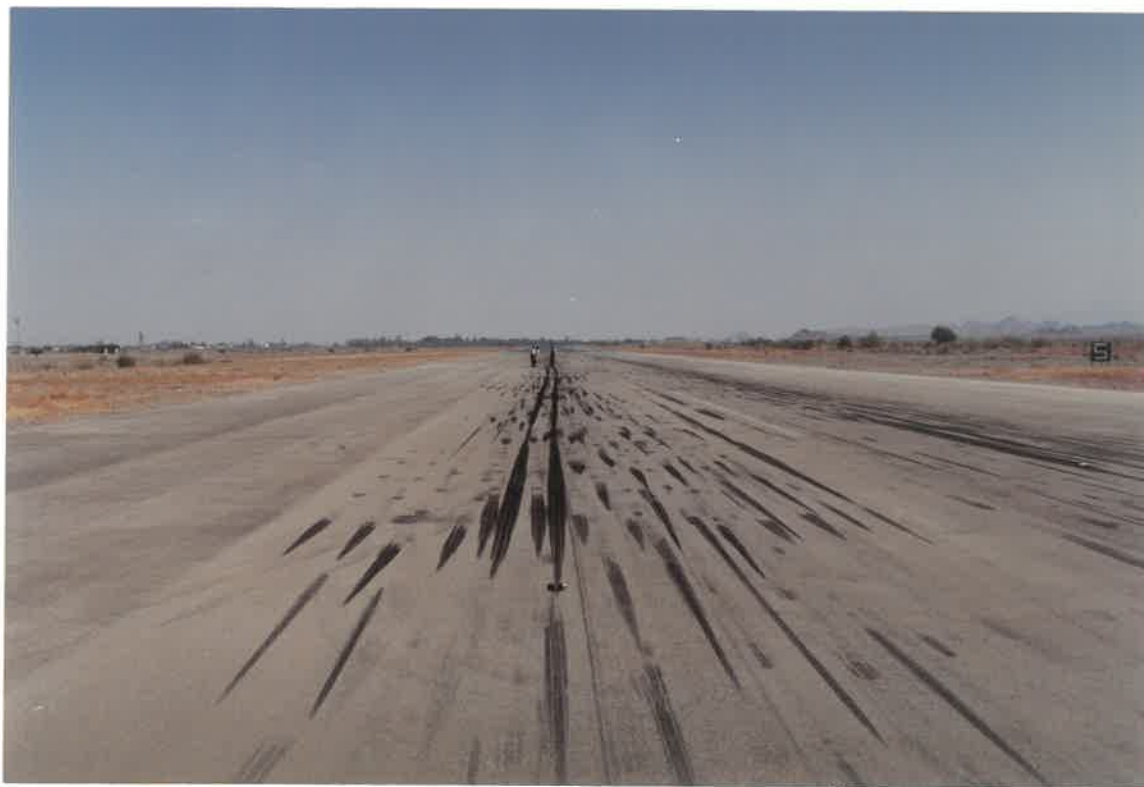
- 17.3 The tyre marks of the left tyres were very dark and almost continuous for the first 1200 feet after touch down.
- 17.4 The direction of the left wheel marks were roughly 084°.

LEFT TYRE MARKS AT TOUCH DOWN

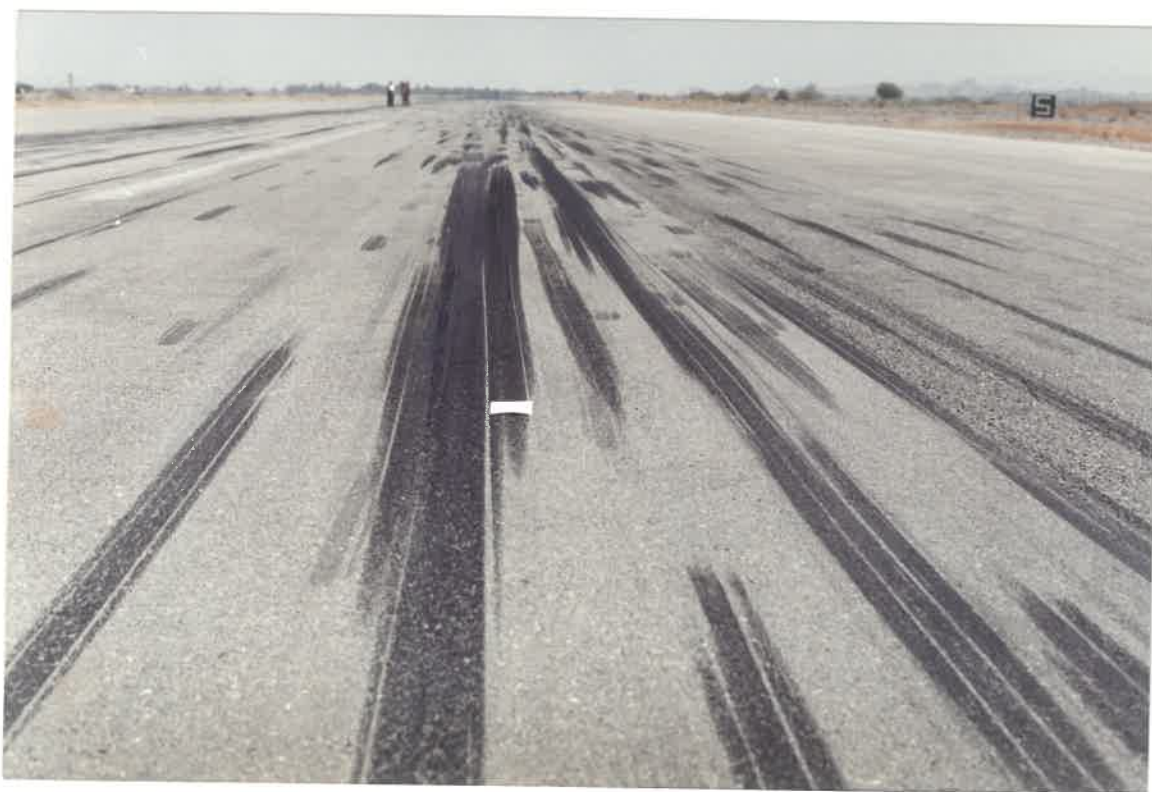
- 17.5 The right side tyre marks originated at about 45 – 50 feet ahead of the left tyre marks.
- 17.6 The right tyre marks also indicate being rubbed deeply against the runway surface almost continuously after touch down.

- 17.7 The direction of the right tyre marks was also about 084°.
- 17.8 The left inner tyre burst mark was evident abeam the 1000' marker (5000' Remaining)

RIGHT TYRE MARKS AT TOUCH DOWN

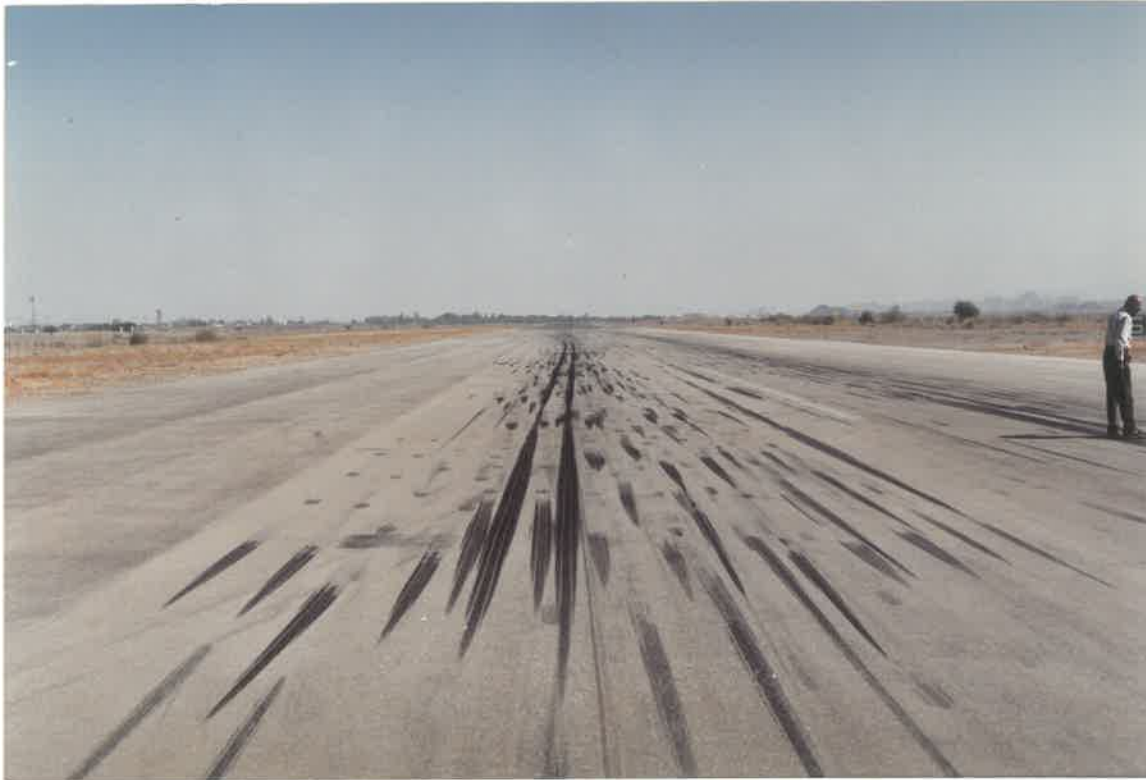
LEFT TYRE MARKS UPTO POINT OF BURST

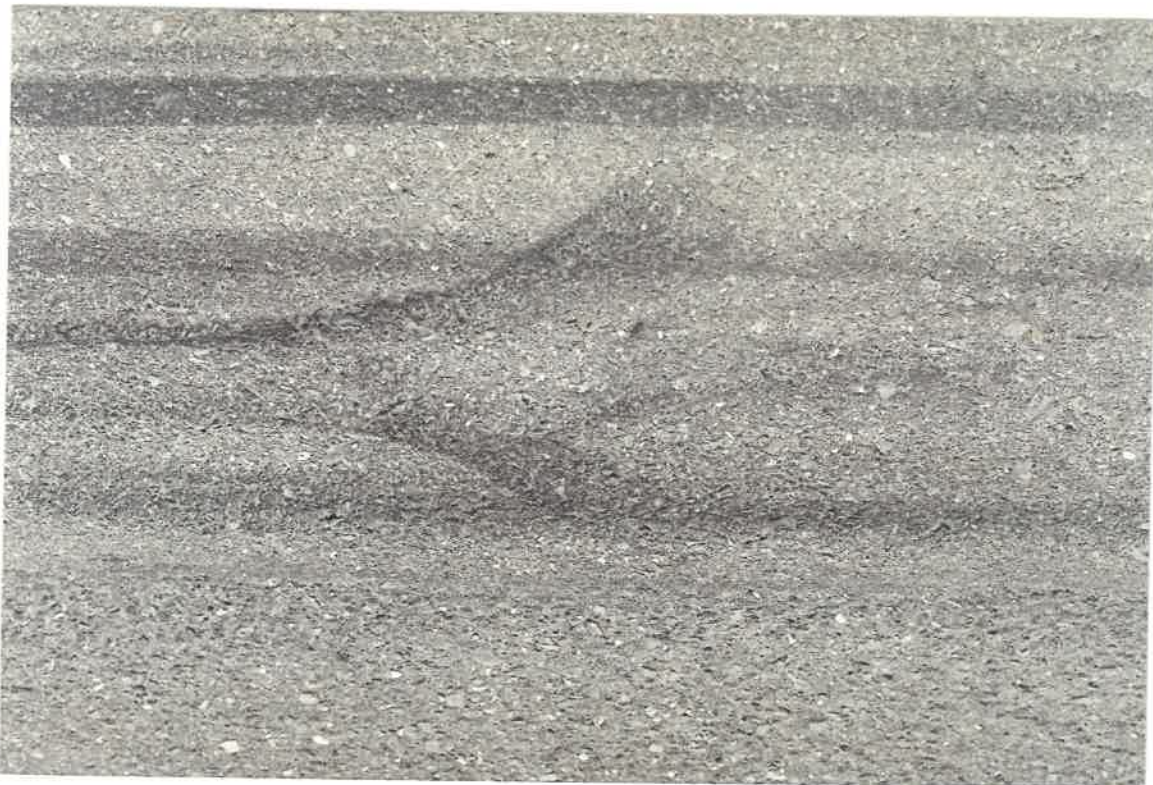
- 17.9 On visual inspection the left inner tyre was found burst.
- 17.10 All four tyres were found with flat spots at one point only.
- 17.11 The aircraft taxied back to the tarmac under its own power and the R/W was not blocked for any appreciable length of time.

LEFT INNER TYRE BURST POINT
