AIRCRAFT ACCIDENT INVESTIGATION  
REPORT ON THE FATAL FLYING ACCIDENT  
INVOLVING CESSNA 185 REGISTRATION  
NO.AP-BBD OF MESSRS. KHAN AVIATION  
WHICH OCCURRED NEAR WATEJI AIRSTRIP.

AUTHORITY : DIRECTOR GENERAL OF CIVIL AVIATION AUTHORITY  
MEMORANDUM NO.CAA/1901/18/FS DATED 19.3.1983  
(APPENDIX "A").

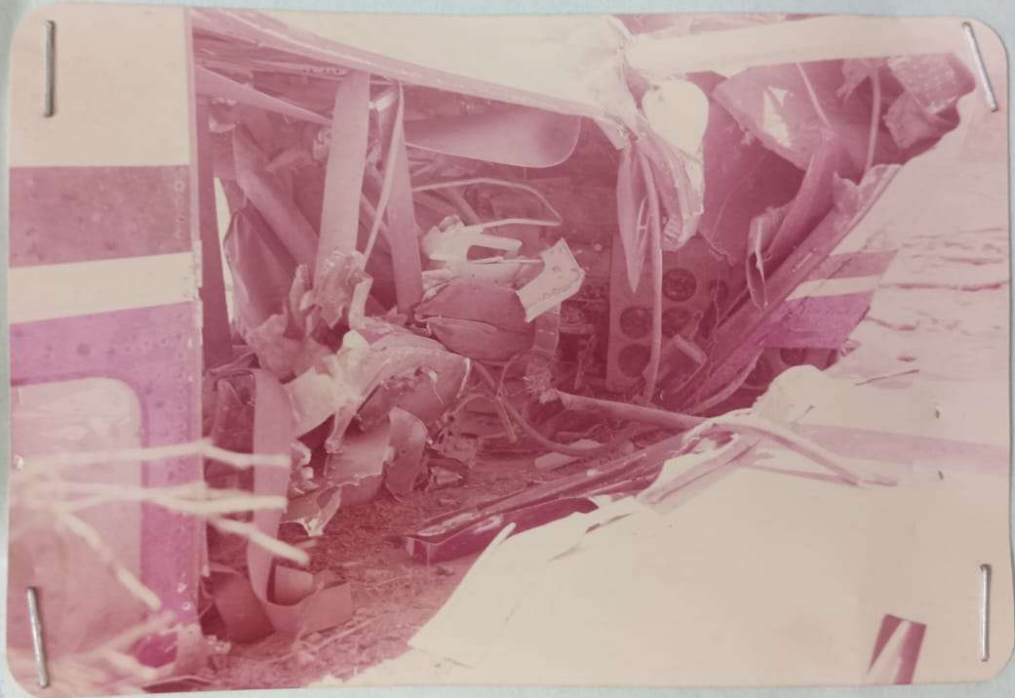
APPENDIX "B12"

THIS IS A VIEW OF THE COCKPIT TAKEN FROM THE RIGHT  
INSTRUMENT PANEL AND THE ENGINE

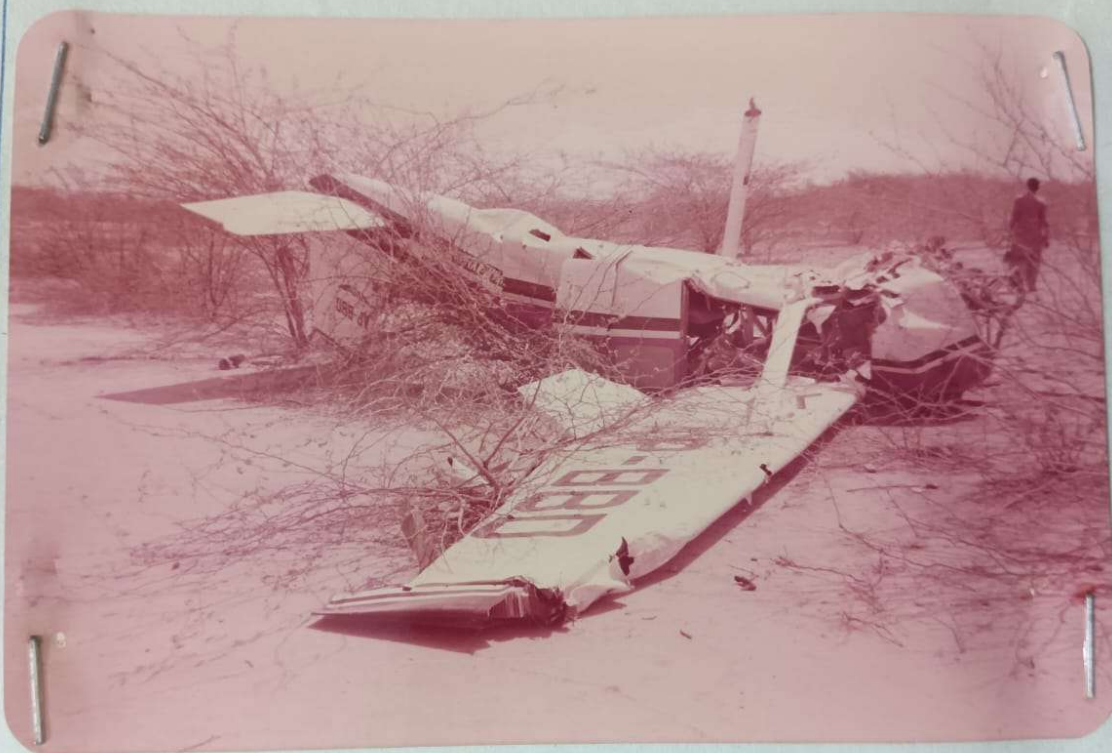
A VIEW OF THE WRECKAGE FROM THE LEFT SIDE SHOWING THE LEFT WING, THE TORN LEFT AILERON AND FLAP. THE BUSHES WHICH HAVE ARRESTED THE AIRCRAFT ARE CLEARLY VISIBLE.

THE REGISTRATION MARK CAN CLEARLY BE SEEN. NOTE THE POSITION OF THE FLAP.

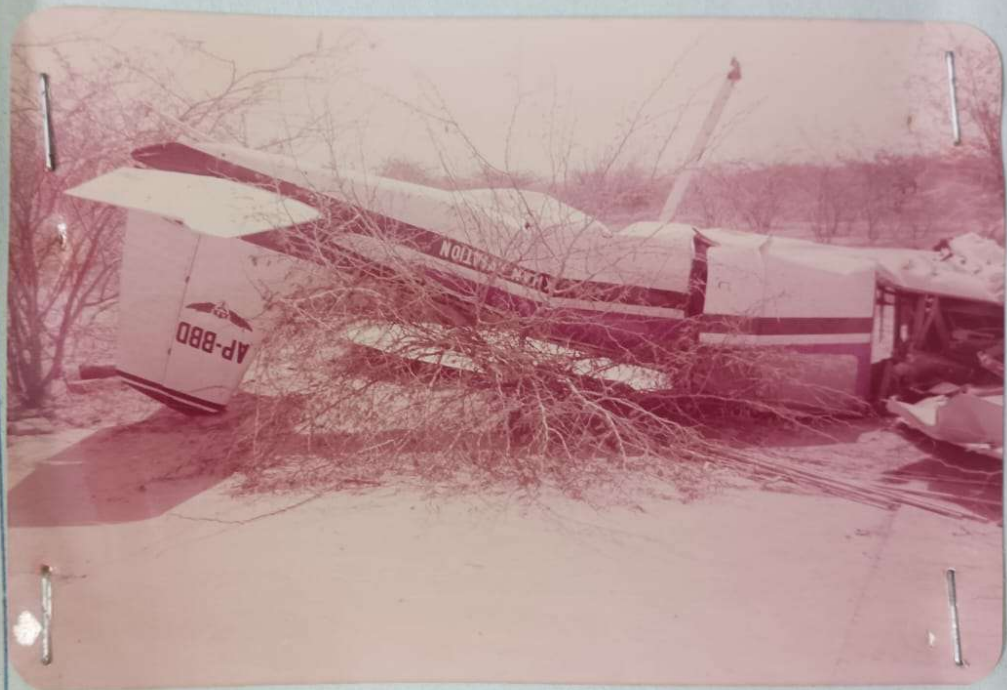
APPENDIX "B10"

A VIEW OF THE WRECKAGE FROM THE LEFT HAND SIDE.  
MOST UNDA MAGED CONDITION OF THE FIN RU

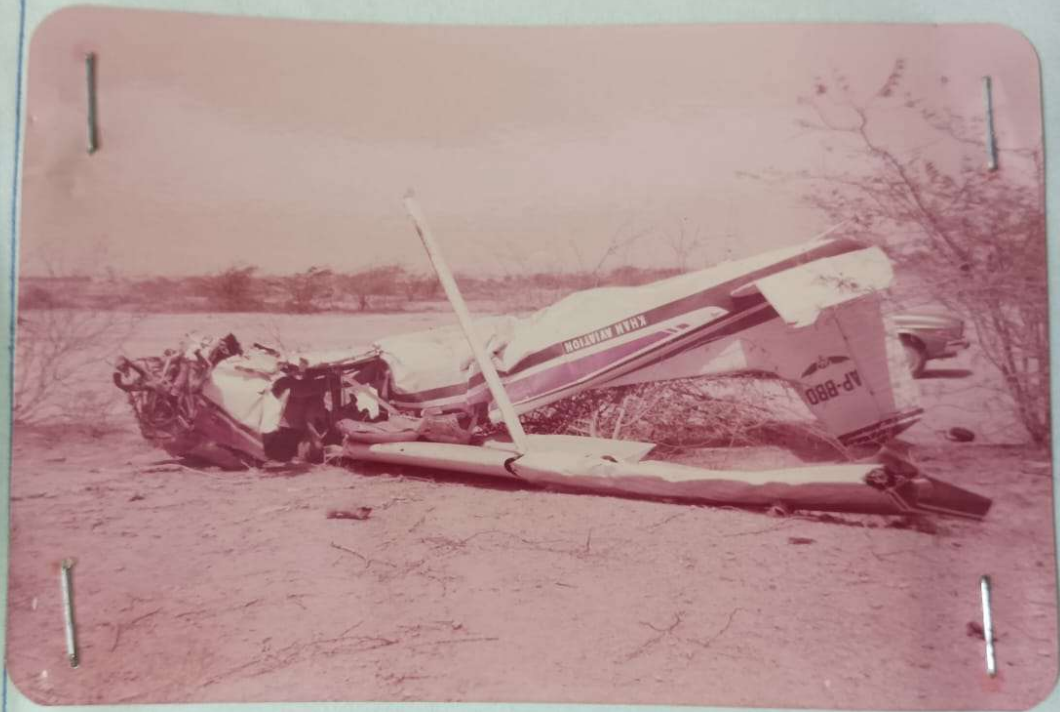
APPENDIX "B9"

THE VIEW OF THE MAIN WRECKAGE WHERE IT CAME TO REST  
NOTES THE DAMAGE TO THE COCKPIT AND THE RIGHT TAIL

THE REGISTRATION MARK CAN CLEARLY BE SEEN. NOTE THE POSITION OF THE FLAP.

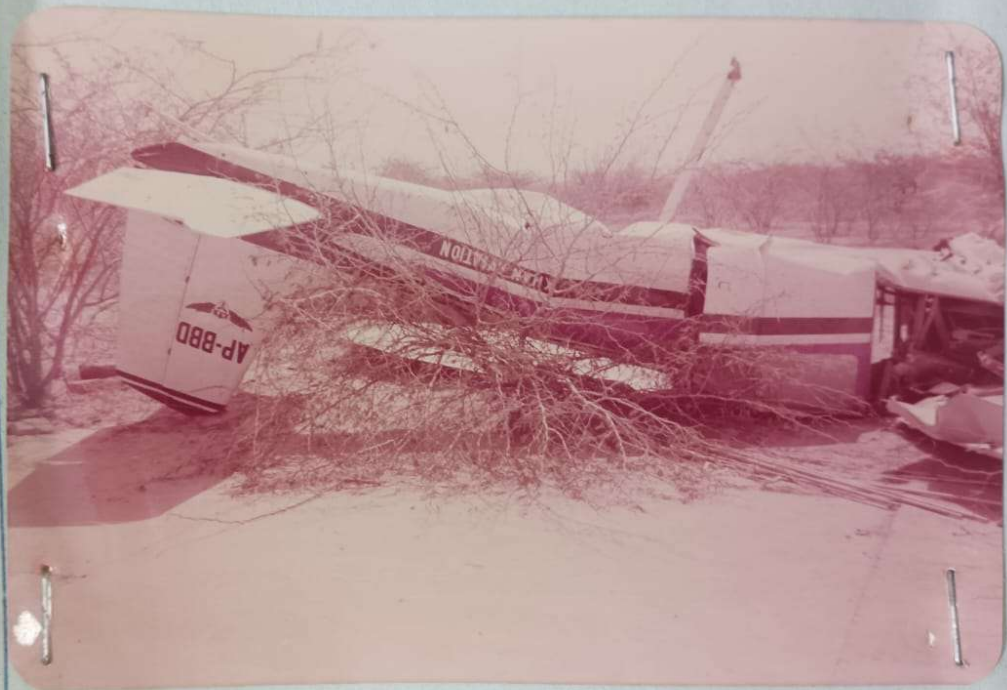
APPENDIX "B10"

A VIEW OF THE WRECKAGE FROM THE LEFT HAND SIDE.  
MOST UNDA MAGED CONDITION OF THE FIN RU

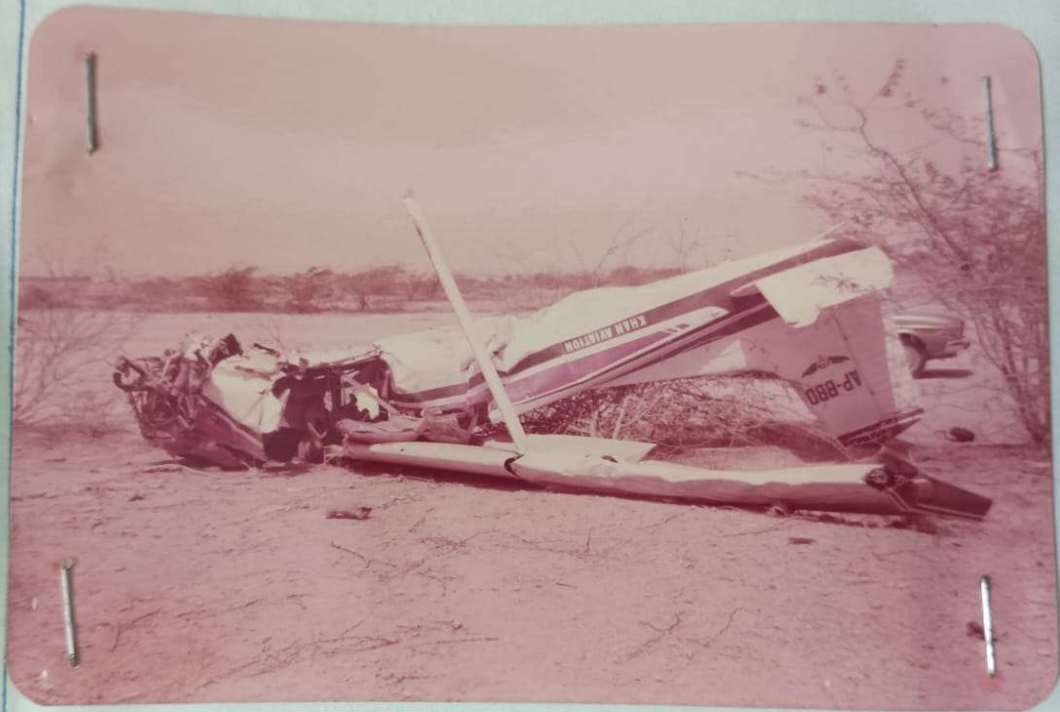
APPENDIX "B9"

THE VIEW OF THE MAIN WRECKAGE WHERE IT CAME TO REST  
NOTES THE DAMAGE TO THE COCKPIT AND THE RIGHT TAIL

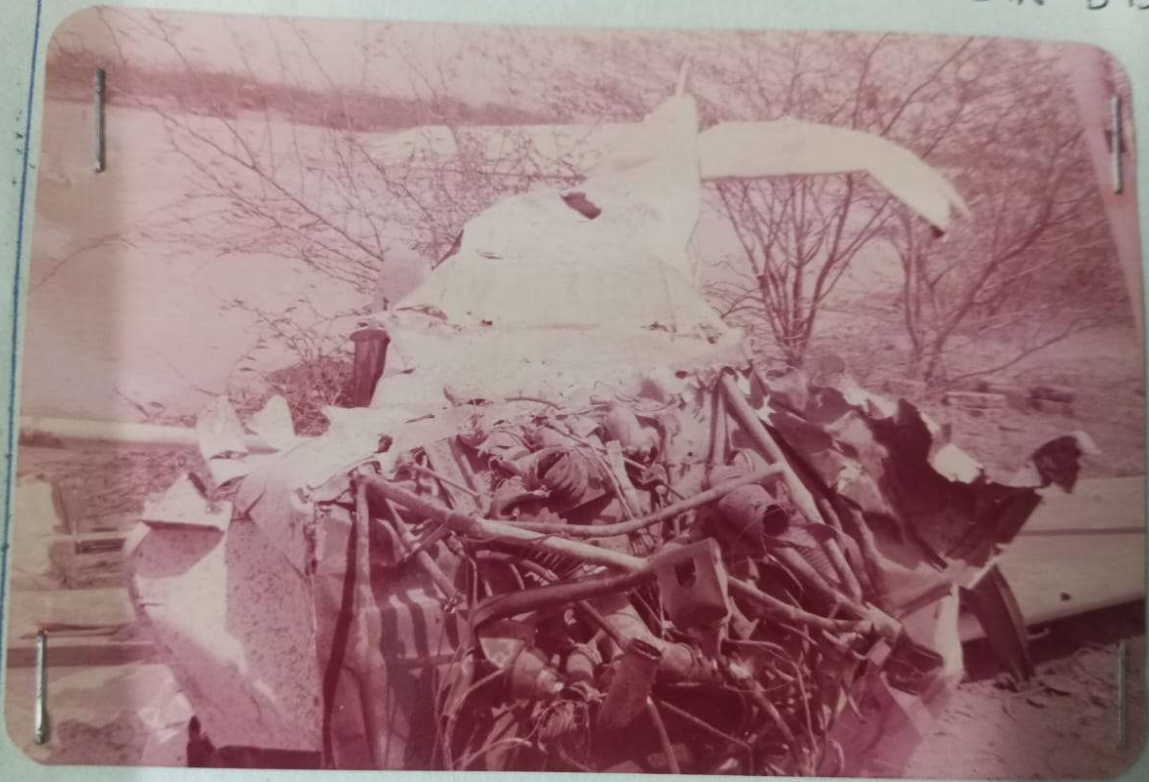
APPENDIX "B-13"

A VIEW SHOWING THE DAMAGED HULLS AND THE DEBRIS

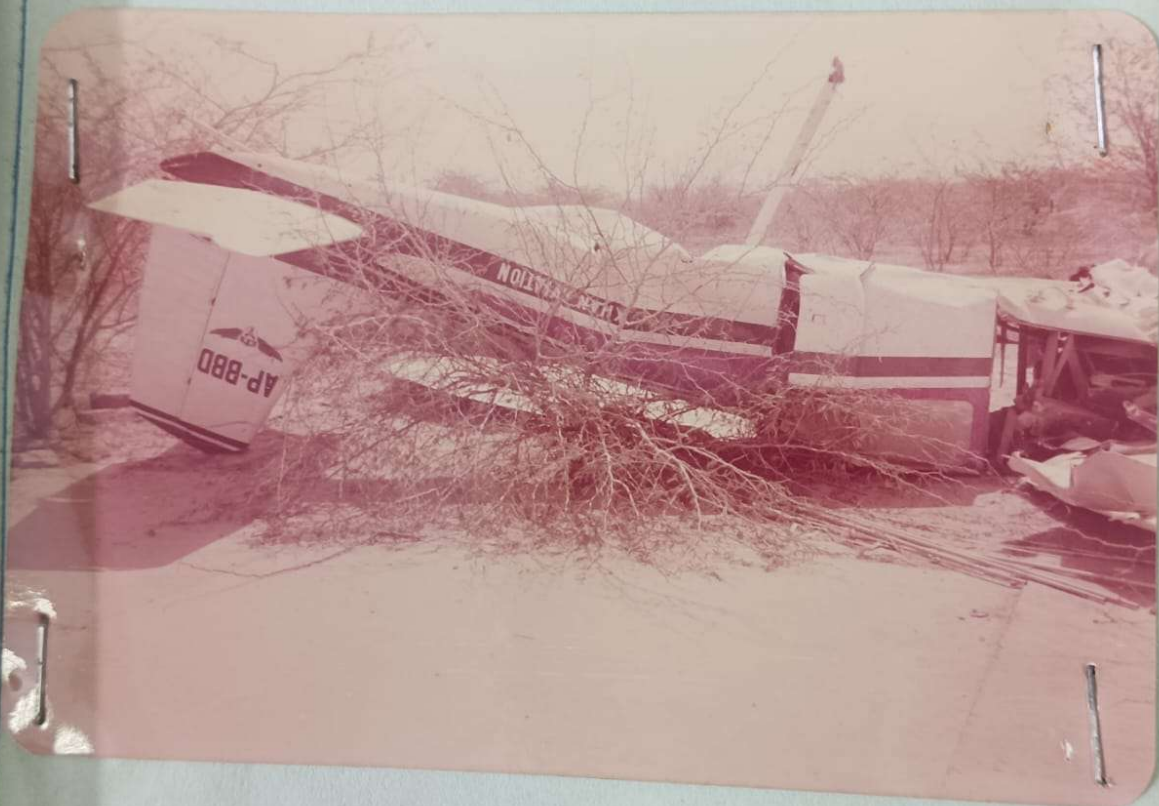
21.4.1.6. After skidding for 110 feet the aircraft was arrested to a sudden halt by a large bush. At this time the tail wheel which had already been damaged got free due to the large forces of deceleration, was thrown forward coming to rest 162 feet from the main wreckage in the same direction.

A VIEW OF THE WRECKAGE FROM THE LEFT HAND SIDE.  
NOTE THE ALMOST UNDAMAGED CONDITION OF THE FIN RUDD  
THE LEFT TAIL PLANE AND ELEVATOR. NOTE THE MISSING  
TAIL WHEEL.

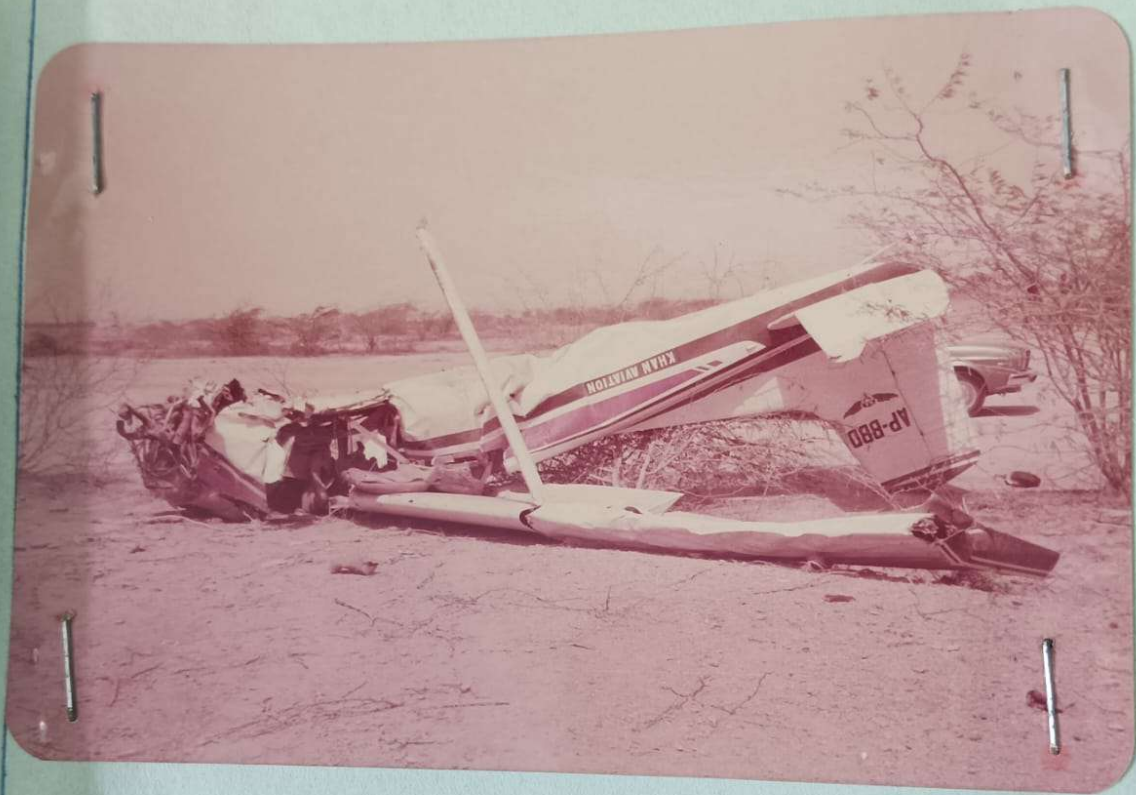
21.4.1.8. Damage to the right horizontal stabilizer probably occurred when the aircraft slewed after the left wing got initially caught in the bush shortly after impact.

THE VIEW OF THE MAIN WRECKAGE WHERE IT CAME TO REST  
NOTE THE DAMAGE TO THE COCKPIT AND THE RIGHT TAIL F  
THE REGISTRATION MARK CAN CLEARLY BE SEEN. NOTE THE  
POSITION OF THE FLAP.

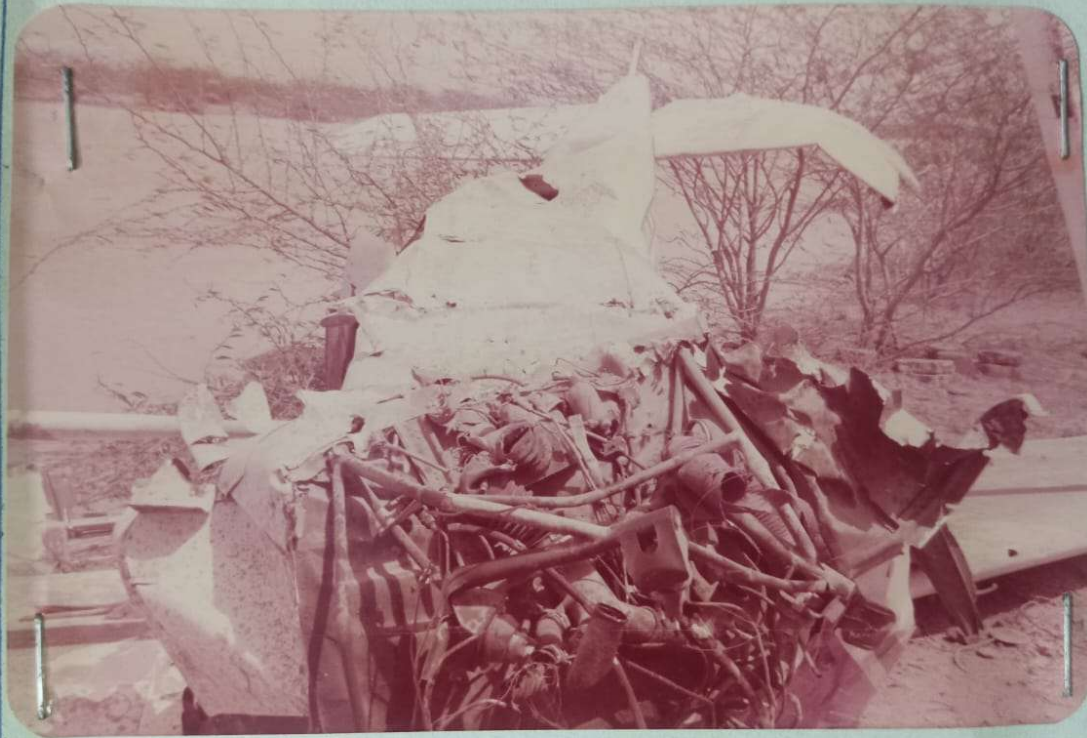
APPENDIX "B-13"

A VIEW SHOWING THE ENGINE MOUNTS AND THE DAMAGED
