# FINAL INVESTIGATION REPORT

SERIOUS INCIDENT OF SHAHEEN AIR INTERNATIONAL (SAI)  
FLIGHT NL-151 (SECTOR ISB – UET), B737-400 AIRCRAFT  
REG # AP-BJT AT QUETTA ON 16<sup>TH</sup> JULY, 2015

## FINAL REPORT

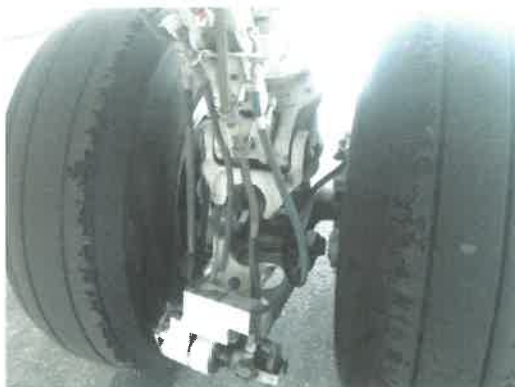
Fractured LMLG Upper Torsion Link

- 2.1.10. The failure mode analysis of the upper torsion link was performed at Institute of Space Technology (IST), Failure Analysis Center (FAC), Pakistan. The FAC analysis report (**Appendix 'E'**) concluded that part failed due to bending overload. There was no evidence of fatigue, stress corrosion cracking and no deviation of chemical composition or microstructure of the material of the failed part was reported.

- 3.1.3. The fracture surfaces of the upper torsion link indicated an over load fracture with no evidence of fatigue or material deficiency.
- 3.1.4. The overload fracture of torsion link was consequence of large amplitude vibrations (resonant vibration) due to shimmy after touchdown.

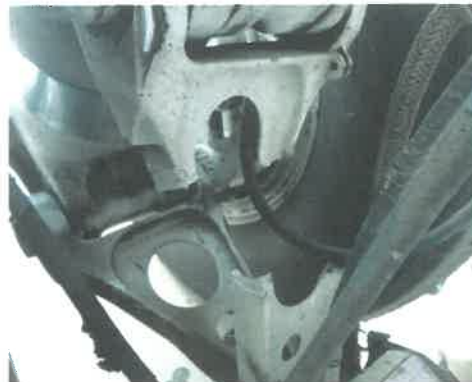
Close up view

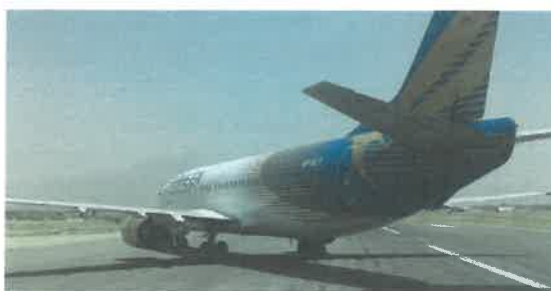
1.12. **Wreckage and Impact Information.** The aircraft was stopped on the runway. There was no other structural damage except failure of LMLG Upper Torsion Link.

Aircraft after final stop

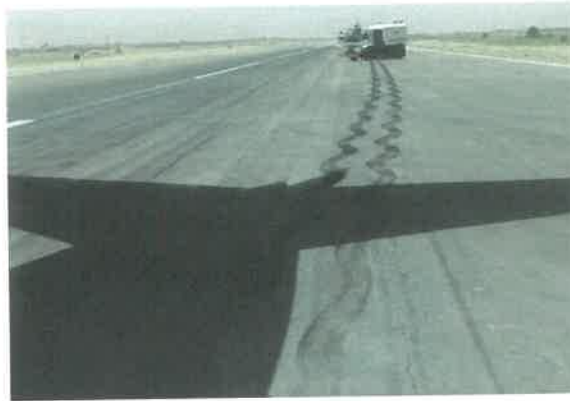
- 2.1.4. Approximately after 4 seconds of touch down oscillations were recorded in the lateral acceleration data. The oscillations in lateral accelerations indicate presence of shimmy event. The presence of shimmy event of the LMLG was also corroborated by tyre marks on the runway. The aircraft came to a stop approximately 50 seconds after touchdown. The zigzag tyre marks on the runway are characteristic indication of the shimmy event.

LMLG tyre marks on runway-viewing backward from aircraft final position

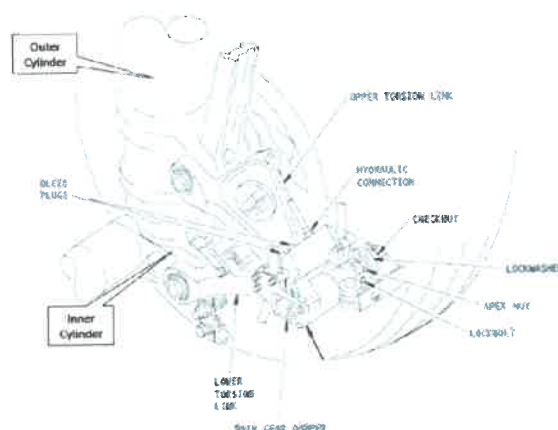
- 2.1.7. The axle of the wheels is mounted on the inner cylinder. The torsion links and shimmy damper assembly prevents pivot of the inner cylinder inside the outer cylinder (torsional movement). The torsional vibrations are prevented by the shimmy damper. It is pertinent to mention that clearance / play at the attachment points of shimmy damper and torsion links are detrimental in effectiveness and efficiency of the whole mechanism to prevent torsional vibrations of the wheel assembly.

Torsion Links and Shimmy Damper Assembly

- 2.1.8. Ineffectiveness of shimmy damper mechanisms results in torsional vibrations, which is termed a shimmy event. If the vibrations approach the natural frequency of assembly then resonance phenomenon is excited which results into very large amplitude vibrations. The large amplitude vibrations exert excessive load on associated linkages, resulting into failure of the torsion links/shimmy damper

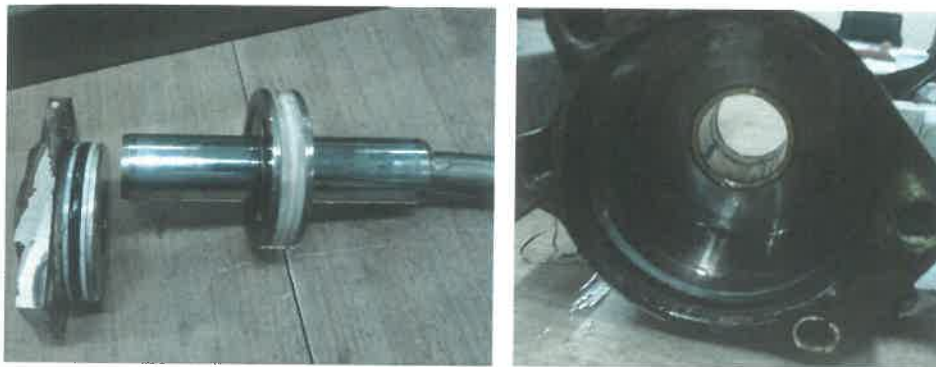
- 2.1.16. The internal hydraulic leaks / damaged of shimmy damper can also adversely affect the damping efficiency. The shimmy damper actuator was found bent / deformed after the incident; therefore, complete bench check was not possible. The partial bench check was carried out which confirmed that there was no internal hydraulic leak in the assembly. After the bench check, tear down examination was carried out and internal seals and piston was verified to be intact.

Shimmy damper internal seals and parts were found intact
