TYRE BURST INCIDENT INVESTIGATION

B-737 AP-BCB

CIVIL AVIATION AUTHORITY  
KARACHI, PAKISTAN

INVESTIGATION REPORT OF LANDING INCIDENT INVOLVING B-737  
AIRCRAFT, REGISTRATION MARK AP-BCB OPERATING PK-333  
FROM LAHORE TO MULTAN ON 23RD DECEMBER 1991, IN  
WHICH THREE TYRES BURST (NO.1,2 & 4) ON  
LANDING AT MULTAN AIRPORT

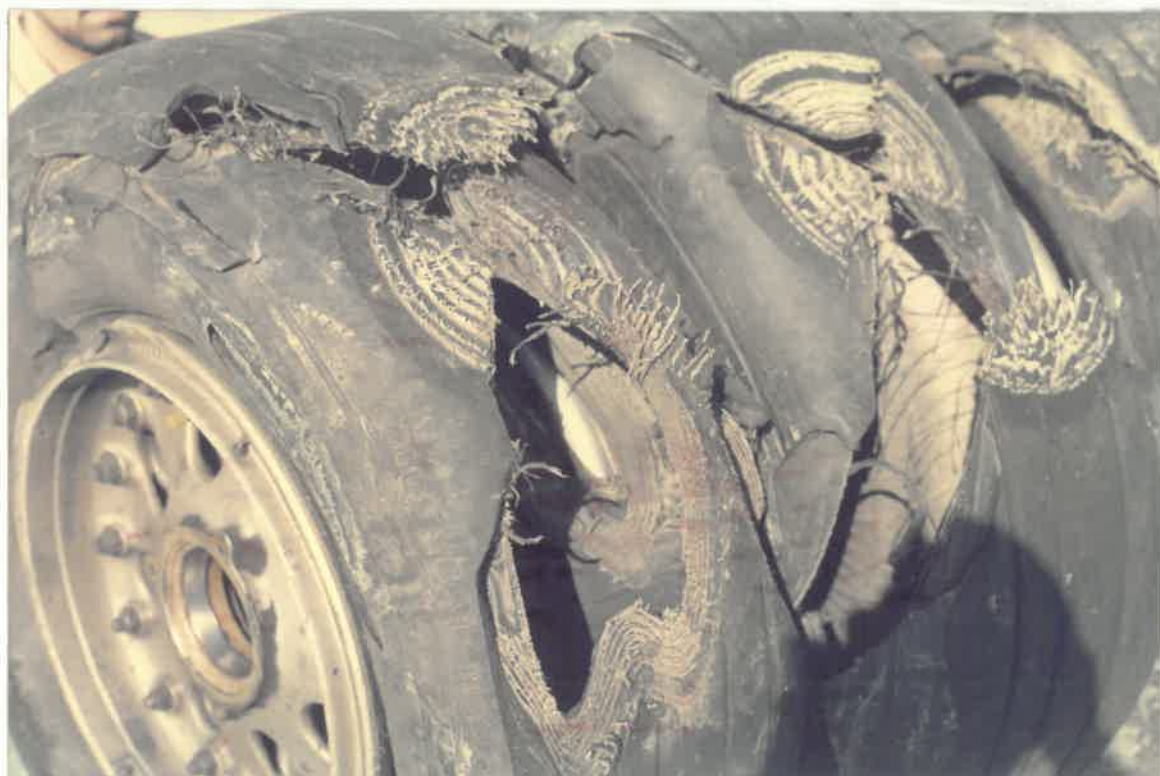
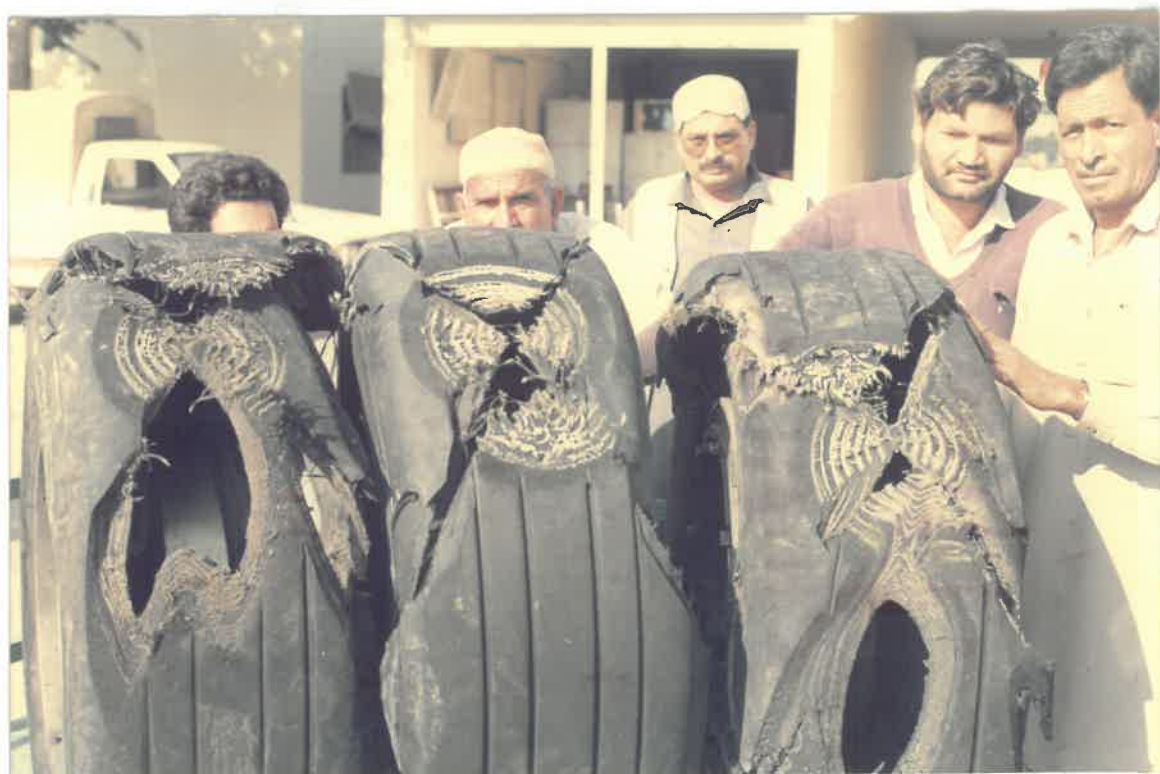
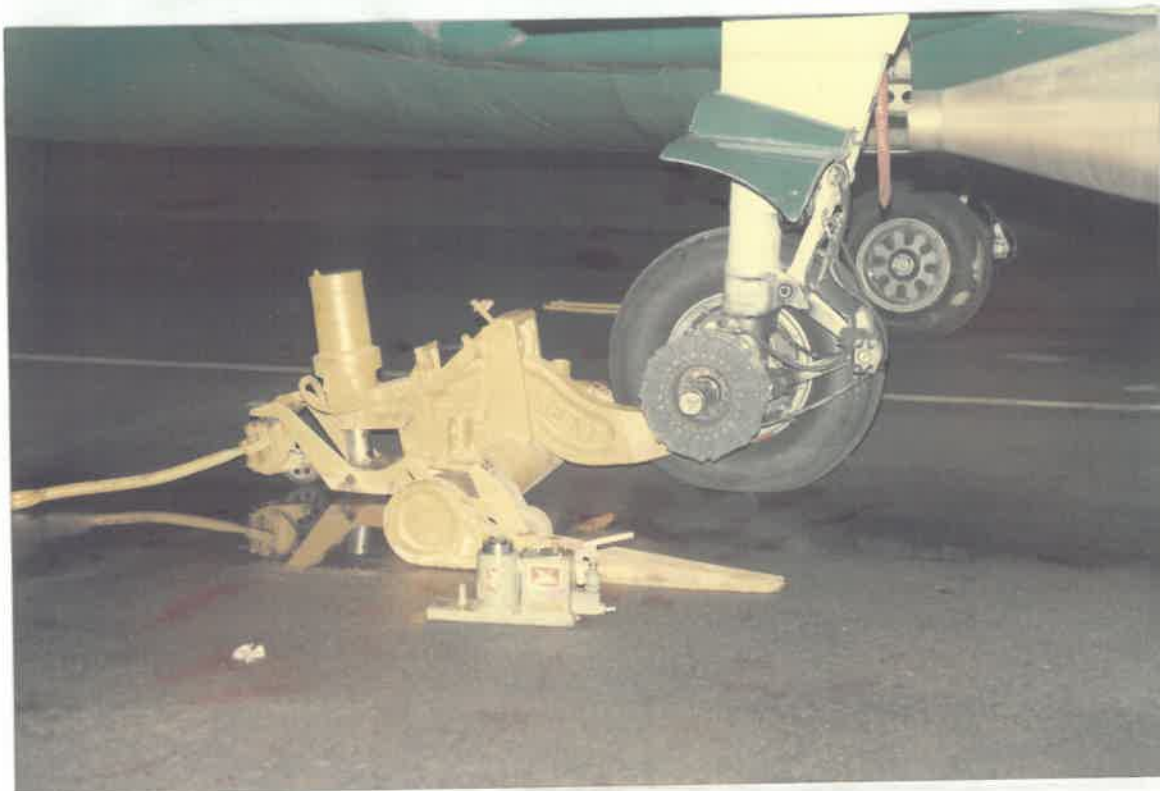
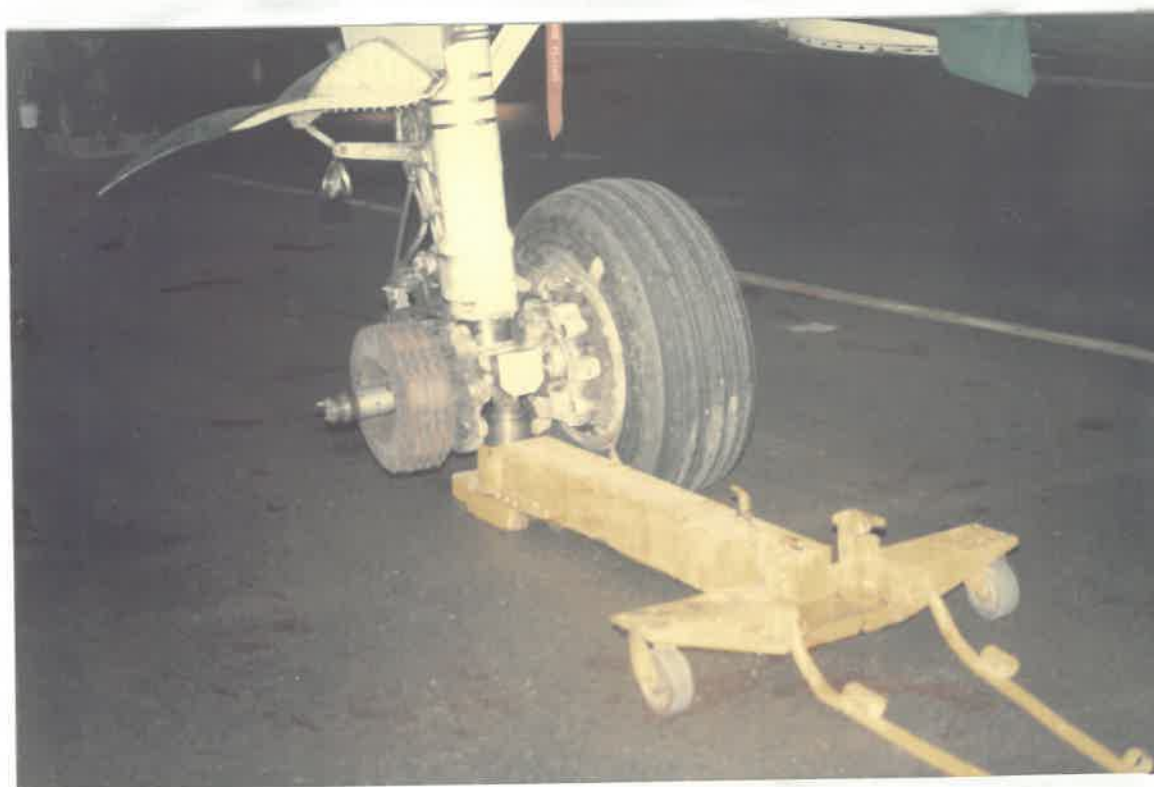
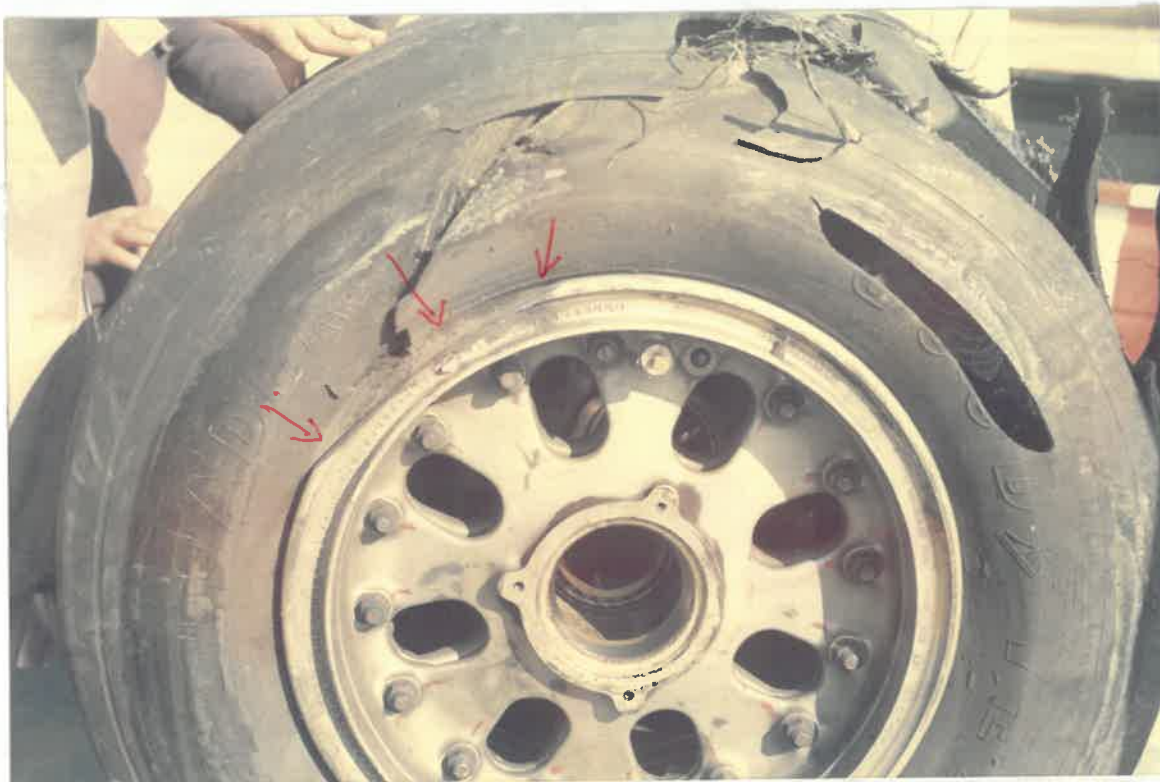
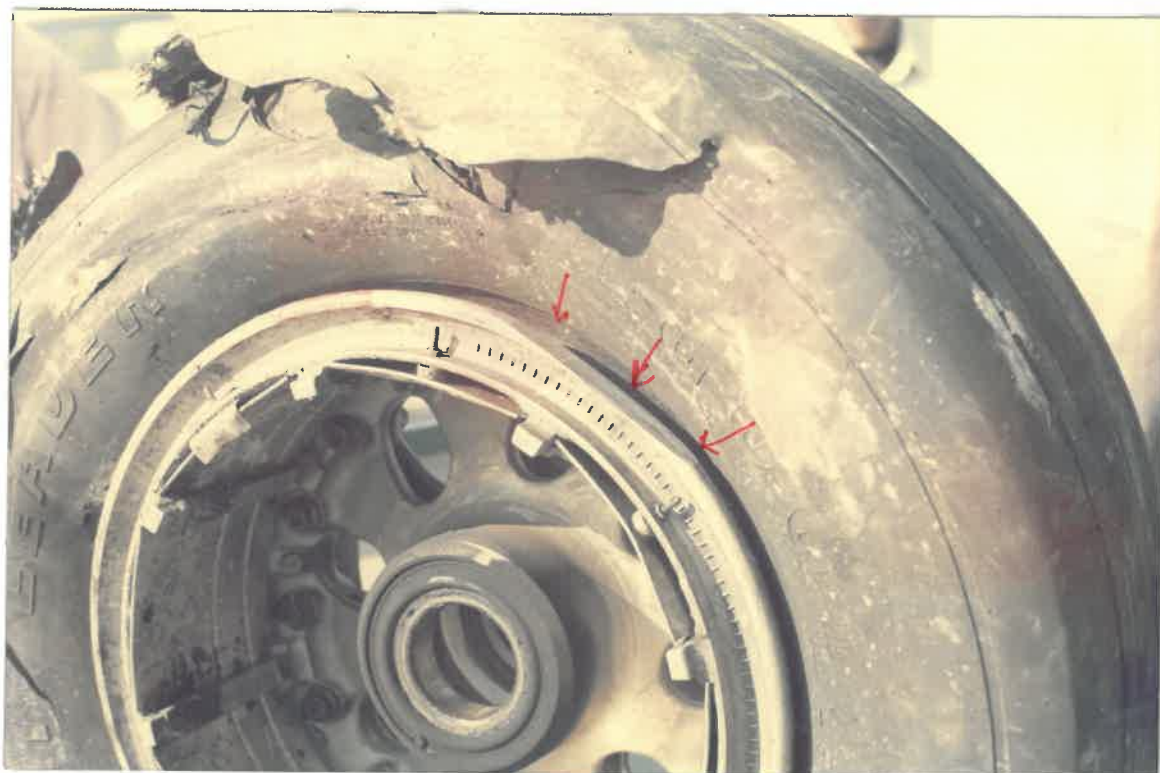
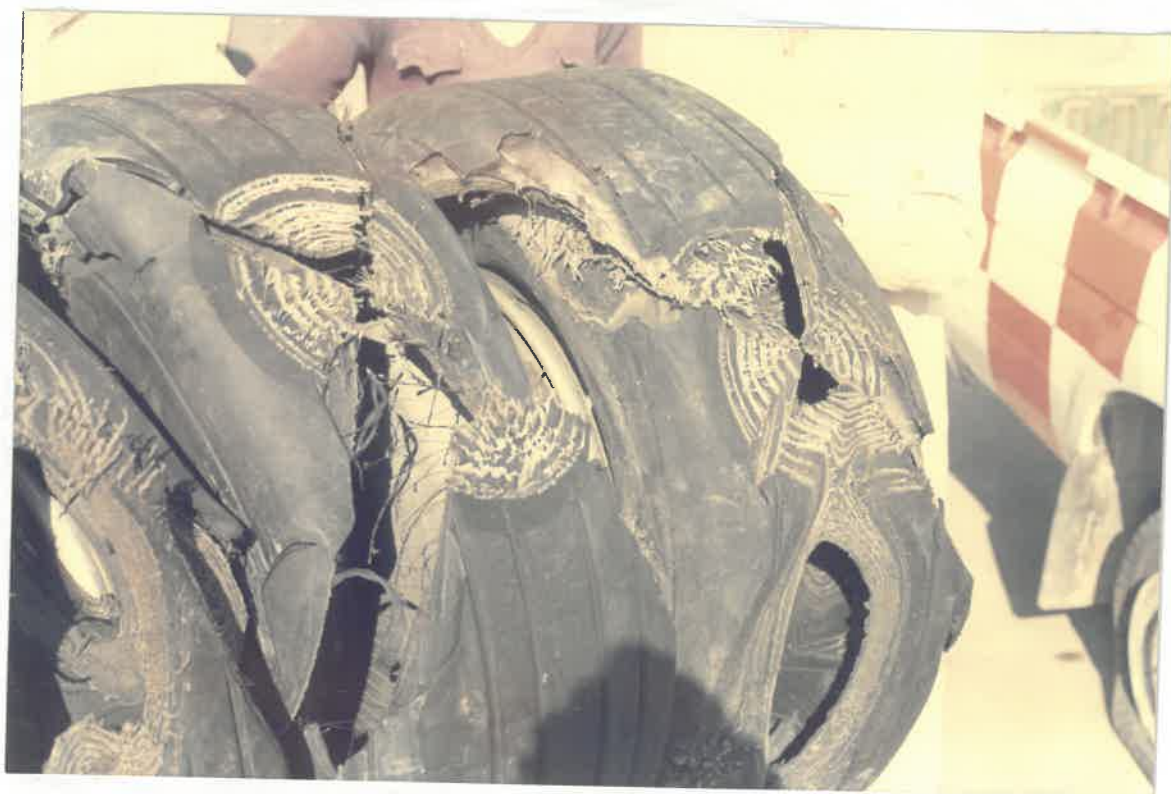
- 3.7. DFDR indicates that speed brakes (ground spoilers) were not used. (manual extension was required). The Pilot stated that he used spoilers.
- 3.8. Manual brake application was carried out incorrectly, which resulted in bursting of three tires. (See Appendix - "B-1 to B-7") which shows positively that they burst due to locking of wheels.
- 3.9. Around 80 kts thud/noise was heard and the deceleration rate increased. The aircraft came to a stop about 1000 ft short of runway 18 threshold.
- 3.10. Evacuation was carried out on the runway, normal stairs were used.

- 5.1. The following tires were burst:-
  - 5.1.1. Wheel position 1, S/N 2969
  - 5.1.2. Wheel position 2, S/N 3672
  - 5.1.3. Wheel position 4, S/N 3194
- 5.2. No. 4 wheel fairing was damaged due to tire burst.

12.1. Three tires were burst because of locking of wheels due to incorrect braking technique, and the aircraft came to a stop at 8500 ft down the runway.
