**AIRCRAFT ACCIDENT INVESTIGATION**

**UZBEKISTAN AIRWAYS IL-76 AIRCRAFT**

**WHICH OCCURRED ON 21-04-1993**

**PESHAWAR AIRPORT**

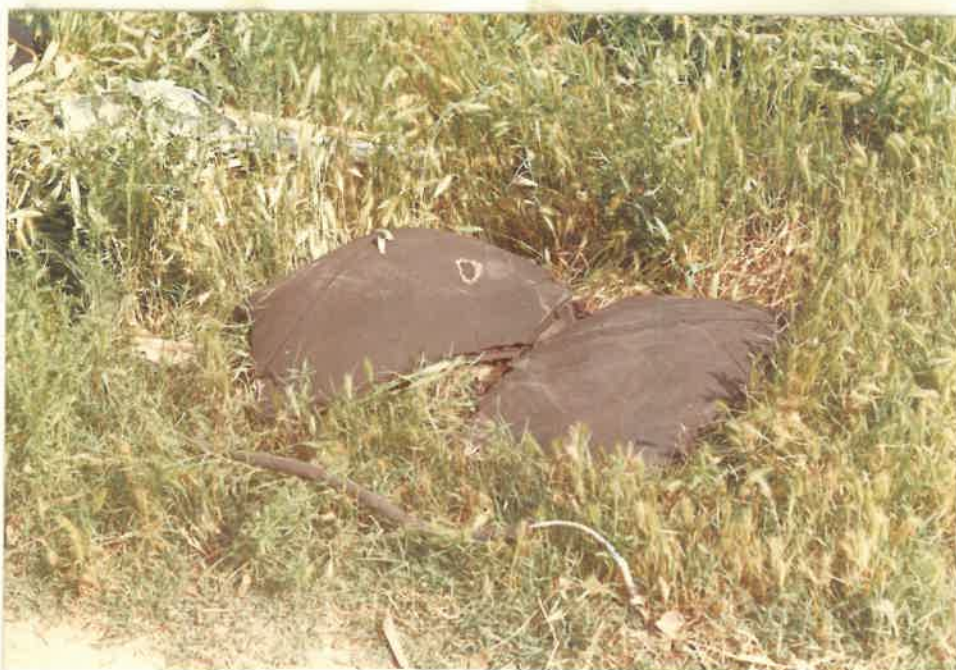
6. TYRES TREAD PIECES AND HOSE

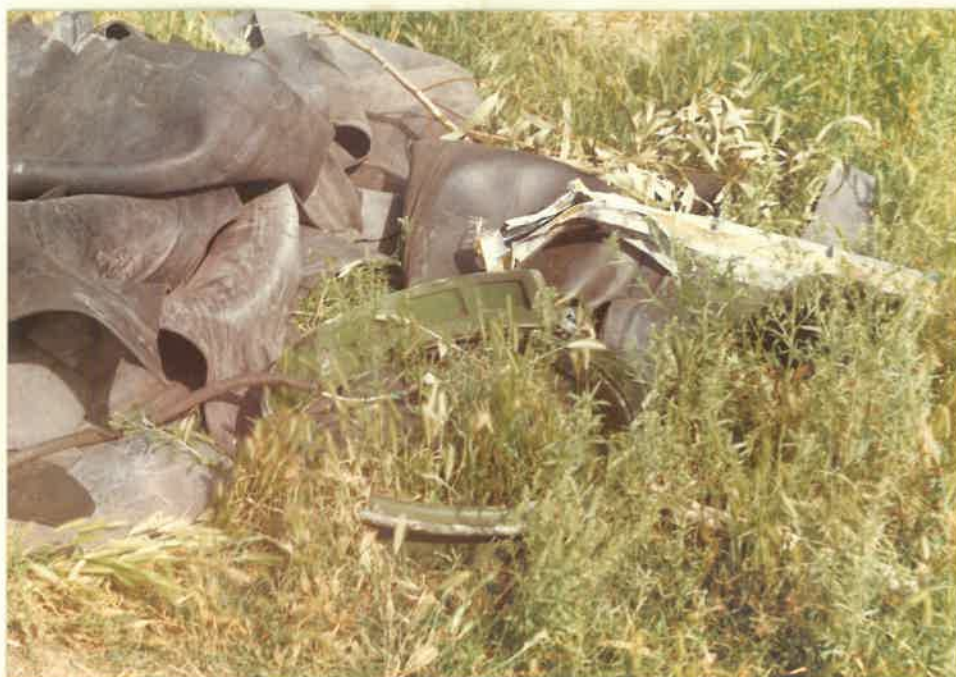
7. TYRE'S TUBES PIECES, RIM PIECES AND STRUCTURE PART

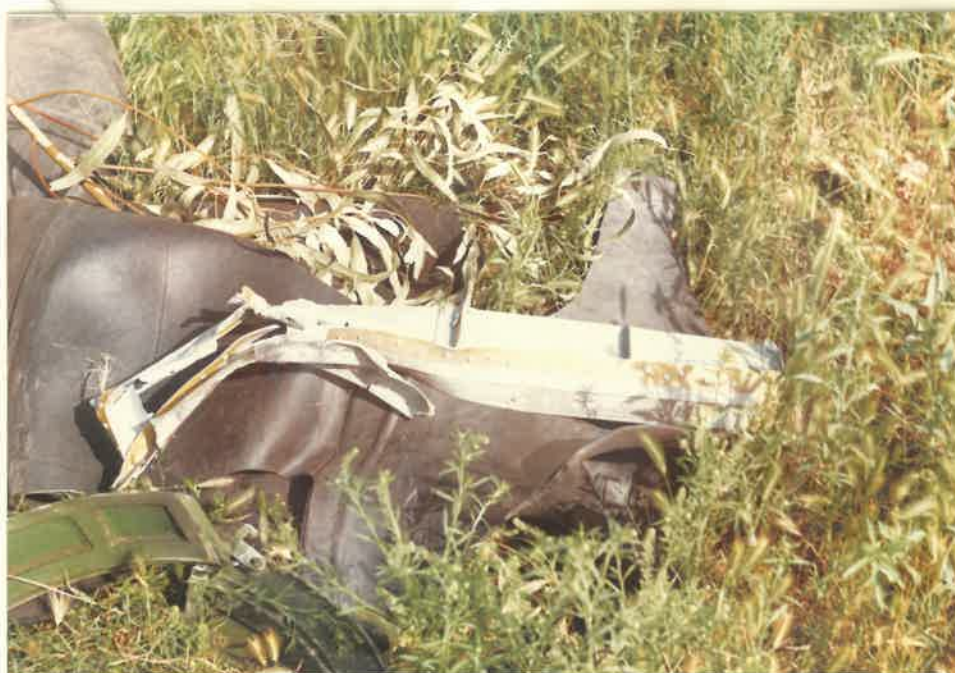
8. TYRE'S TUBES PIECES, RIM PIECES AND STRUCTURE PART

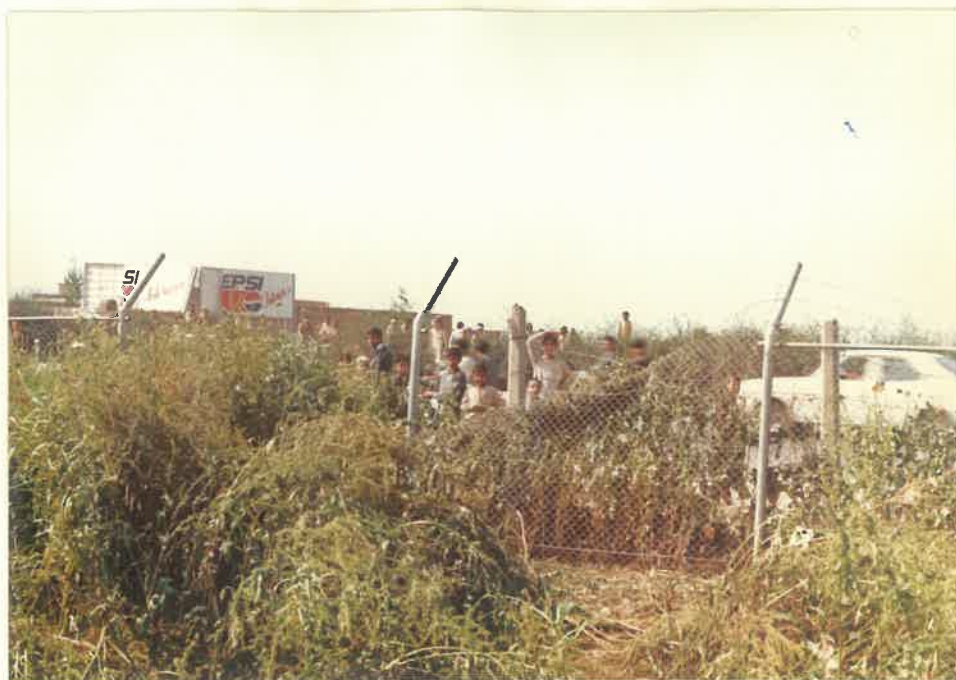
9. AIRPORT PERIMETER FENCE

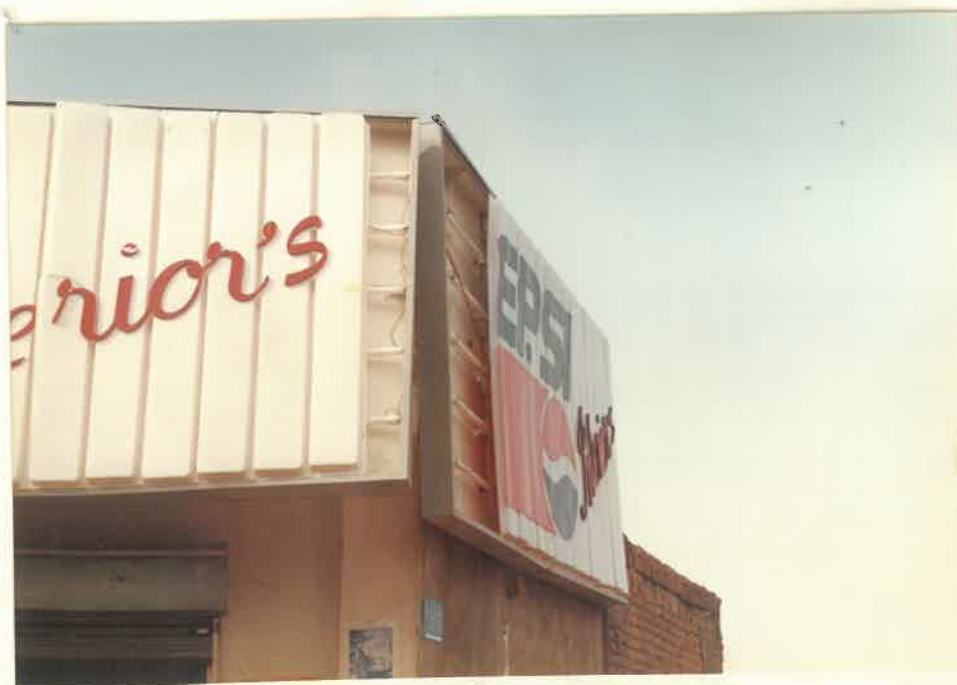
10. DAMAGES ACROSS JAMRUD ROAD SIGN BOARD

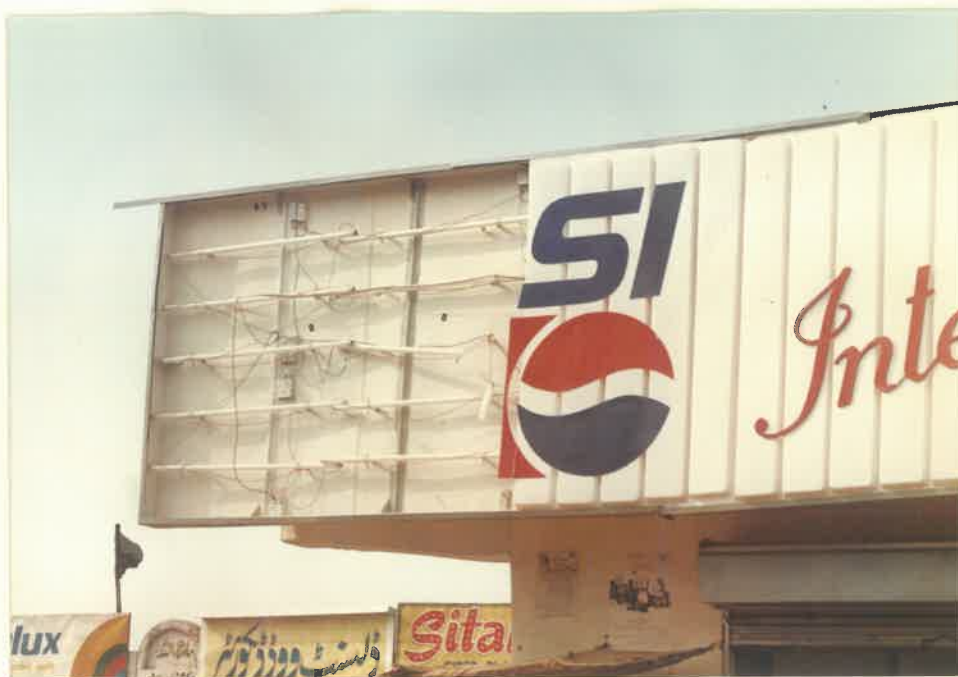
11. DAMAGES ACROSS JAMRUD ROAD SIGN BOARD

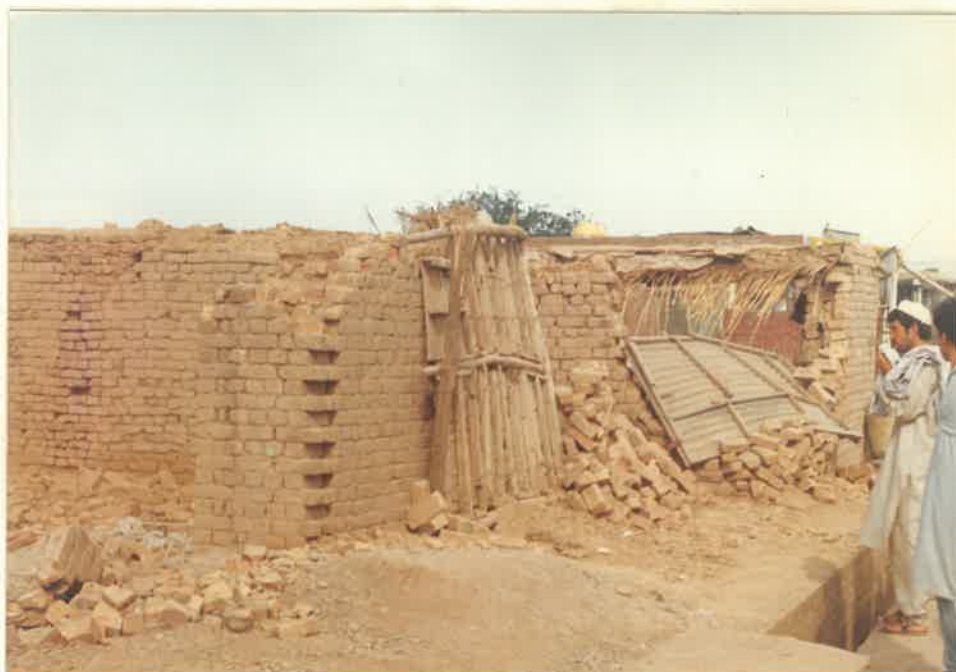
12. DAMAGE OF WALL UNDER CONSTRUCTION ACROSS ROAD

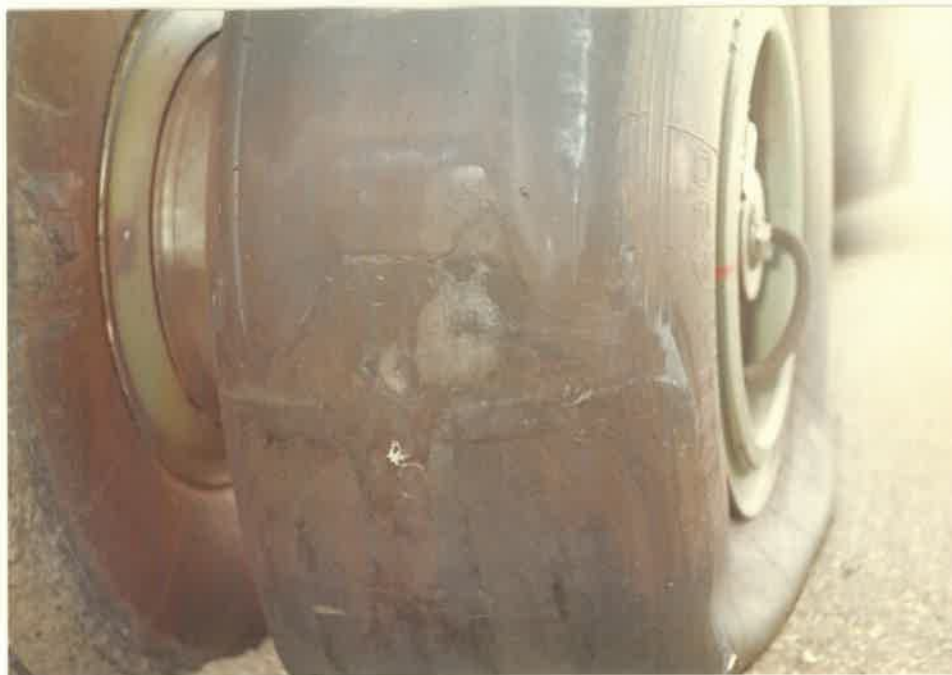
- 16.8. As the runway was partly contaminated with water the co-efficient of friction was low and there was aquaplaning. Due to this aircraft came to stop in the over-run area. Due to excessive braking the tyres burst. After tyre burst the wheel came in contact with runway and wheel rims were damaged. However, there was no damage to runway.

15. AQUA PLANNING MASK ON L/H MAIN WHEEL (MW)

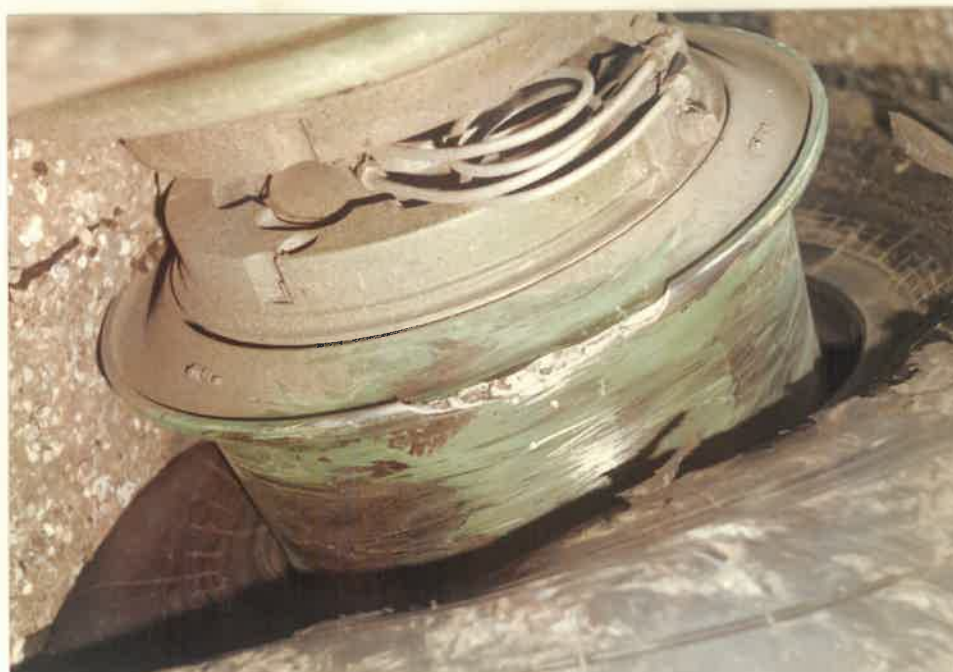
16. MW RIM DAMAGE

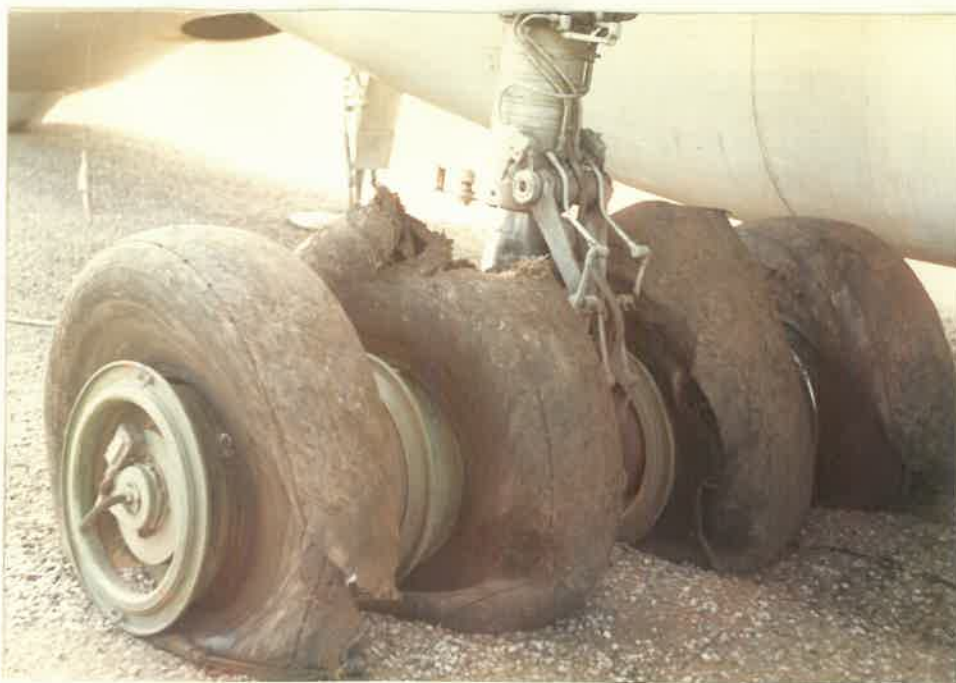
10  
17. R/H REAR BOGIE MAIN WHEELS BURST

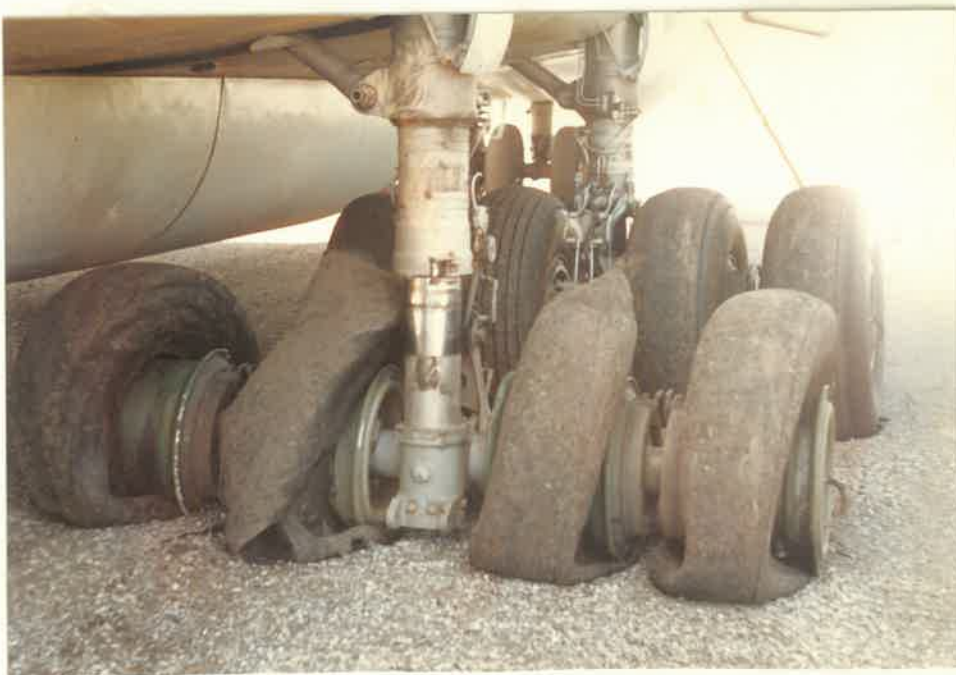
18. R/H BOGIE WHEELS

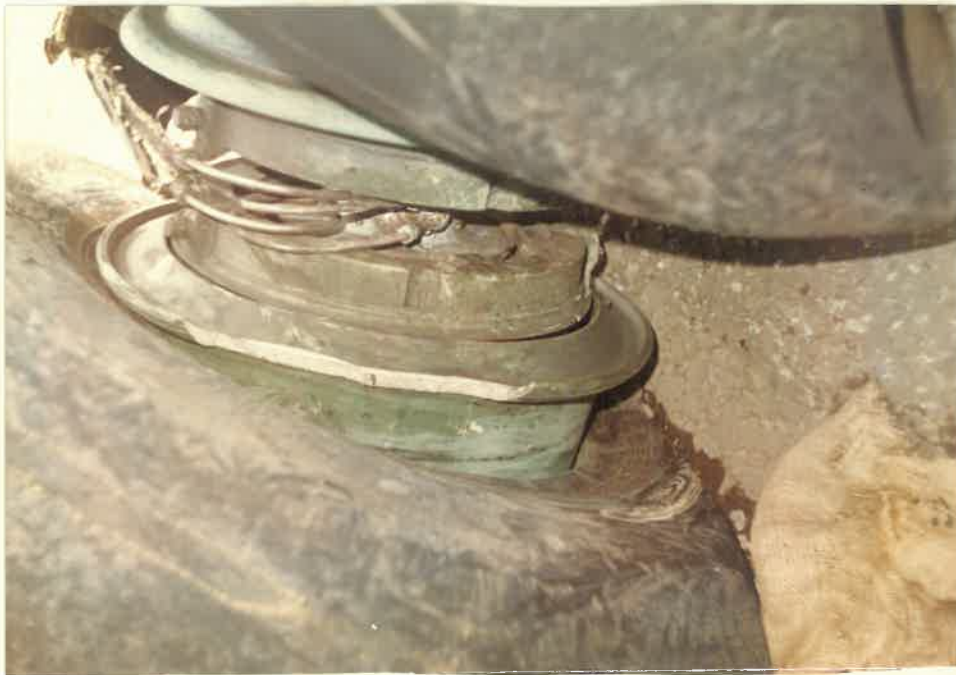
19. MW RIM DAMAGE

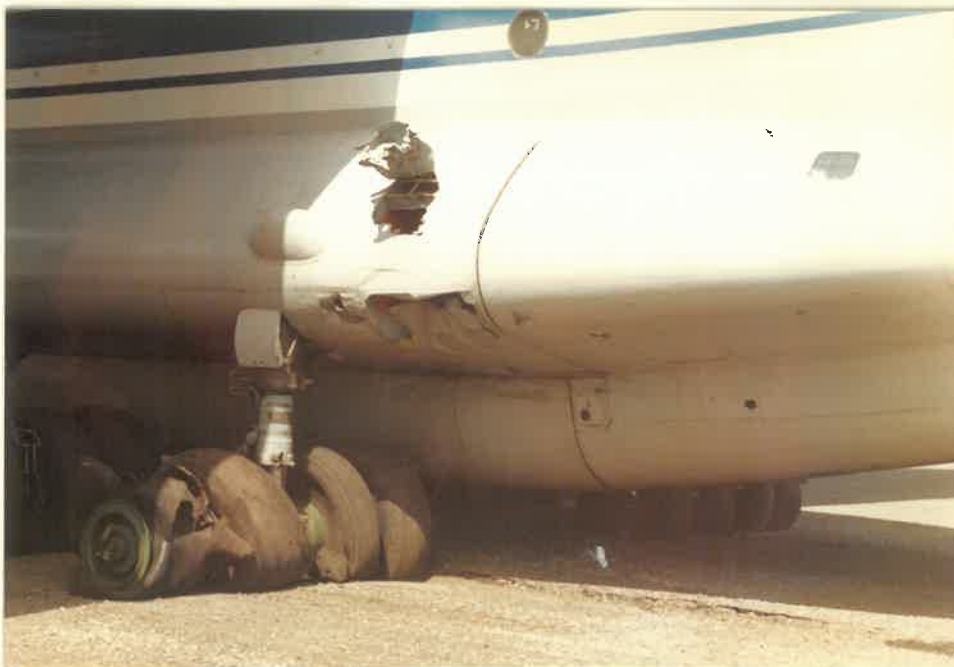
20. L/H REAR BOGIE MAIN WHEELS

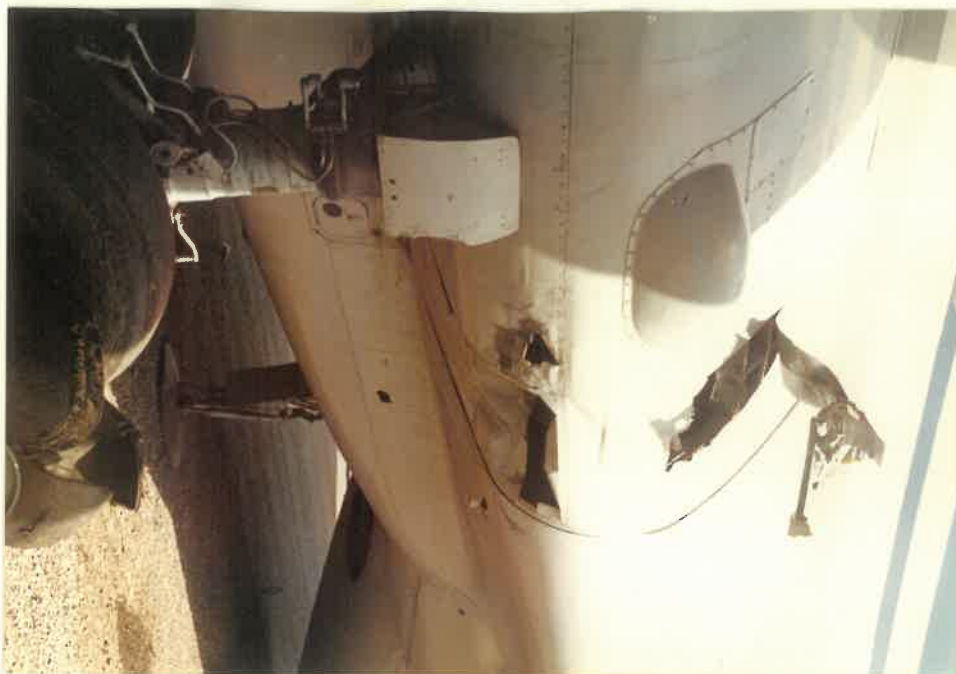
21. L/H REAR BOGIE ATTACHMENT UPPER PANEL DAMAGE

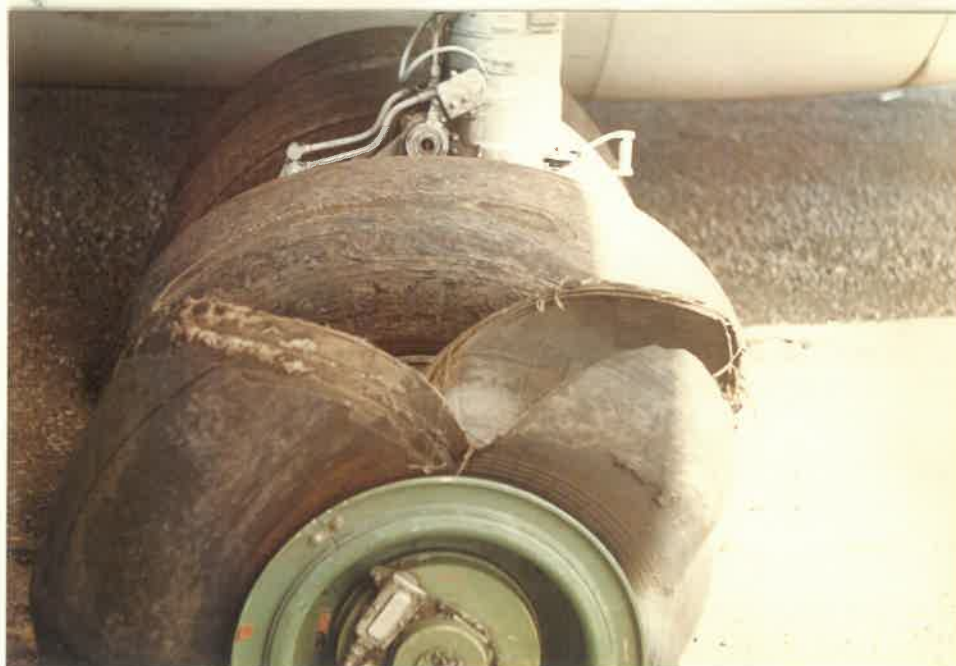
22. L/H REAR BOGIE MAIN WHEELS TYRES DAMAGES

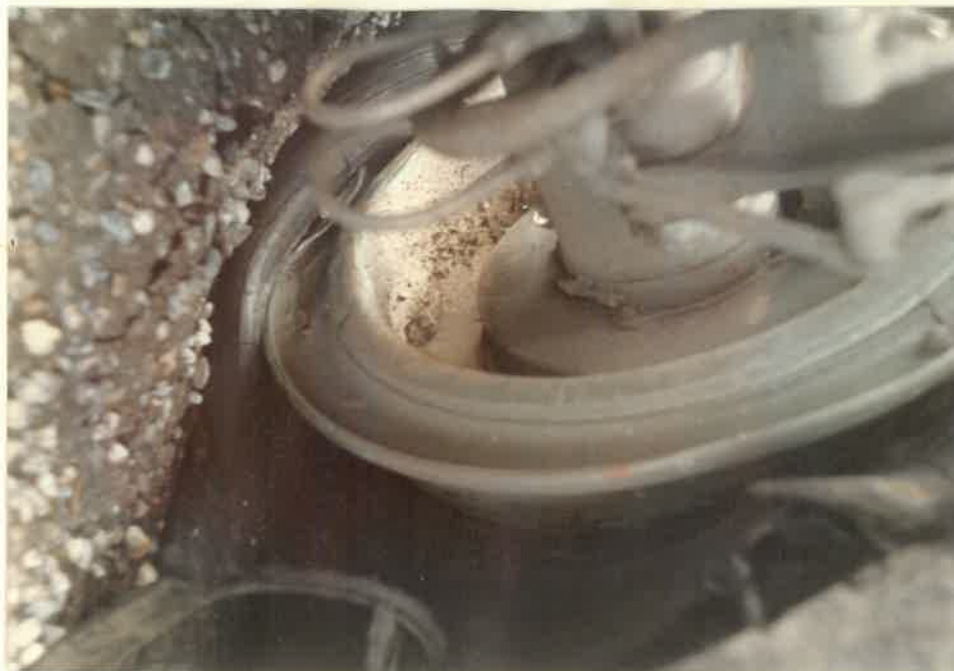
23. MAIN WHEEL RIM DAMAGE

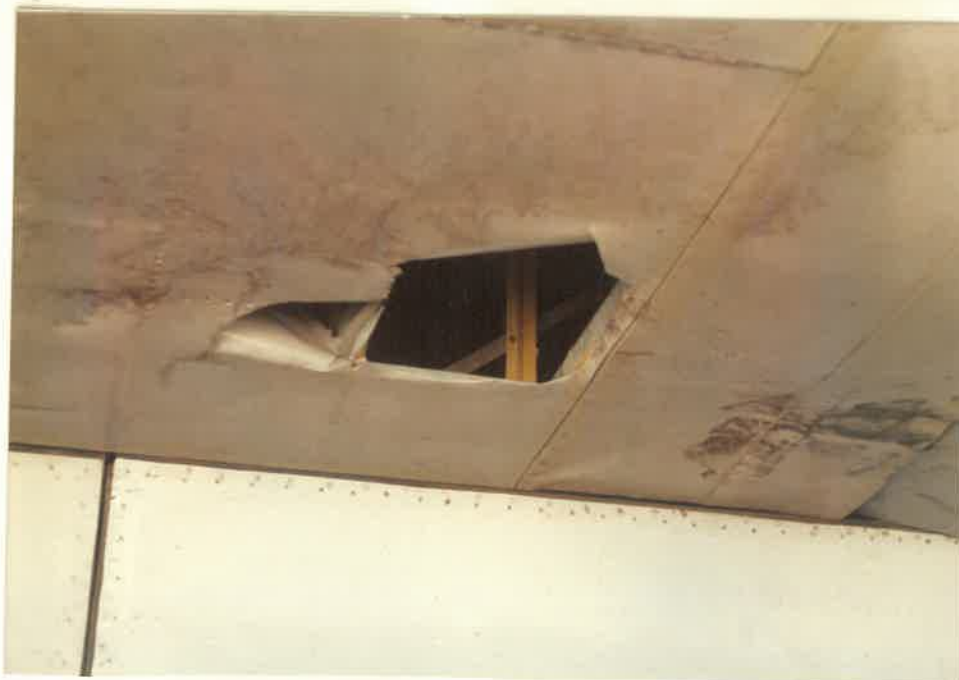
24. R/H MAIN WHEELS PANELS UNDER SURFACE SKIN DAMAGE

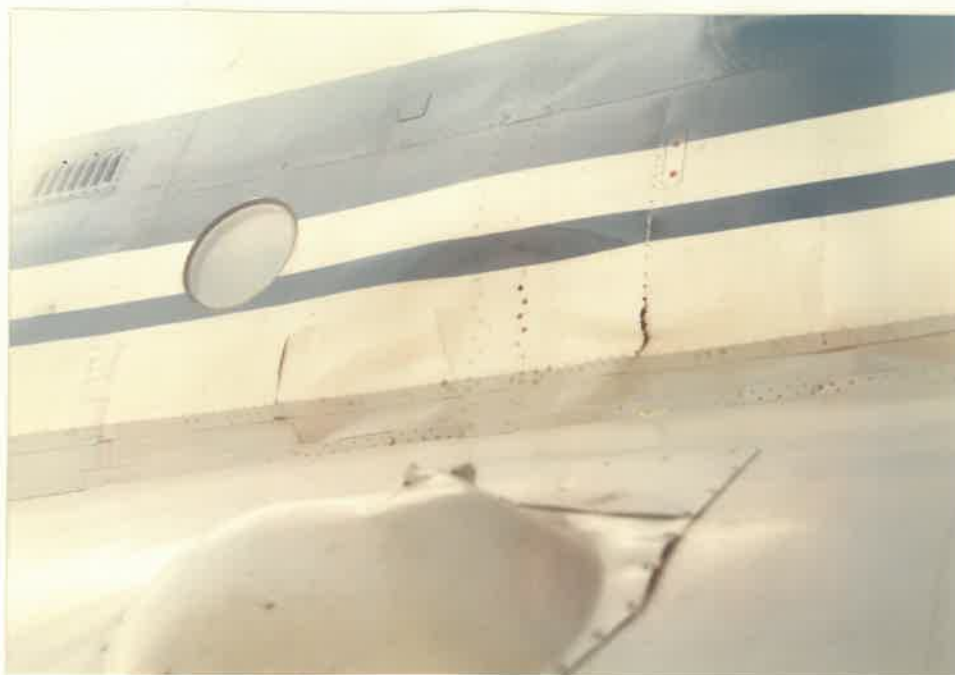
25. R/H FUSELAGE SKIN DAMAGE

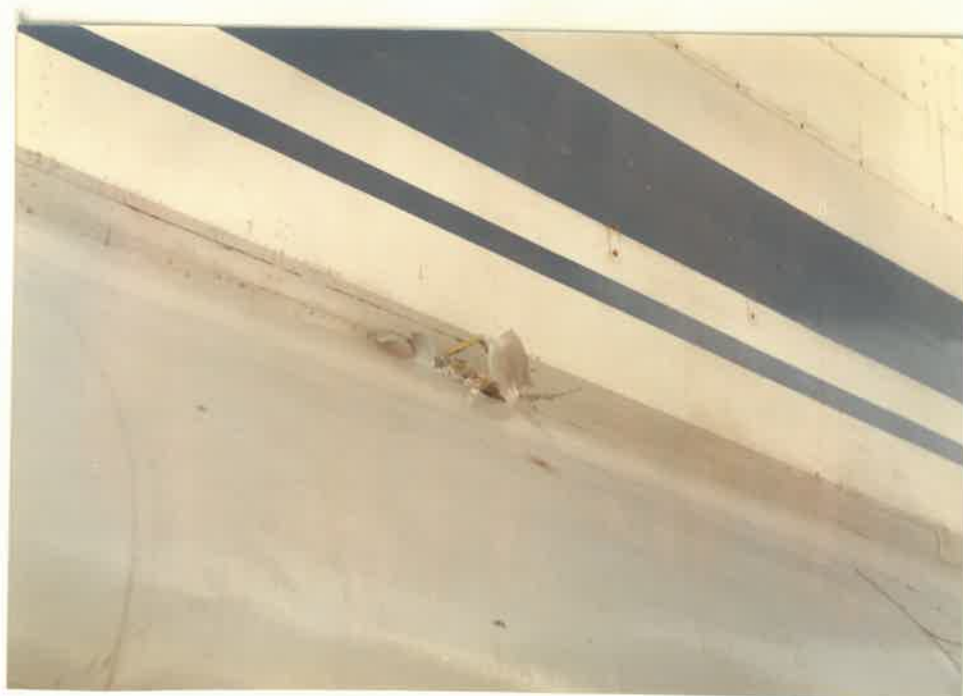
26. R/H MAIN WHEELS UPPER PANEL SKIN AND WIRING DAMAGE

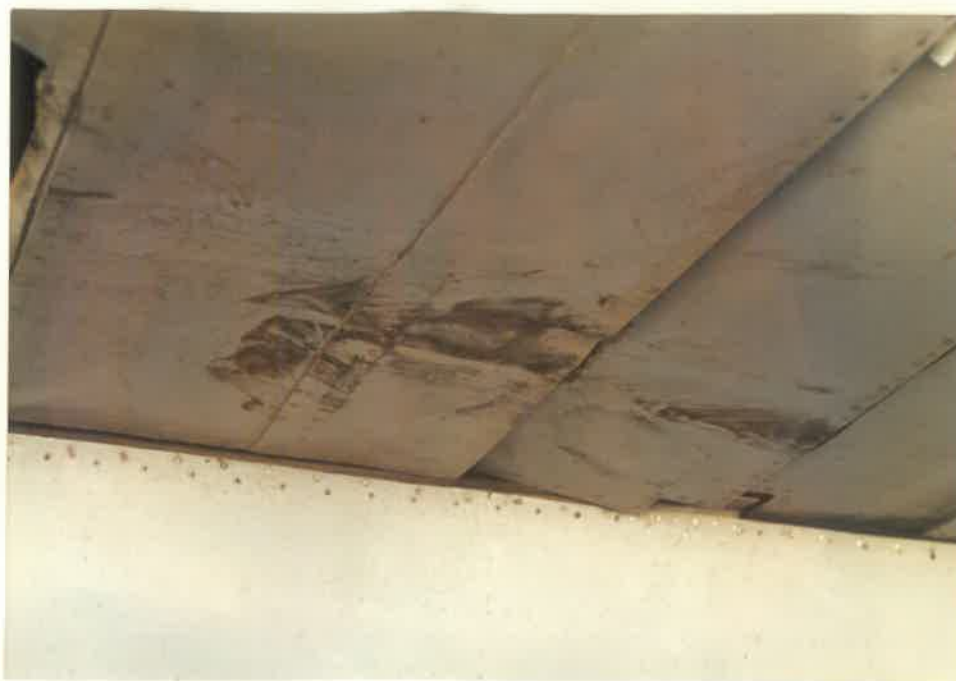
27. R/H MAIN WHEELS PANELS UNDER SURFACE DAMAGE

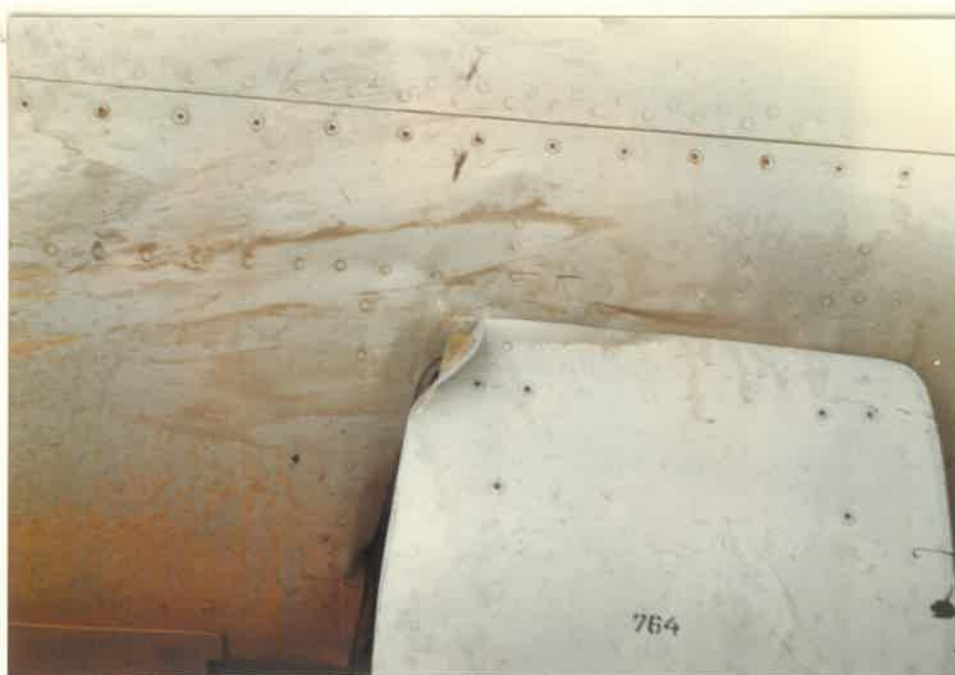
28. FUSELAGE SKIN PANEL DAMAGE

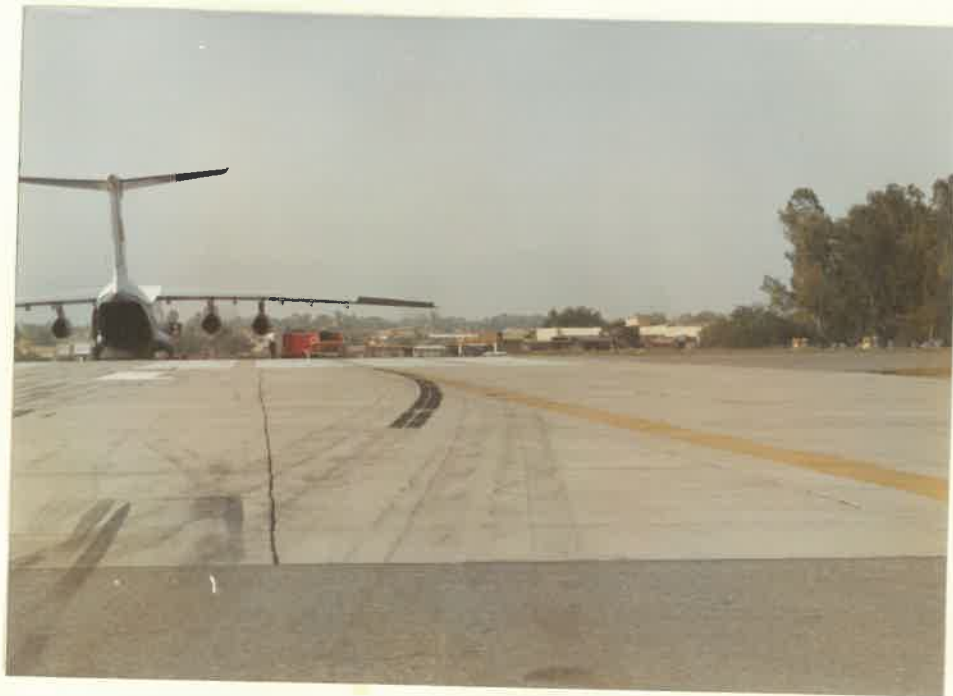
29. TYRE MARKS ON RUNWAY

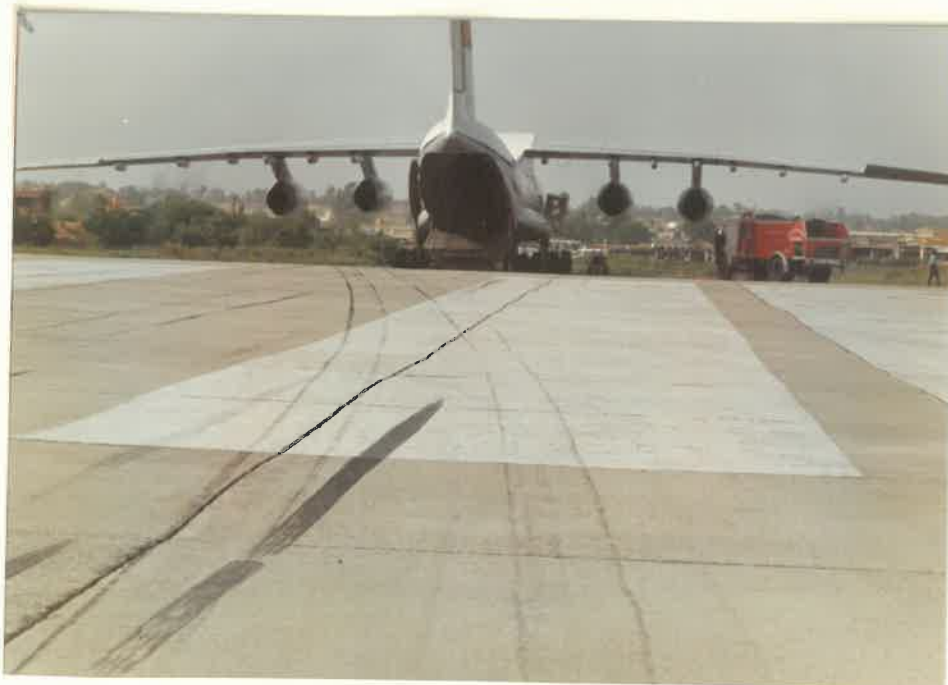
30. TYRE MARKS ON RUNWAY

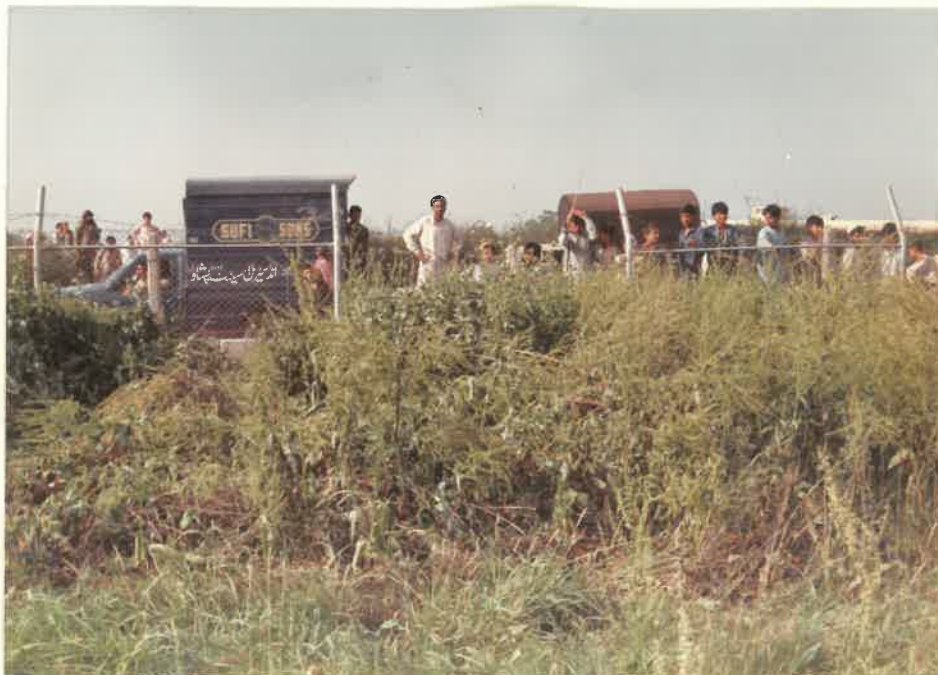
31. DAMAGE TO SHRUBS & GRASS DUE TO AIRCRAFT WASH & JET BLAST
