# FINAL INVESTIGATION REPORT

SERIOUS INCIDENT OF RUNWAY EXCURSION BY  
M/S GULF AIR FLIGHT GFA 784, A330, REG. NO. A9C-KD  
AT BACHA KHAN INTERNATIONAL AIRPORT (BKIAP)  
PESHAWAR ON 04-04-2017

## FINAL REPORT

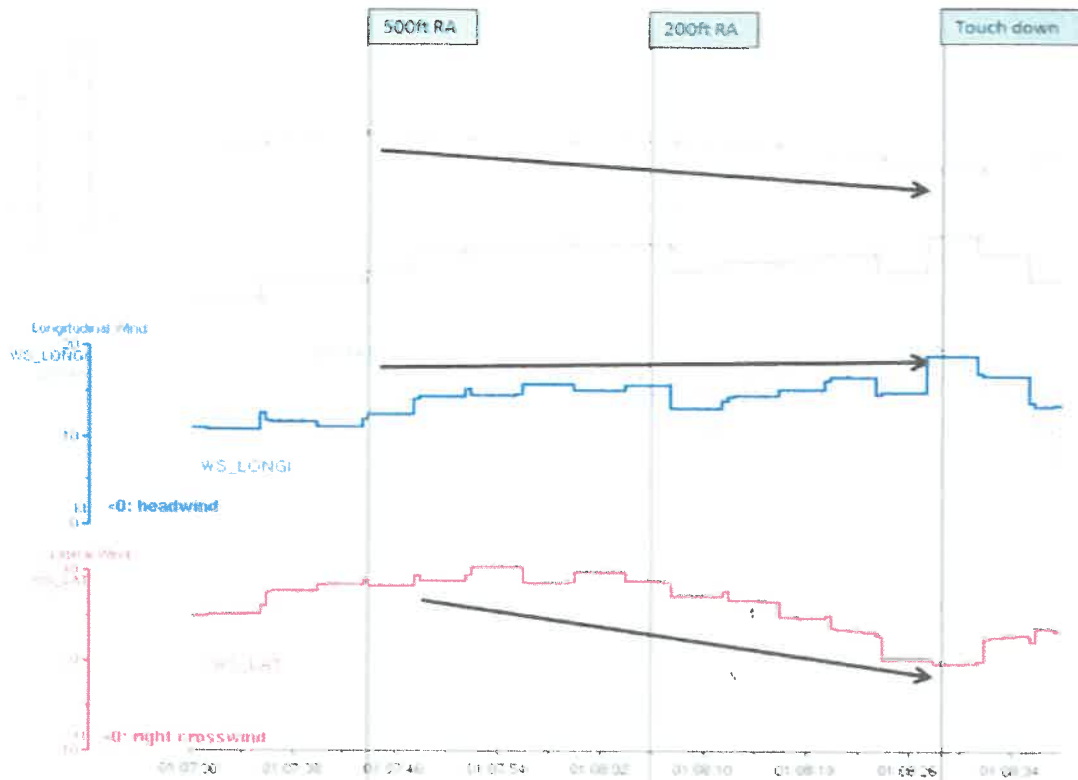
#### Recorded Wind during Final Approach

1.7.3.1 According to cockpit crew heavy rain was encountered on finals and landing. The wind computed from FDR parameters was 16 kts tailwind. The graphical representation of the encountered wind is as follows:-

- 1.7.3.2 Between 500 ft till touchdown the average wind recorded by the DFDR was from 191° and 17 kts (tailwind component 16 kts and left crosswind component 06 kts). Below 200 ft, the crosswind component was decreasing to almost zero, however, the tailwind remained constant about 16 kts.
- 1.8 **Aids to Navigation.** The mishap aircraft was equipped with serviceable ADF, VOR / DME, ILS and GPS for the conduct of flight operations. All ground equipment related to ADF, VOR / DME and ILS was serviceable at the time of occurrence.
- 1.9 **Communications.** The mishap aircraft was equipped with serviceable UHF / VHF sets for radio contact with all concerned agencies during flight / on ground.
- 1.10 **Aerodrome Information.** The BKIAP, Peshawar detailed aerodrome data is appended below:-

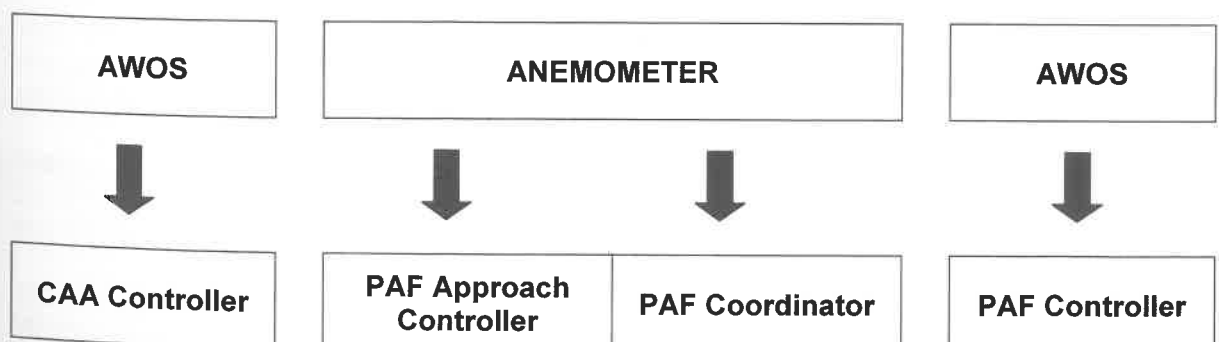
- 2.2.6 At ATC Tower BKIAP Peshawar, anemometer / AWOS displays in front of ATC controllers are as depicted below:-

- 2.2.7 The positioning of CAA controller in Bacha Khan Tower is on the extreme left corner of the front console. From this position, while sitting, the anemometer dials are not visible to ATC controllers at both ends. Additionally, no formal training has been imparted to PCAA controller to use AWOS which may lead to incorrect display due to undesirable incorrect settings (as in the case under discussion).
- 2.2.8 Less reported tailwind lead to incorrect decision by the cockpit crew to land through runway 35.
- 2.2.9 Actual tailwind beyond the permissible limits of landing lead to landing at higher ground speeds thereby increasing landing roll.

3.3.3 Inaccurate wind reporting by the Aerodrome Controller by using an equipment for which he was neither trained nor authorized.

4.2. PCAA (Directorate of Operations) is to review the process of determining / reporting the runway surface conditions in case of rain as per international standards. Also relevant procedures should also be revised / prepared & ensure use of standard R / T phraseology by all ATC units in Pakistan.
