## **FINAL INVESTIGATION REPORT**

### **SERIOUS INCIDENT (TCAS – RA) BETWEEN AIRBLUE FLIGHT ABQ611, AIRBUS 321-211 AIRCRAFT, REG. NO. AP-BMW (DUBAI – PESHAWAR) AND MILITARY AIRCRAFT ON 13-12-2021**

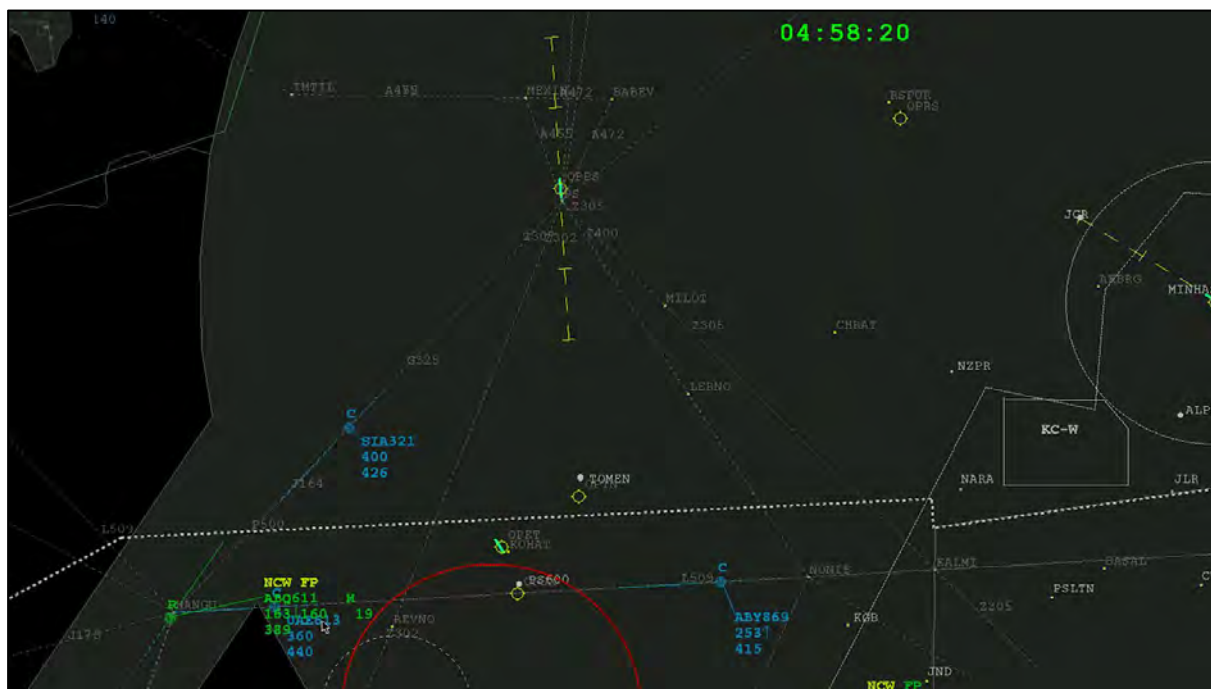
Figure 2 ABQ611 came in contact with Tower Controller

1.1.2. Once ABQ611 came in contact with Peshawar ATC Tower, Civil Controller asked ABQ611 to maintain FL160 and hold over Peshawar VOR for 20 min as advised by Military Supervisor due to Military traffic at FL140 on recovery for landing.

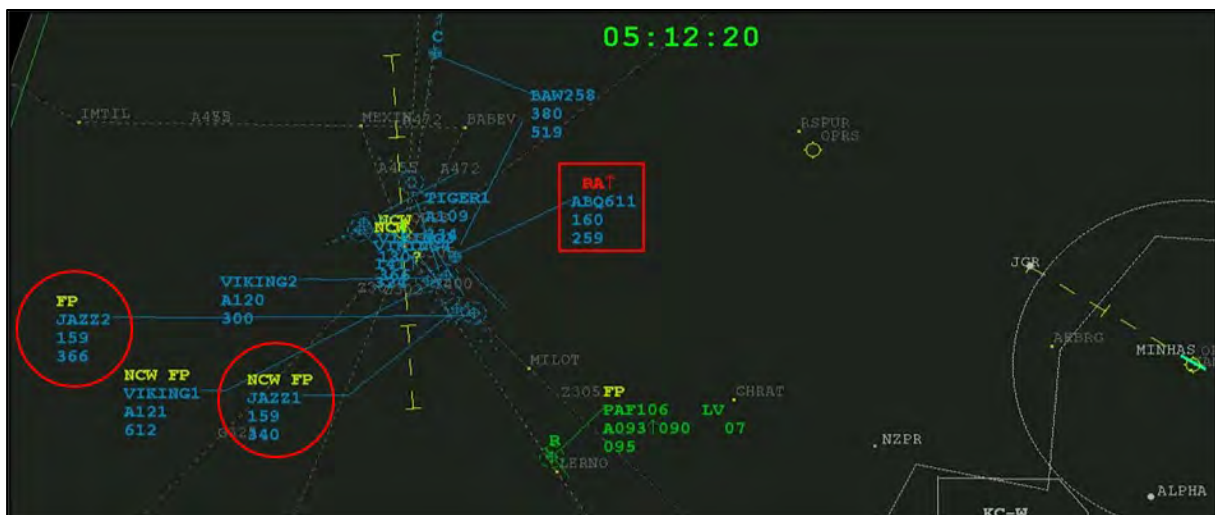
Figure 10 Activation of TCAS - RA

2.1.8. At 05:12:20 h, ABQ611, while in the hold over Peshawar VOR, reported TCAS – RA.

2.1.10. At 05:12:41 h, ABQ611 climbed to FL175 and reported clear of conflict.

2.1.18. Brief report by COO, BKIAP, Peshawar reveals that upon query from Military Supervisor, JAZZ formation of 2 x JF-17 Military aircraft were cleared from FL140 to FL160 and further to FL180 without information / coordination with Civil Controller, which resulted in activation of RA and multiple TAs for ABQ611.

4.1.1. Air Headquarters should ensure regular briefings for all PAF aircrew as well as military ATCOs on the operation and limitations of TCAS-RA in civil aircraft (particularly regarding speed variations and rates of climb and descent) to maintain proper separation and spacing between the traffic.

4.1.2. PCAA / PAA and Air Headquarters should establish proper coordination between civil and military controllers through formal letters of agreement (LOAs) to promote safe air operations practices.
