CIVIL AVIATION AUTHORITY PAKISTAN

INCIDENT INVESTIGATION REPORT

PIAC BOEING 737 - AP-BEH

OCCURRED ON 29<sup>TH</sup> DECEMBER 2001

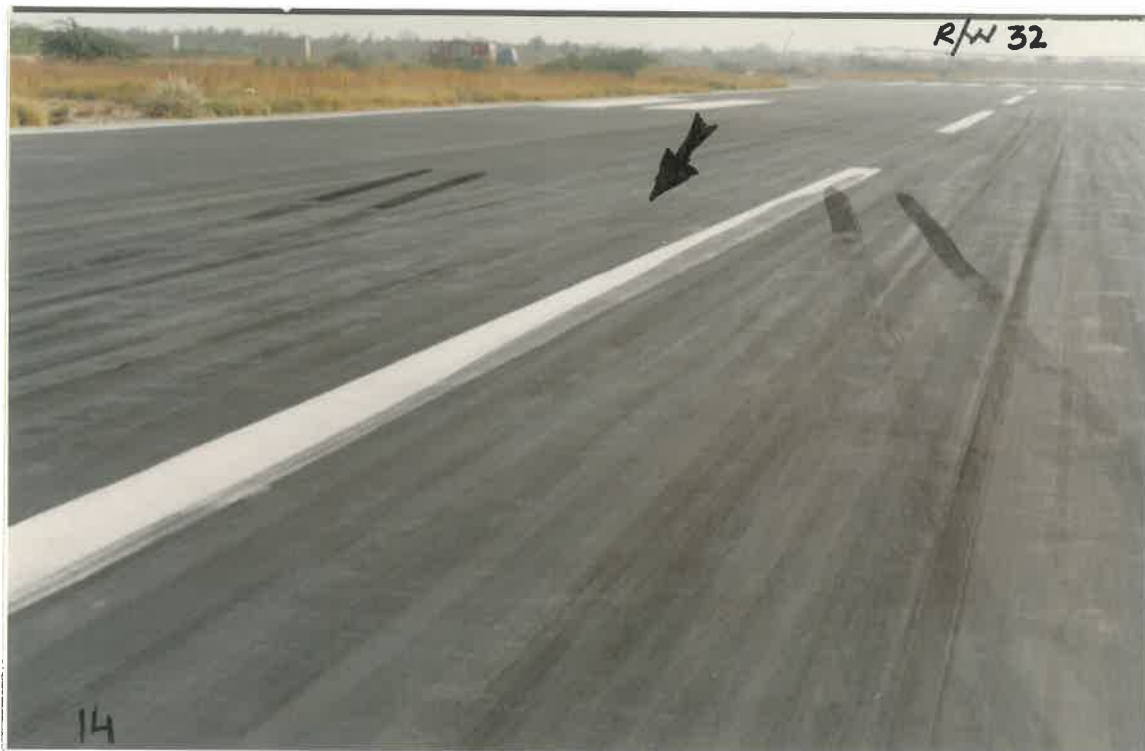
1.11.1 Tyre marks of the initial impact indicate a crab to the left. The approximate direction of the aircraft was established as 309 degrees as against the runway direction of 320 degrees. The aircraft left wheels went off the prepared surface at 1150 feet from the threshold. The re-entry of the aircraft on the main runway was indicated by the tyre marks on the ground at 1950 feet from the threshold. The aircraft left wheels traveled on the unprepared surface (kuchtha) for about 800 feet. (Appendix 'H-1 to 3').

INITIAL IMPACT - TOUCH DOWN-TYRE MARKS

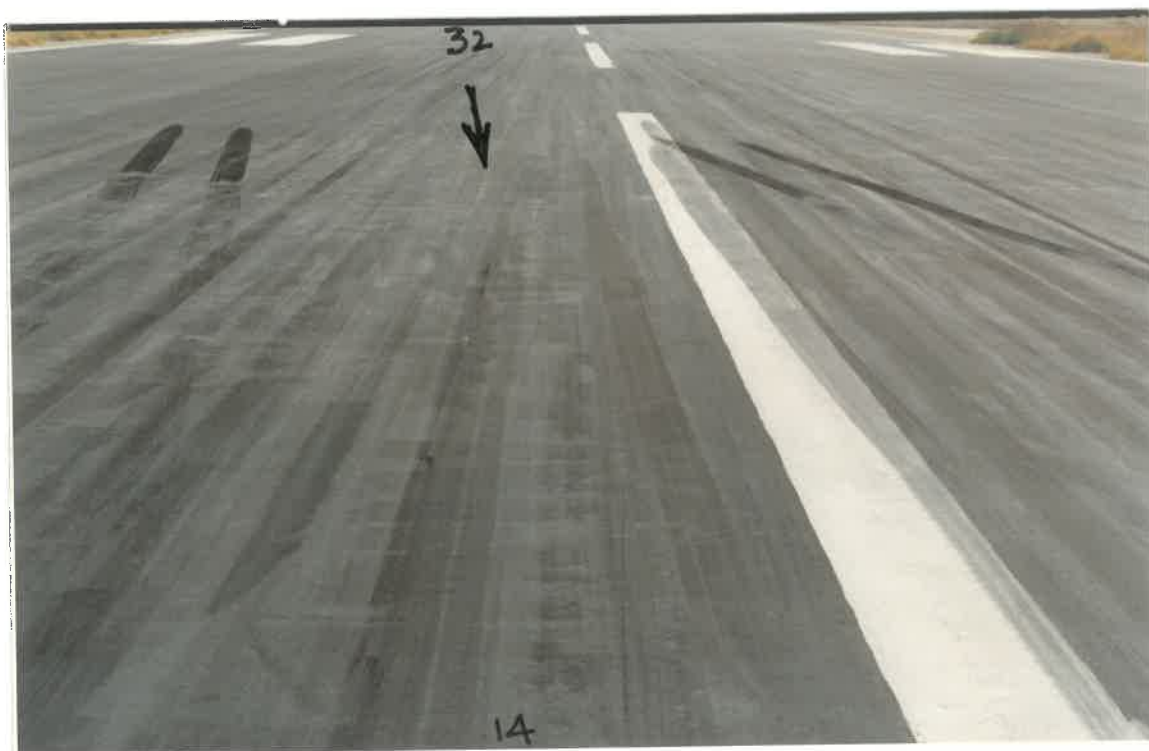
- 3.1.11 The aircraft landed close to the center line in a crab to the left.
- 3.1.12 Before a correction could take effect the aircraft went off the prepared surface to the left of the runway.

CRAB TO THE LEFT - RIGHT WHEELS IMPACTED FIRST  
R/W DIRECTION 320° TOUCHDOWN DIRECTION 309° (APPROX)

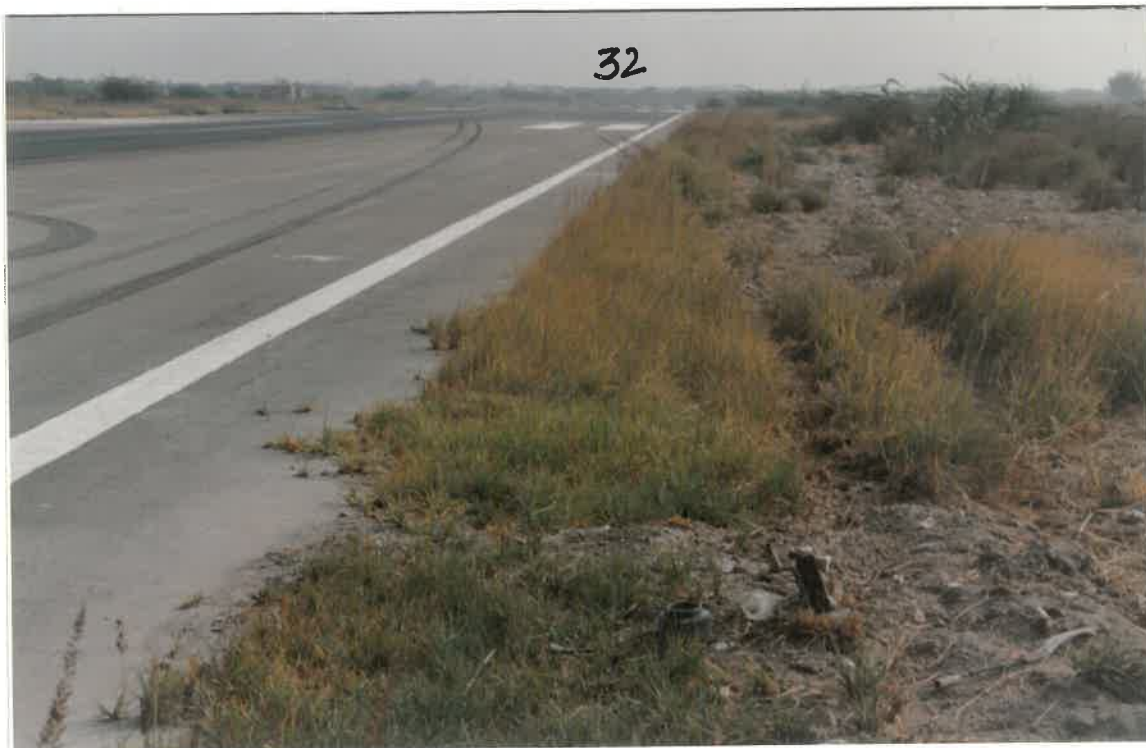
A/C LEAVING PREPARED SURFACE AT 1150 FEET FROM THRESHOLD <sup>R/W</sup> 32

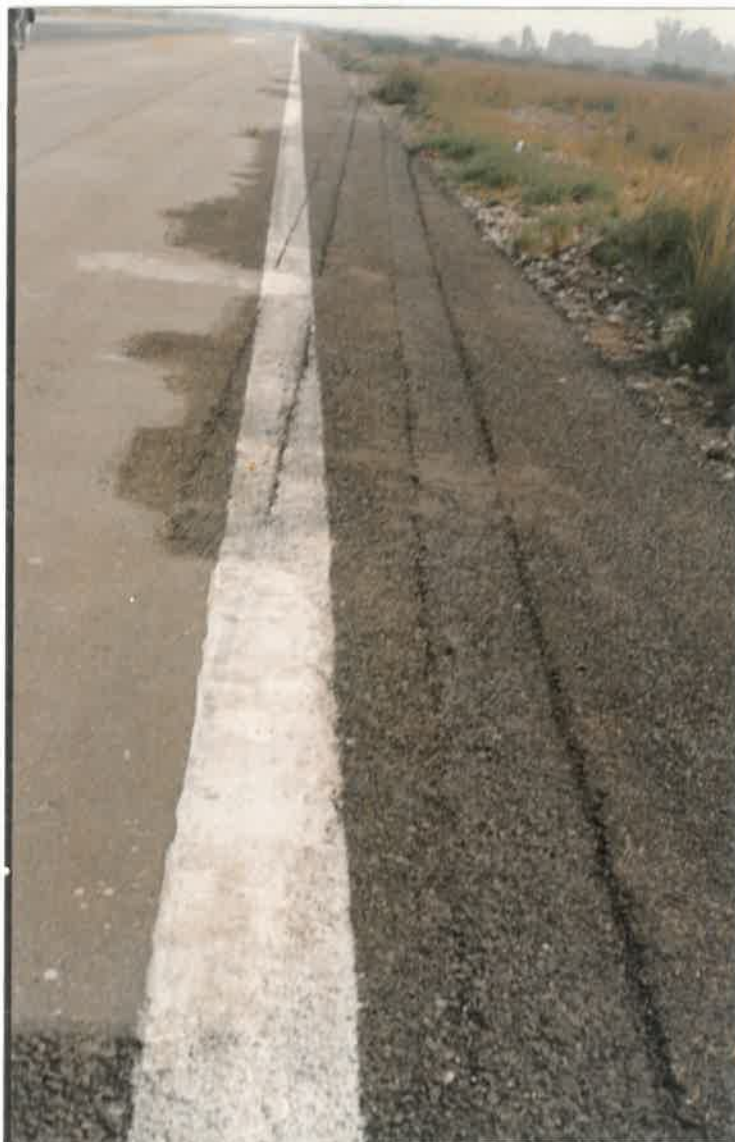
- 3.1.13 It traversed on the unprepared surface for about 800 feet before re-entering the prepared surface.
- 3.1.14 No call was given to the ATC regarding the aircraft having left the prepared surface after landing.

A/C REENTERING R/W AT 1950 FEET FROM THRESHOLD <sup>R/W</sup> 32

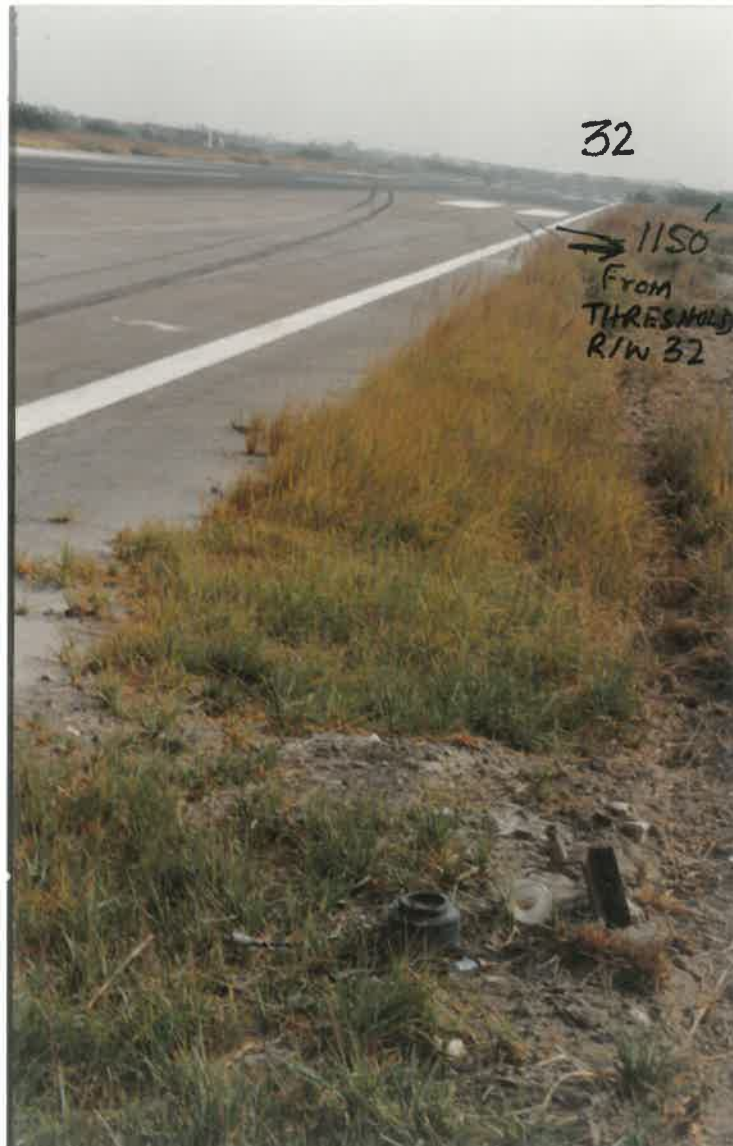
One runway light was broken as a result of being over run by the aircraft. (Appendix 'H'-1').

- 3.1.15 The air traffic controller, suspecting that the aircraft had gone off the runway, inspected the runway to confirm his suspicion.
- 3.1.16 It was found that fresh tyre marks existed on the unprepared surface and a runway light was found broken.

RIGHT LANDING GEAR TYRE MARKS VISIBLE  
LEFT LANDING GEAR TYRE MARKS VISIBLE  
BROKEN R/W LIGHT
