NO.HQCAA/1901/213/SIB

**AIRCRAFT INCIDENT INVESTIGATION M/S WING AVIATION  
FLETCHER FU-24 REG NO.AP-AZG WHICH OCCURRED  
ON 27TH SEPTEMBER, 1996**

**AIRCRAFT INCIDENT INVESTIGATION**

**INVESTIGATION IN RESPECT OF INCIDENT TO M/S WING**  
**AVIATION (PVT) LTD, AIRCRAFT REG NO. AP-AZG OCCURRED**  
**ON 27TH SEPTEMBER, 1996 AT RAHIM YAR KHAN.**

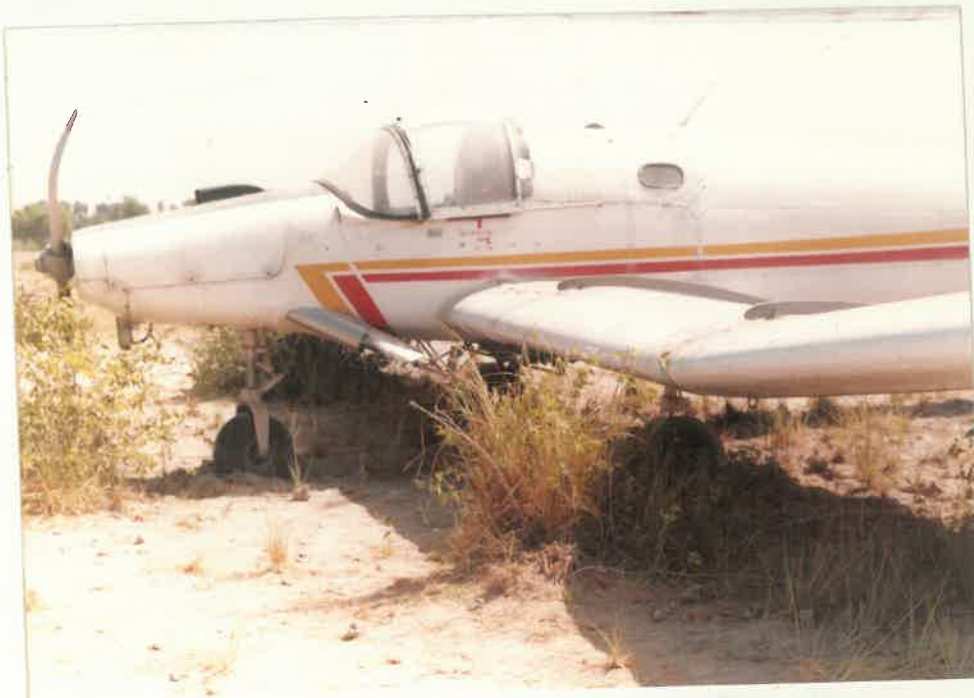
APP 'B1'

- 5.1. Engine propeller was deshaped due to touching the ground during landing and the aircraft structure had minor damage.

AIRCRAFT AT SITE EVIDENCE: PROP DAMAGE

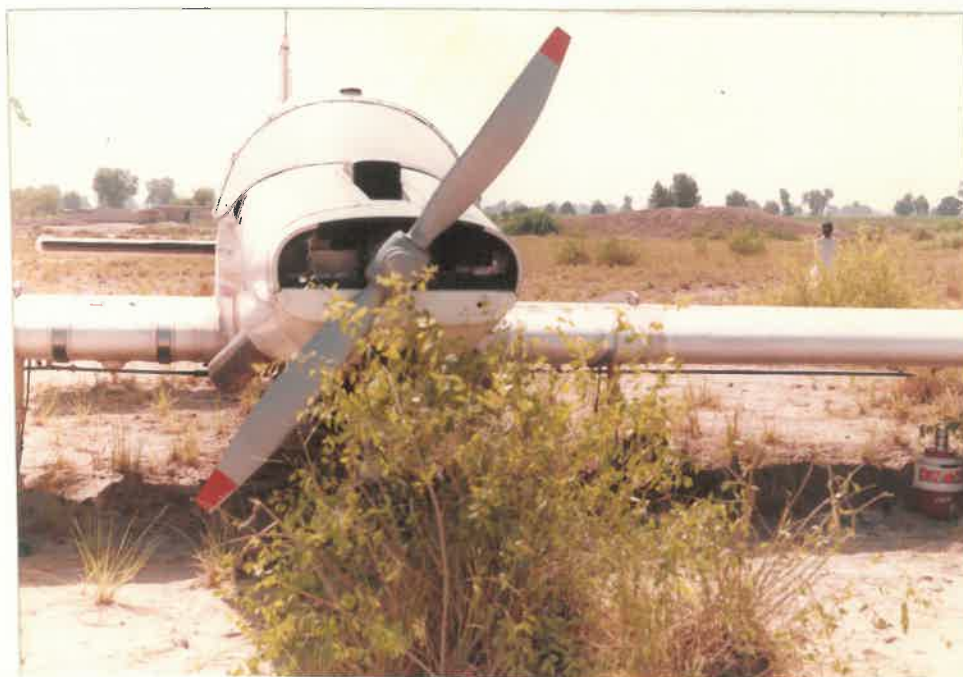
APP 'B2'

AIRCRAFT AT SITE EVIDENCE: BACK GROUND OF  
LANDING FIELD & PROP DAMAGE

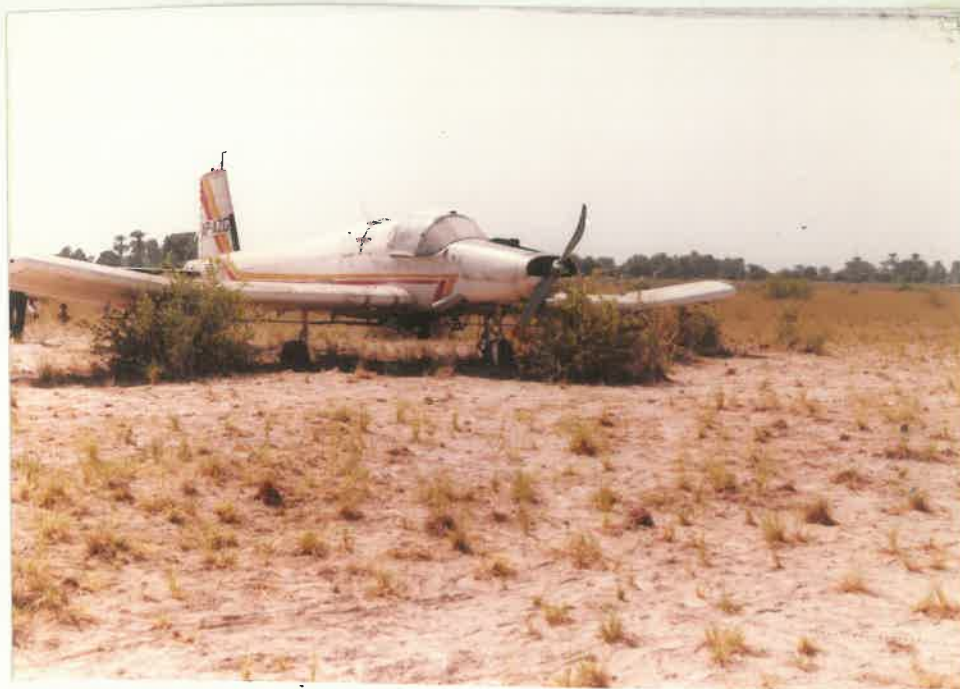
19. On reaching the site the SIB team observed that the Captain of the aircraft had handled the aircraft in a professional manner and executed a safe landing on an uneven sandy ground without causing any damage to any property. However, due to bumpy ground the propeller had touched the ground and was deshaped. The aircraft structure specifically the landing gear area sustained minor damage. Photographs covering site details are given in Appendix 'B1' to 'B4' of this report.

AIRCRAFT AT SITE EVIDENCE: BUMPY SANDY  
FIELD & PROP DAMAGE

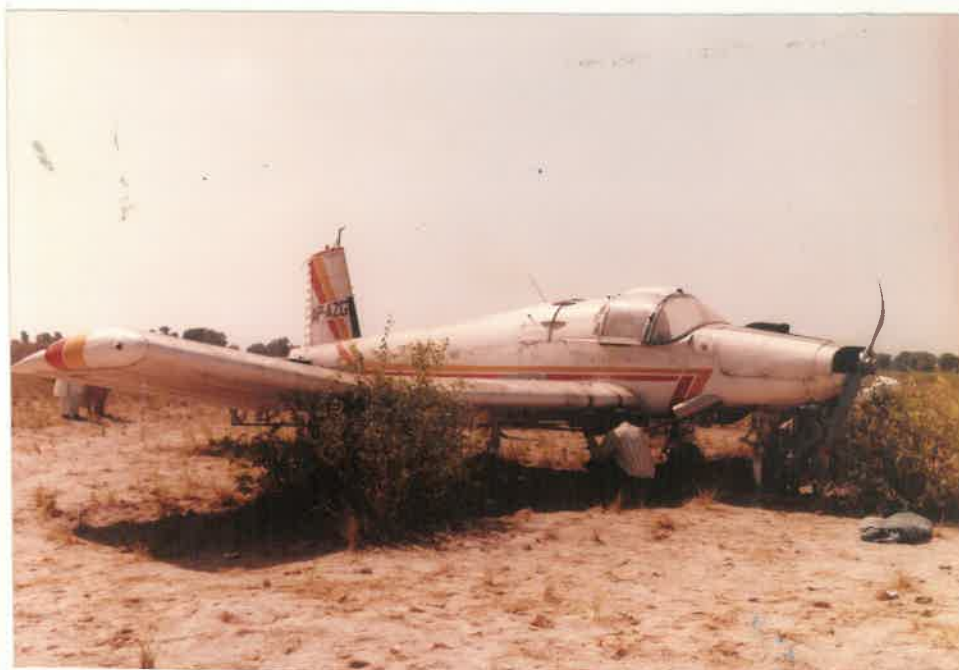
AIRCRAFT AT SIGHT. EVIDENCE: BUSHY AND  
UNEVEN SANDY FIELD
