***SAFETY & INVESTIGATION BOARD  
PAKISTAN CIVIL AVIATION AUTHORITY***

**AIRCRAFT ACCIDENT INVESTIGATION REPORT**

**AP-BHK (Metro)**

**SKIDDING OFF THE RUNWAY  
AT JINNAH INTERNATIONAL AIRPORT, KARACHI**

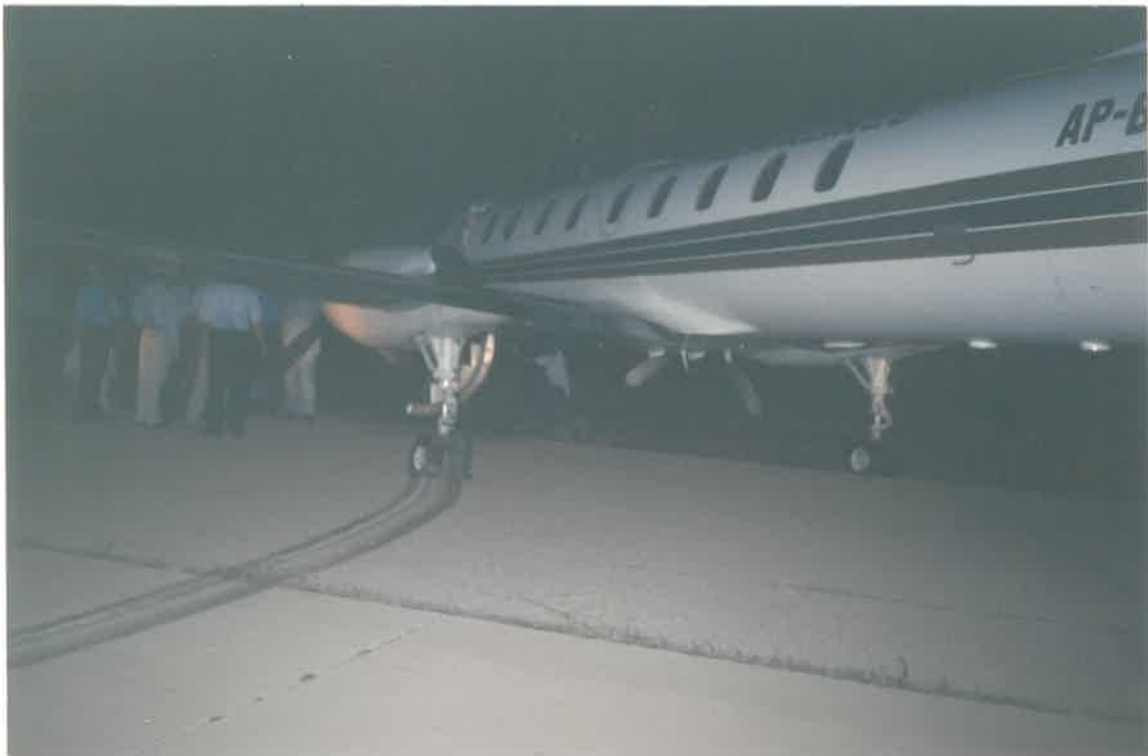
3. The PIC cautioned the Co-pilot twice to control the Aircraft, subsequently PIC took over the controls from the Co-pilot. He initially tried to use the nose wheel steering without success. Later on he tried to use the differential power technique. The Aircraft responded by straightening out in the Katcha but it struck a Main Hole approximately six inches high in the Katcha adjacent to Runway and close to taxiway 'F' at approximately 3000 feet down the Runway. The severe damage was caused to the nose landing gear, oleo and nose wheel well area.
