Civil Aviation Authority  
Safety Investigation Board  
(SIB)

## Investigation Report of Boeing 737-340 Aircraft Pressurization Failure

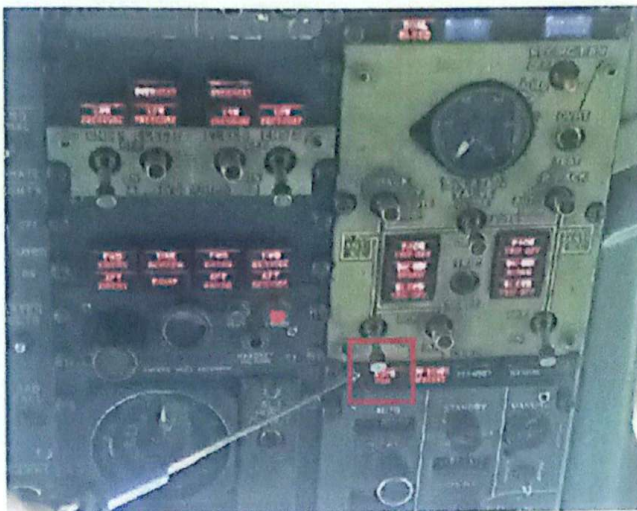
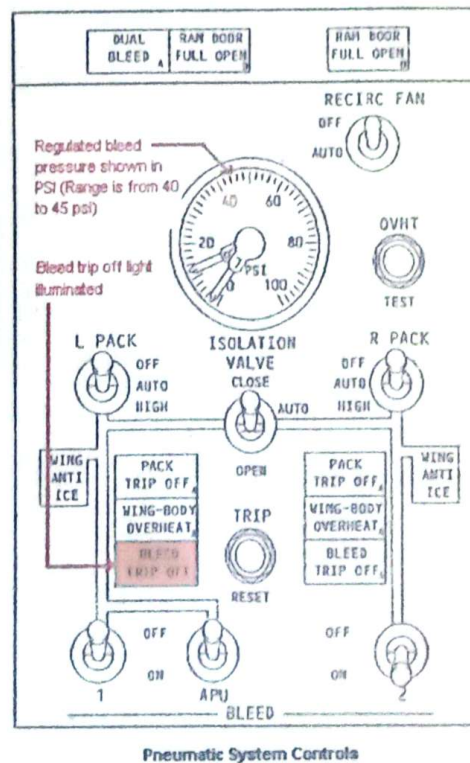
Bleed trip off light

- 9.2 At FL 370, the crew experienced pressurization problem. The left bleed trip off light illuminated, which indicated that the related engine bleed air temperature or pressure had exceeded its limits. To establish the fact whether the light illuminated due to high temperature or over-pressurization, the reset switch is first pressed as per checklist. By pressing the reset switch, the bleed air temperature cools below limits. In this case, after pressing the reset switch, the bleed trip off light did NOT extinguish which indicated that the pressure regulator / shutoff valve (PR/SOV) automatically closed due to over pressure. The upstream bleed air had exceeded 180 psi and the pressure regulator could not regulator 45 psi.

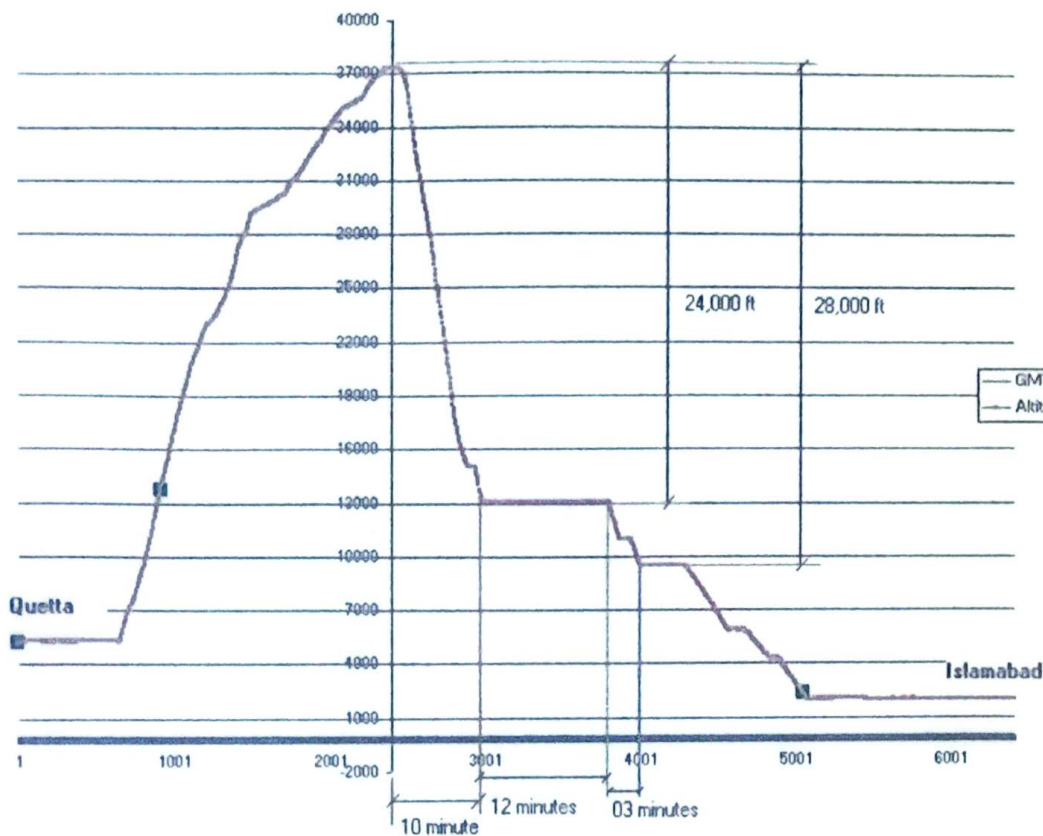
Graph

cockpit crew declined for any ground assistance. As per DFDR, the aircraft reached to FL 9928 ft in 24 minutes. The oxygen available for a passenger is 10 minutes, whereas, the pilot took 24 minutes to reach a safe altitude of 10,000 ft or below (As per emergency decent check list the aircraft should be brought down to lowest safe altitude or 10,000 feet whichever is higher).

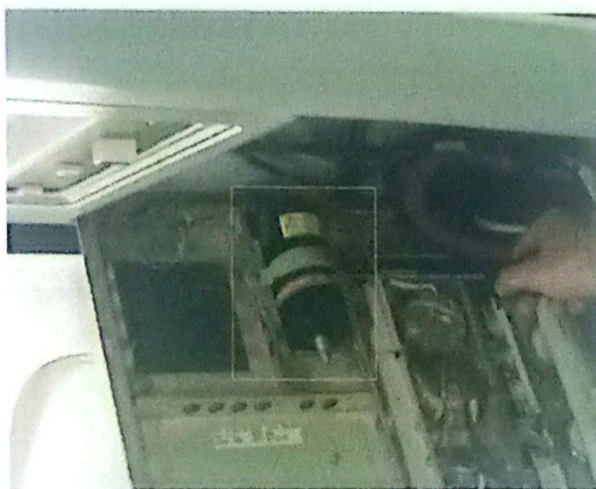
- 9.9 The oxygen mask in the aft 'C' toilet and L2 cabin crew station did not drop. The generator which provides oxygen to seat no 28 JKL (three seats) did not operate. The remaining oxygen generators that were reported as unserviceable by the cabin crew were serviceable and had been used. This was checked by a heat sensitive tape (orange color) on the oxygen generator which turns black when the generator is used.

**Oxygen chemical generators. The orange strip turns black when the generator is once used.**
