# FINAL INVESTIGATION REPORT

SERIOUS INCIDENT OF M/S PIAC FLIGHT PK-785 (ISB-LHR), B777-200ER  
AP-BGJ FIRE / SMOKE IN FWD GALLEY OVEN # 3 DATED 05<sup>TH</sup> APRIL, 2017

SERIOUS INCIDENT OF M/S PIAC FLIGHT PK-353 (PEW – KHI), B777-200ER  
AP-BGK HEAVY SMOKE / FIRE INSIDE OVEN AT POS: FW D#2  
DATED 23<sup>RD</sup> MAY, 2017

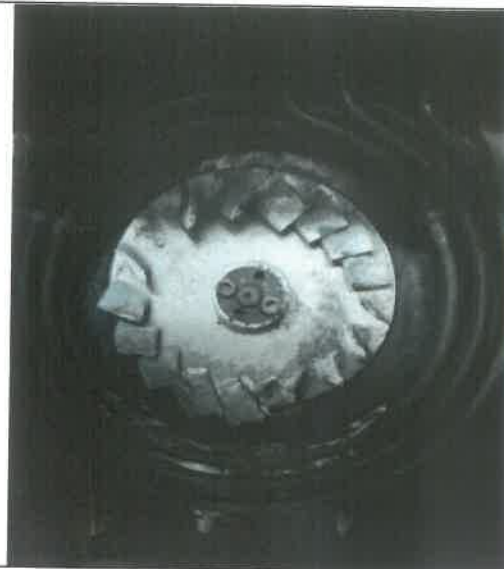
- 2.1. **Case-I (AP-BGJ, Oven S No. 06-02-0897 dated 05/04/2017).** Physical condition of the oven was found to be very dirty. On opening the door, the unit was found blackish with burnt edible oil. The Overheat protector was found not tripped and after powering it ON, heavy grinding noise was observed. Once its fan cover was removed, the fins of the Impeller fan were found broken and melted. No signs of rubbing found on the fan cover and the fan was rotating freely by hand.

Damaged Fins of the Impeller

- 3.1.1 The Oven pertaining to the Case-I was declared beyond economical repair by the OEM.
- 3.1.2 The OEM concluded that Oil splashes lead to the fire inside the oven which ultimately damaged the impeller fan.
