**ACCIDENT INVESTIGATION REPORT  
ON  
M/S STAR AIR AVIATION  
DORNIER-228-200 AP-BGF  
OCCURRED ON 19 FEBRUARY 2003  
AT  
JINNAH INTERNATIONAL AIRPORT  
KARACHI**

## FINAL REPORT

### ACCIDENT INVESTIGATION: M/S STAR AIR AVIATION, DORNIER 228-200, REGISTRATION # AP-BGF ON 19<sup>TH</sup> FEBRUARY 2003 AT JINNAH INT'L AIRPORT, KARACHI

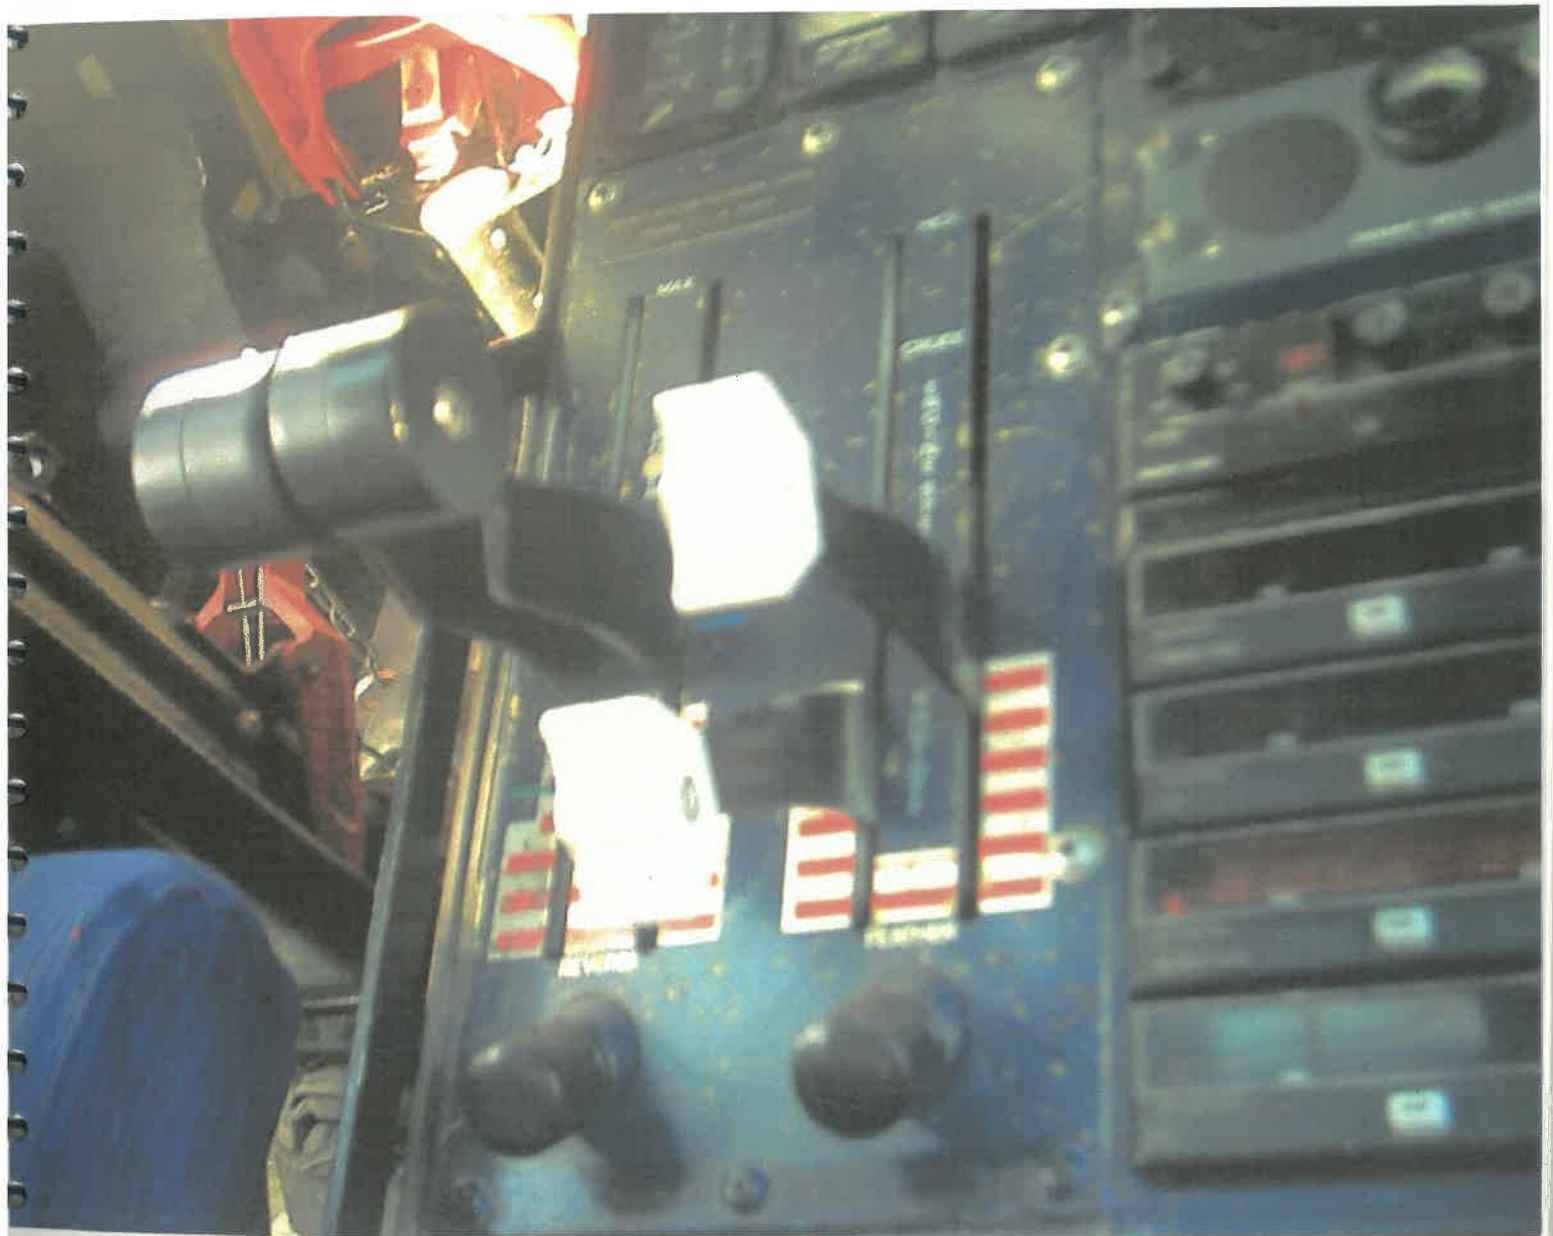
3.13.1 Engine # 2 Speed Lever found above low position (5<sup>th</sup> red graduation on the pedestal) and ahead of Engine No. 1 Speed Lever (which was at mid third red graduation marking on pedestal). This indicates differential power setting (Appendix 'P1' & 'P2').

3.13.2 Both the power levers were at Flight Idle (FI) position (Appendix 'P1' & 'P2').

4.3.7.5 Both the **Power levers** in the cockpit were found in the flight idle range (actual position at F1 which is air operation starting range corresponding to blue line on the pedestal). The left **Speed lever** was found placed in the shutoff range (not in the minimum or feathered position). As per manufacturer's callout, the **Power lever range** between ground idle and flight idle is used for taxiing. This clearly implies that **taxiing should not be done with Power lever in Flight idle range.**

4.3.7.6 As mentioned earlier the position found on both engine **Power levers** was in the FI range and indicates that the aircraft was being taxied at flight idle selection, which would mean that the pilot added too much power causing

**CLOSER VIEW OF POWER LEVERS (LEFT BLACK KNOBS)  
AND SPEED LEVERS (RIGHT WHITE KNOBS) POSITION**

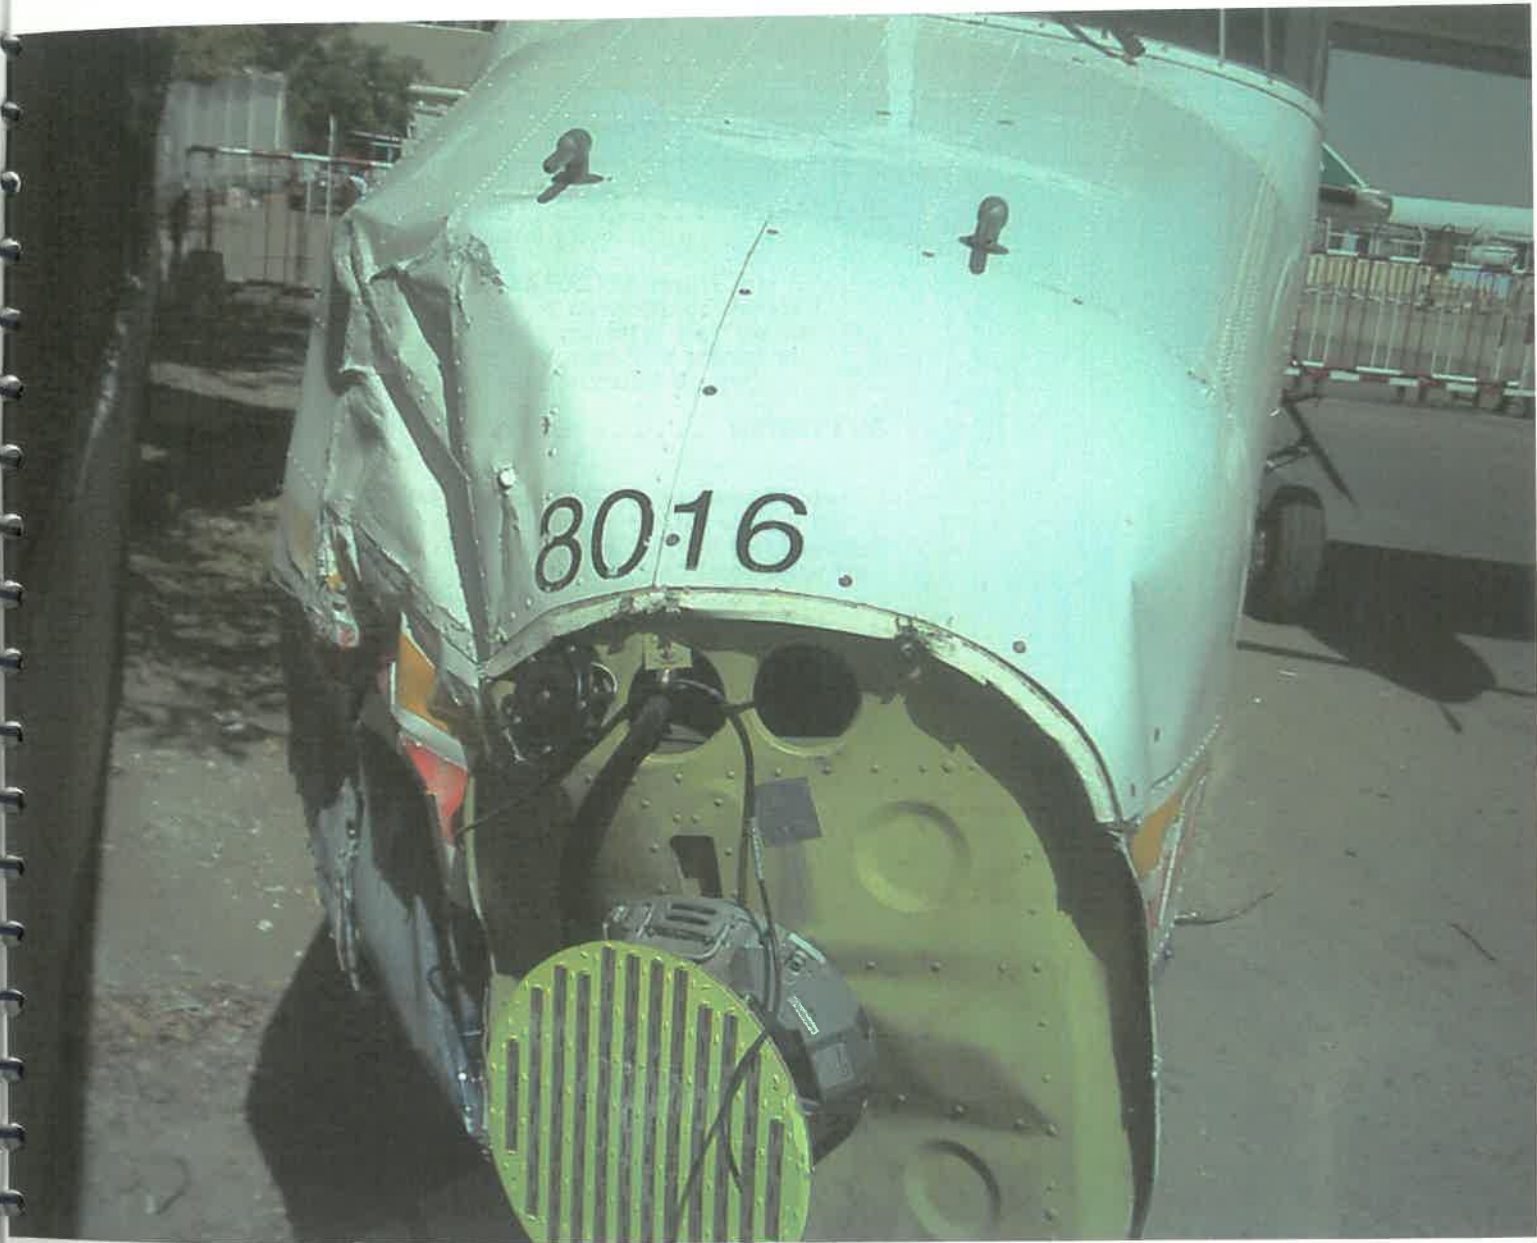
- 3.13.13 Paint marks observed on wall structure at point where nose radome impacted.
- 3.14 **MEDICAL AND PATHOLOGICAL INFORMATION:** Medical and Pathological information on the pilots is at Appendix 'Q1' & 'Q2' and indicate no abnormality.

- 4.1.6.4 **Negation of Hypothesis 1.** Hypothesis 1 is negated because the nose impacted the wall at a very shallow angle, which indicates that an effort was made to recover the aircraft to the left but the NWS authority was limited to 8°. The impact of the nose is not very close to the fence, which was engaged by the propeller. The swing rate was not so vicious or else the passengers would have felt the extreme swinging movement and reflected it in their statements.

NOSE IMPACTED AT A SLANT ANGLE
