**PAKISTAN CIVIL AVIATION AUTHORITY  
(SAFETY & INVESTIGATION BOARD)**

**SERIOUS INCIDENT TO M/S. AIR BLUE, A-320,  
REG. NO. AP-BGV ON 24 JULY 2006  
AT  
ALLAMA IQBAL INTERNATIONAL AIRPORT,  
LAHORE**

## FINAL REPORT

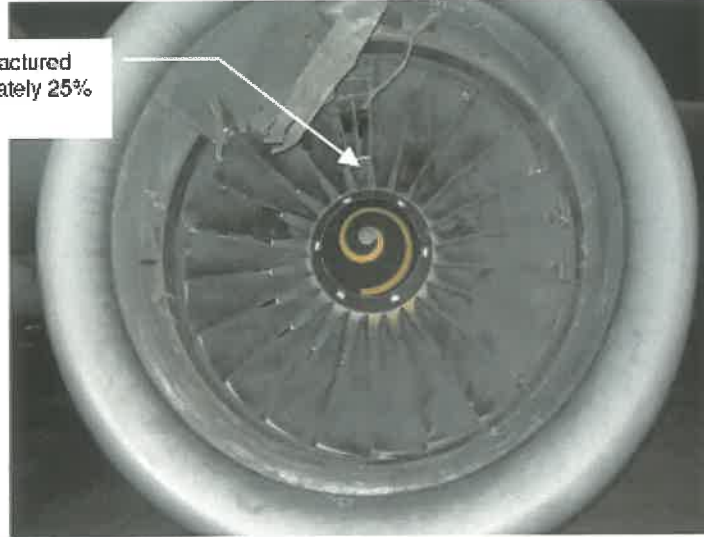
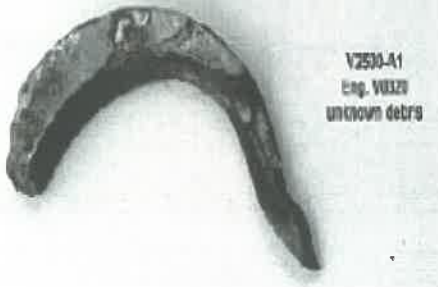
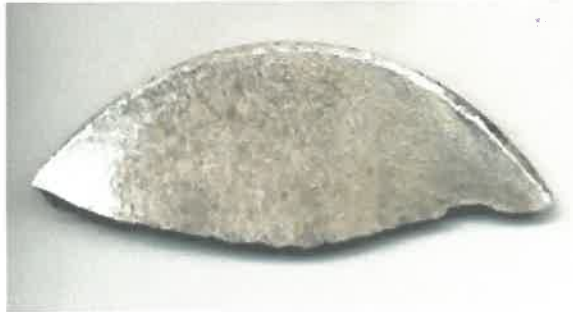
Fan blade fractured  
at approximately 25%  
height

2.6.2 Fan Blade No. 21 had failed at approximately 25% height. This particular fan blade part number 6A7650 and serial number RGA10904 showed two fatigue origins. See **Figures 3 and 4** for Fan blade 21 Fracture and fatigue origins.

- 3.3 On 24 July, during the eventful flight, the engine damage was indicated on ECAM and engine was shutdown.
- 3.4 The blade was damaged initially by fatigue cracking on the concave panel. Two origins were found on the inner surface of the panel at 25% height in the front part of the cavity.

- 3.5 The crack had propagated from the first origin forwards to the leading edge and rearwards to the trailing edge prior to final release.
- 3.6 The second origin initiated due to load changes in the blade subsequent to the first origin.
