# AIRCRAFT INCIDENT INVESTIGATION REPORT

PIA BOEING - 707 AP - BBK  
PESHAWAR AIRPORT  
ON  
17TH OCTOBER, 1990

**LANDING INCIDENT AT PESHAWAR AIRPORT ON 17TH OCTOBER, 1990 AT**  
**1650 HRS PST INVOLVING PIA BOEING 707 REG. MK. AP-BBK**  
**WHILE OPERATING SCHEDULED DOMESTIC PASSENGER**  
**FLT.PK.326 FROM KARACHI TO PESHAWAR**

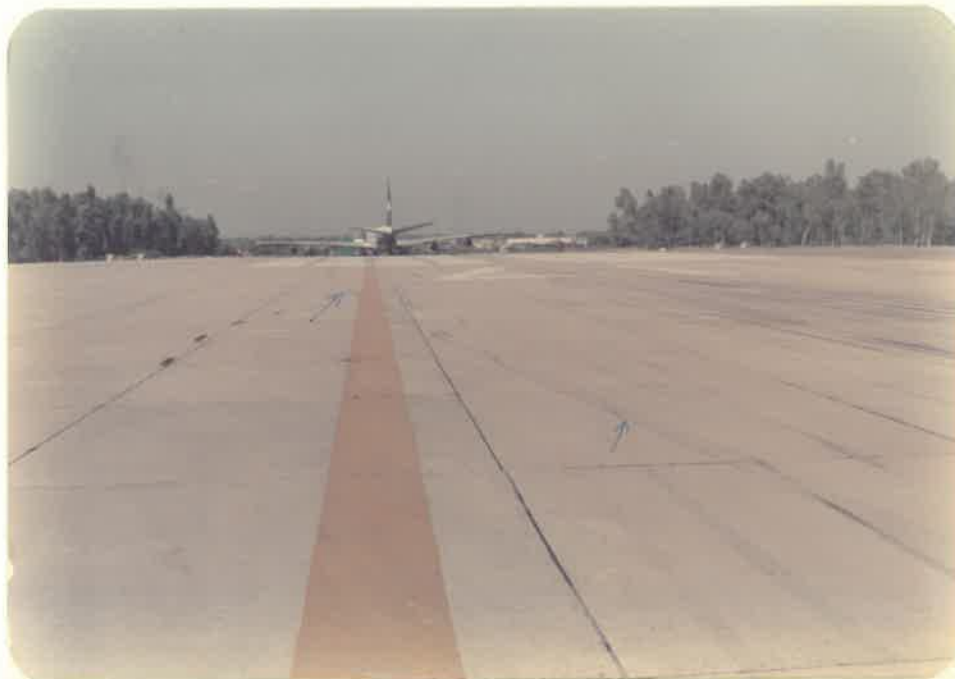
APP "B1"

WHEEL MARKS CROSSING CENTRE LINE FROM  
RIGHT TO LEFT.

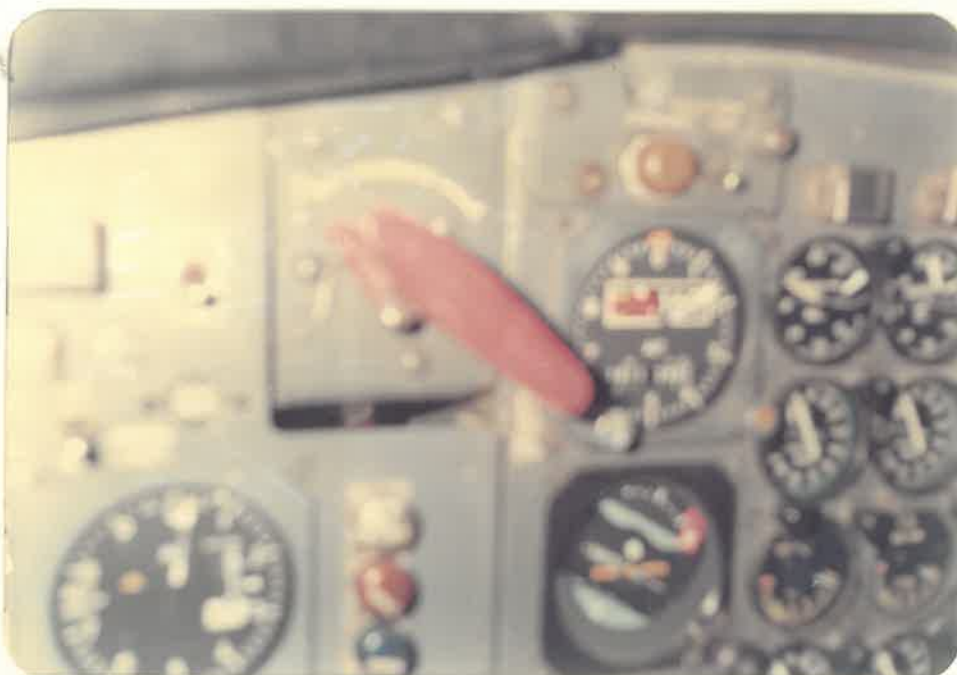
APP "B2"

EMERGENCY BRAKE HANDLE WAS OPERATED  
(WIRE LOCK BROKEN)

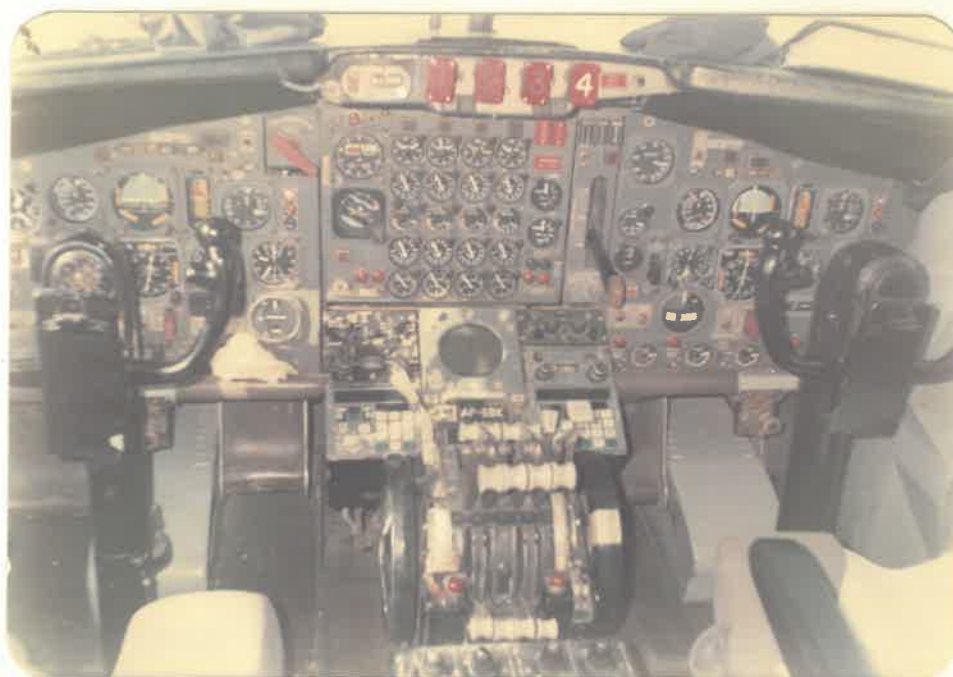
APP. "B4"

GENERAL VIEW OF COCKPIT

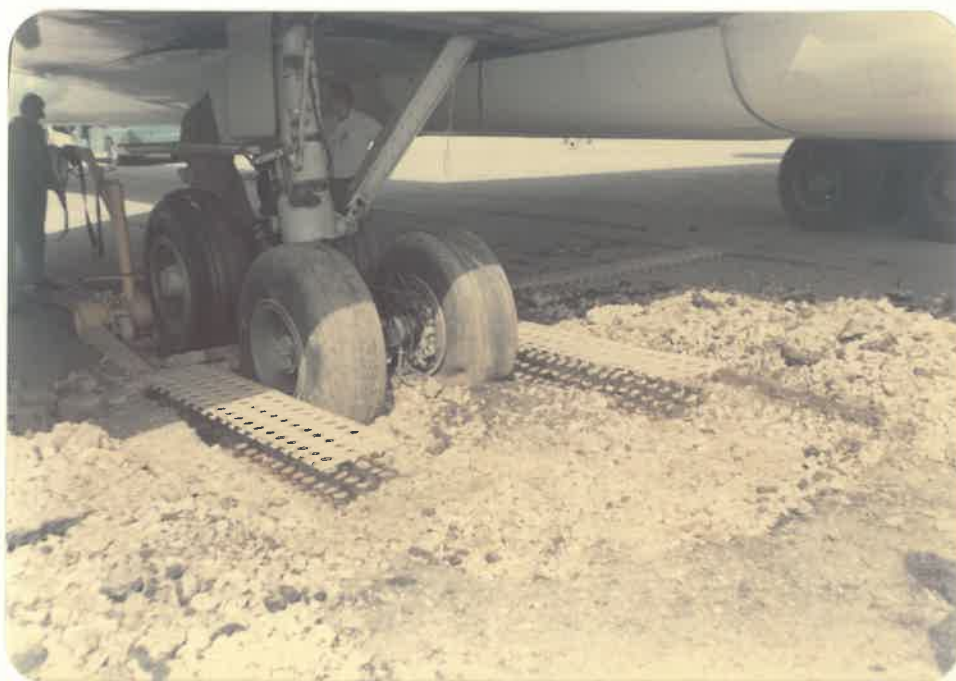
APP. "B6"

NOSE-WHEEL STEERED TO APPROX. 40° ANGLE.

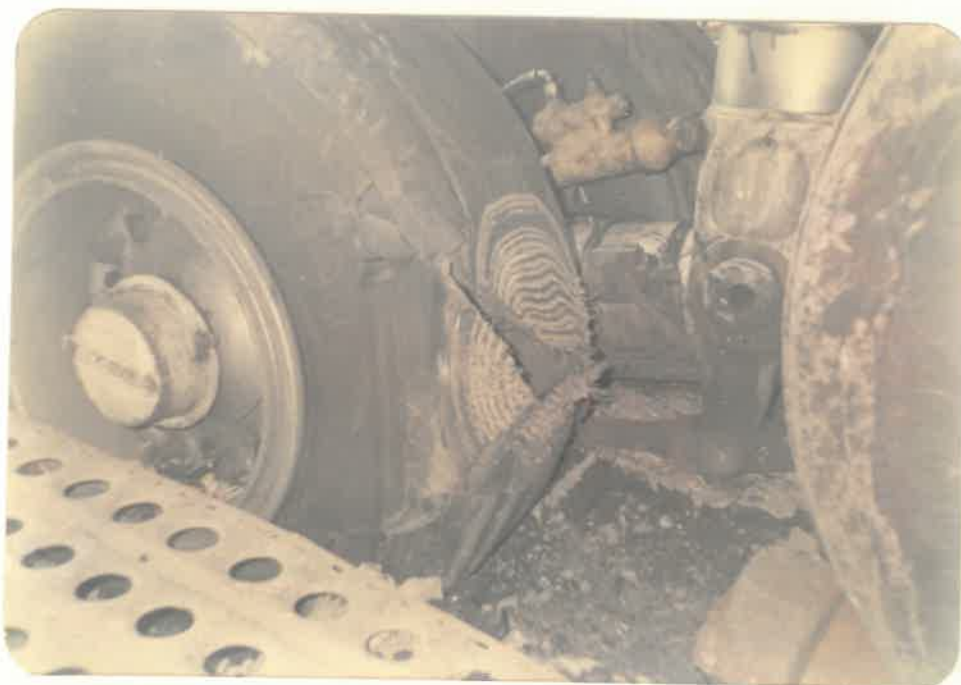
APP. B7

12.1. The aircraft was found on the over run of 35 with its left main landing gear sunk and No.1 forward and No.2 Rear tyres of leftside gear burst.

- 17.5. The incident of sinking of left hand main landing gear boggie into ground and remaining there under heavy side loads for several hours could have caused hidden/internal damages/cracks

PORT MAIN LANDING GEAR SUNK INTO GROUND  
APPROX. 6" TO 8"

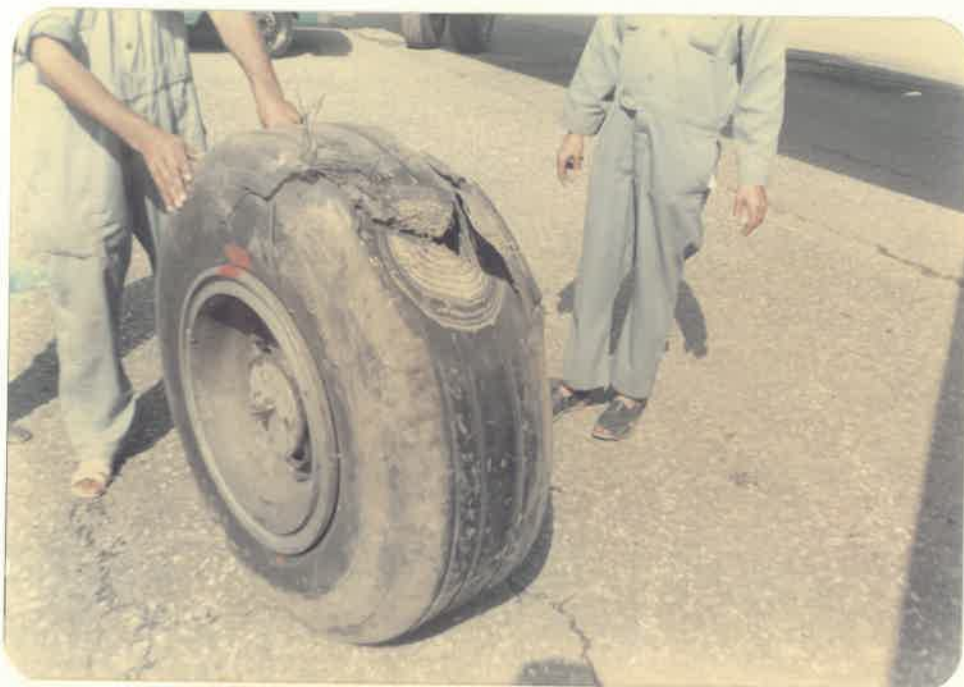
APP. B8

5.1.1. No.1 Forward & No.2 Rear tyres were found burst.

- 19.10. Two tyres burst was due to application of emergency brakes thereby causing the wheels to lock and subsequently a blow out of the tyres.
- 19.11. The damage on the other tyre were scubbing marks due application of pneumatic brake on rough area & not due to aquaplaning.

REAR NO. 2 TYRE

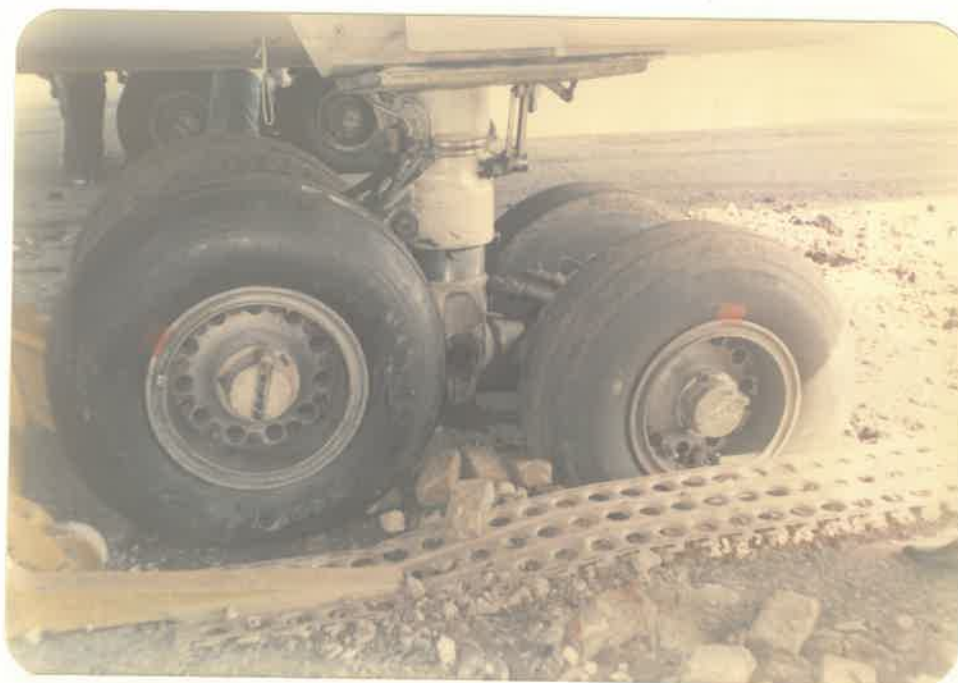
APP 'B9'

FORWARD NO.1 TYRE ALREADY REMOVED ON 17.10.90  
SHOWING DAMAGE DUE TO EXCESSIVE BRAKING.
