**INCIDENT INVESTIGATION REPORT IN RESPECT  
OF M/S BHOJA AIR YAK-42D AIRCRAFT REG.NO.LY-AAV**

**WHICH OCCURRED ON 14TH MARCH, 1997**

**ISLAMABAD INTERNATIONAL AIRPORT  
ISLAMABAD**

**INVESTIGATION REPORT: INCIDENT TO M/S BHOJA**  
**AIRLINES (PVT) LTD YAK-42D AIRCRAFT REG NO. LY-AAV**  
**OCCURRED ON 14TH MARCH, 1997**

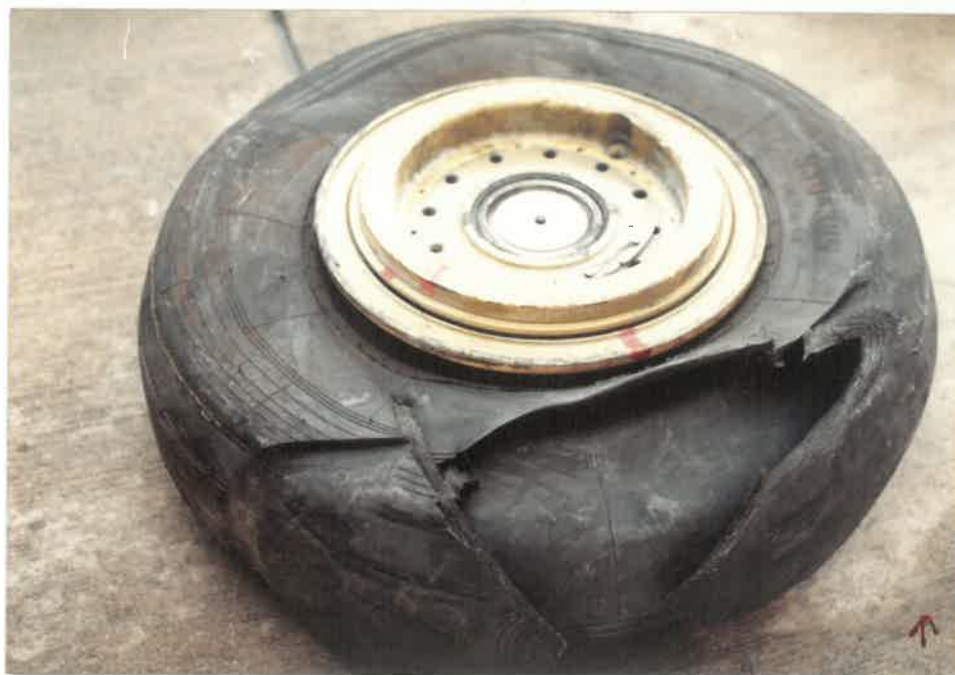
- 16.3. The 3 tyres of left main landing gear which were burst displayed evidence of flattened area of tread leaving a knot in the wood' type effect and scuffed appearance. Additionally, the slippage marks on all tyres were dislocated and all tyres had evidence of disfigurement. Refer appendices' B1 to B6 to this report.

a 'knot in the wood' type effect. The third tyre had disfigurement due to lateral rubbing and subsequent wear. The Board is of the opinion that the two rear tyres remained locked after the pilot applied brakes and eventually due to extensive wear the rear tyres of left main landing gear exploded. Subsequently, due to over loading and lateral rubbing the left forward inner main landing gear tyre also was burst. However, the tyres burst sequence occurred in the far later part of the landing roll at low speed prior to aircraft came to dead stop on the runway.

REAR TYRE

NOTE: RUBBING EVIDENCE - SLIPPAGE, MARK MISALIGNMENT

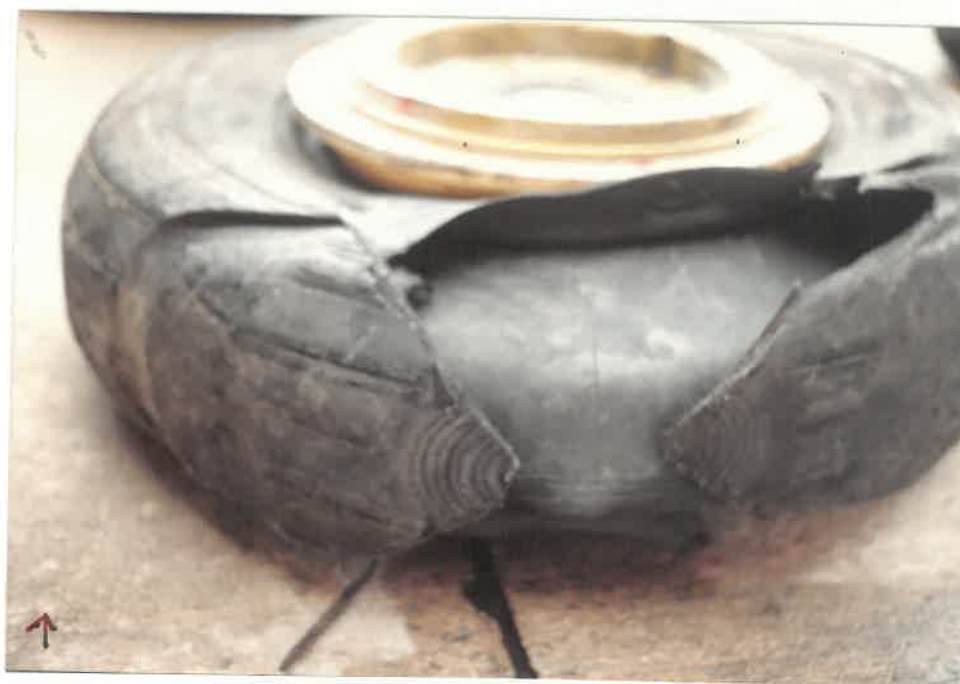
REAR TYRE ANOTHER VIEW

NOTE: RUBBING EVIDENCE & 'KNOT IN THE WOOD' MARK

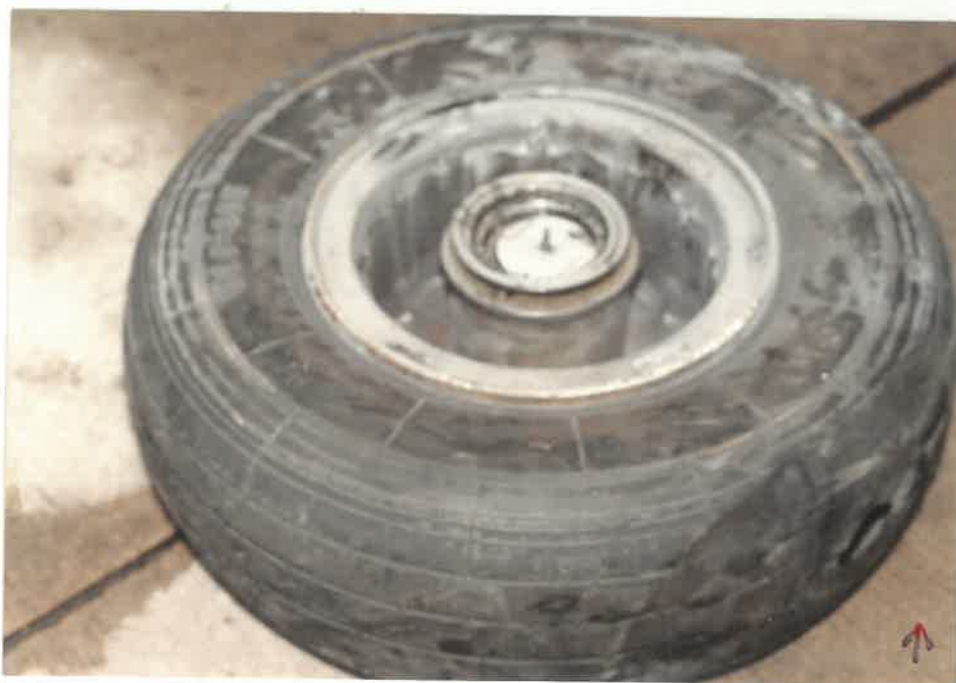
- 17.6. Keeping evidence of rubbing observed on two rear tyres (Refer Appendices 'B1 to B6') after the incident and faulty antiskid system of the left rear main wheels the Board is of the opinion that two rear left main landing gear tyres were locked during landing roll at Islamabad due to faulty antiskid system caused by material failure of camshaft No. YA51-034 which restricted drop of brake pressure when brake pedals were released.

- 18.8. Both rear tyres that were burst displayed evidence of rubbing caused by locking of wheels.
- 18.9. The forward left inner main tyre which was burst displayed evidence of lateral rubbing and disfigurement.

REAR TYRE : RUBBING MARK DUE TO WHEEL LOCK  
NOTE - KNOT IN THE WOOD TYPE EVIDENCE

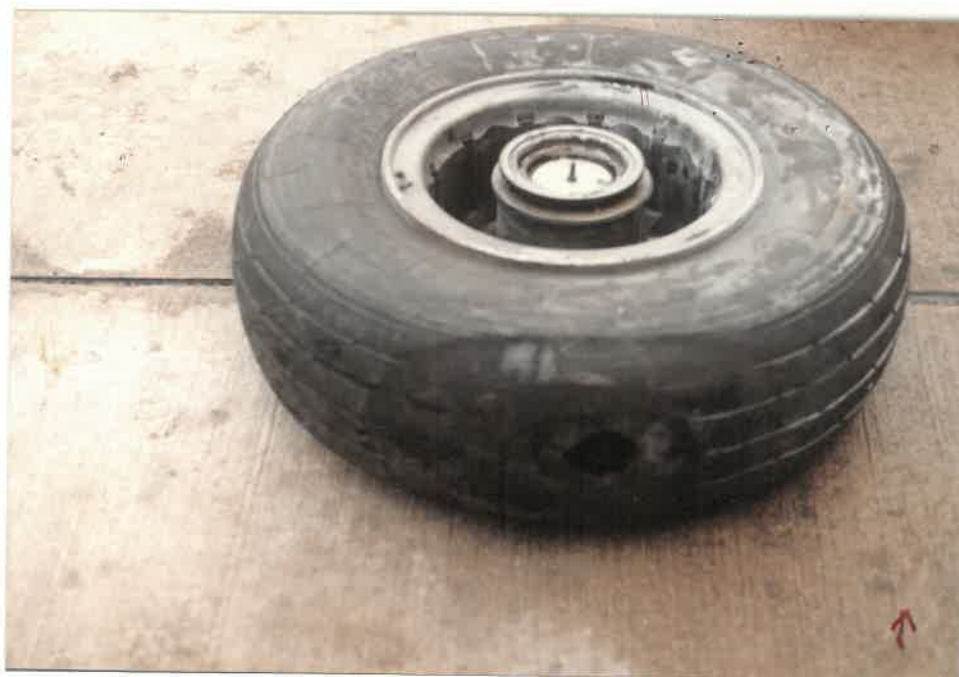
REAR TYRE : KNOT IN THE WOOD TYPE  
EVIDENCE (ANOTHER VIEW)

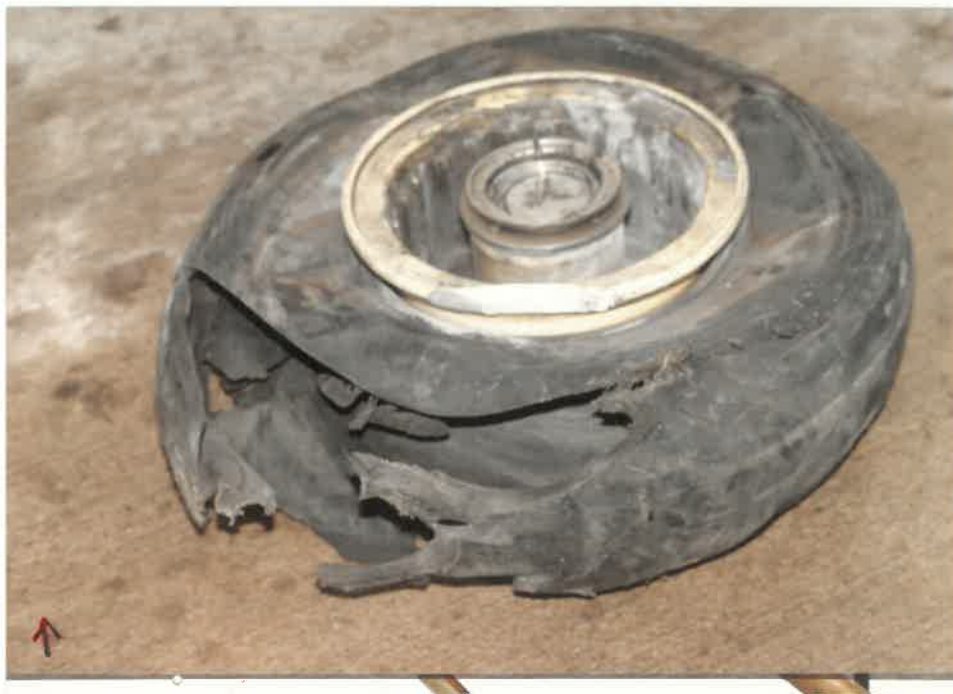
LEFT MLG FORWARD WHEEL  
NOTE: \* LATERAL RUBBING MARKS  
\* DISFIGUREMENT

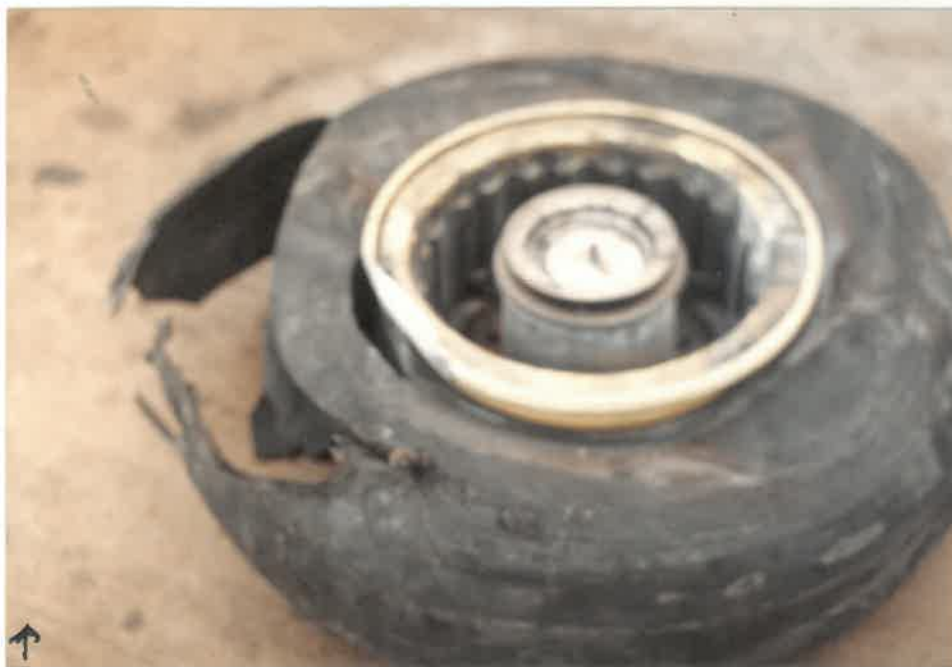
FORWARD WHEEL  
NOTE: NOTE LATERAL RUBBING MARKS

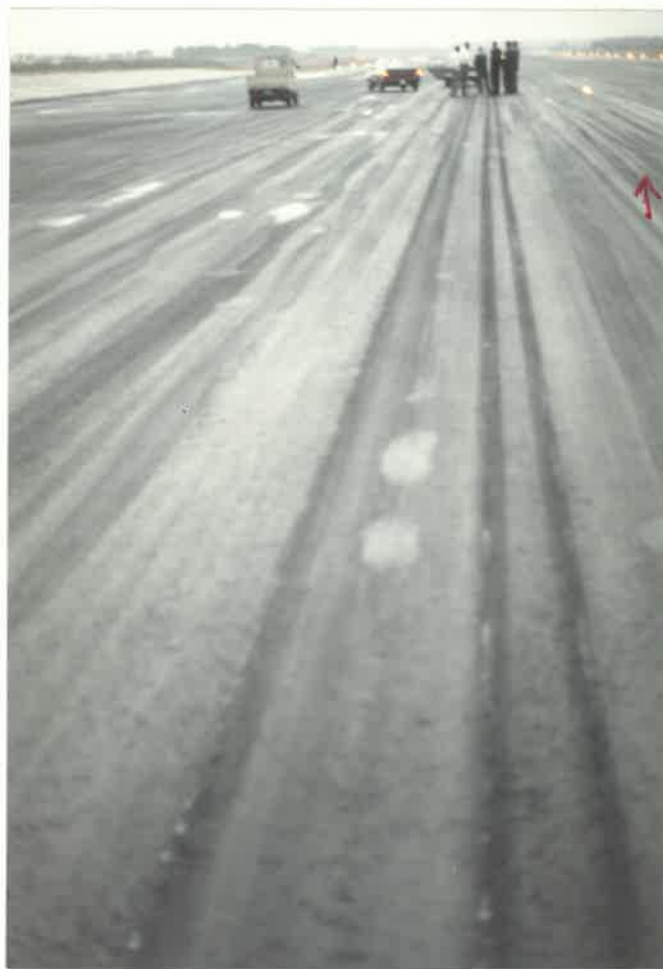
APP. B7

landing at Islamabad and the aircraft touch down speed was about 200 KPH. Additionally, soon after touch down the pilot had to apply comparatively more pressure on left brake pedal to keep the aircraft on the center line of the runway. Tyres marks on the runway displayed evidence of wavy pattern with drifting tendency to the right. Refer Appendices 'B7 to B9' to this report.

LEFT MLG TYRE MARKS BETWEEN 4000 TO 5000 FEET  
FROM THE STOPPING POINT OF A/C

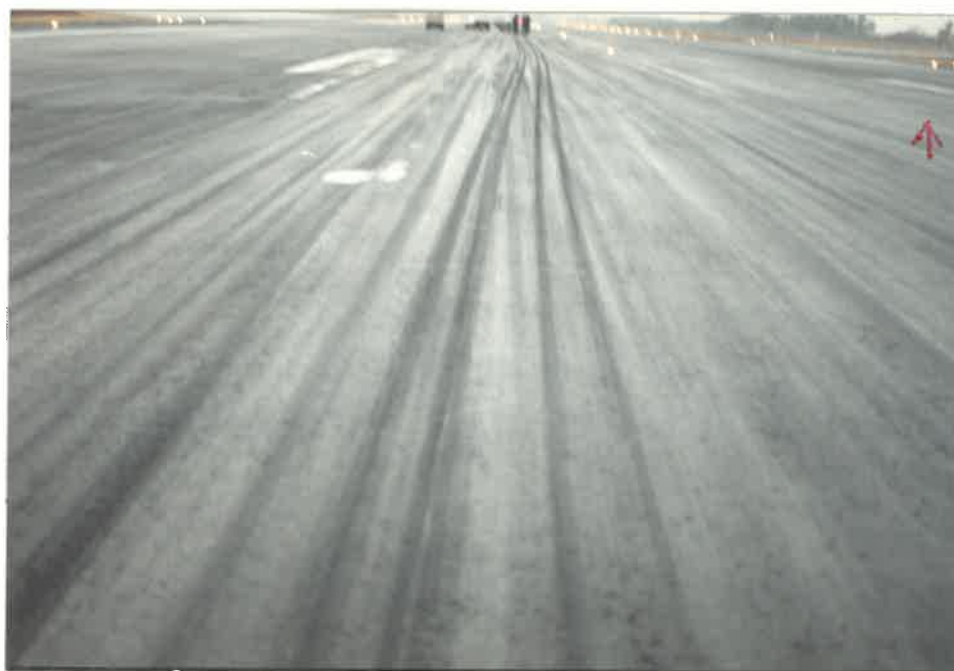
APP. B8

TYRE MARKS BETWEEN 500 - 1000 FEET BEFORE THE  
STOPPING POINT OF A/C

NOTE: WAVY PATTERN OF LEFT TYRE.

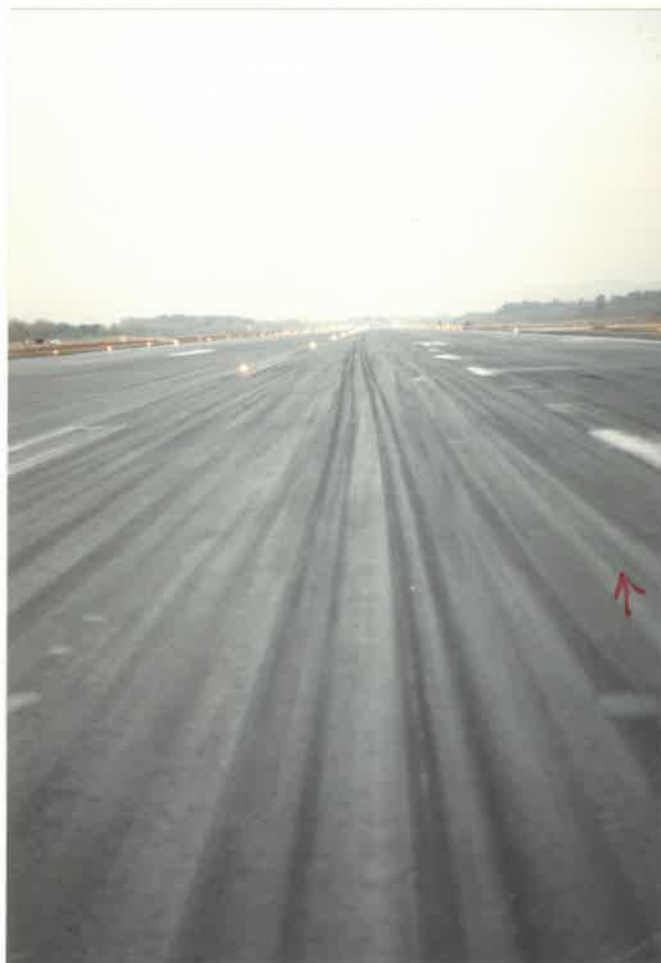
TYRE MARKS OF RT MLG TYRES ABOUT 2000 TO 3000 FEET  
FROM THE STOPPING POINT OF A/C.
