INCIDENT INVESTIGATION REPORT - ON THE INCIDENT TO  
PIAC A-300 AIRCRAFT REGISTRATION MARKING AP-BBM  
WHICH OCCURRED WHILE OPERATING SCHEDULED PASSENGER  
FLIGHT NO. PK-725 OF 29TH MAY, 1985 AT 1759 HRS LT

Memorandum No.HQ.CAA?1901/59/AIB dated 4-6-85

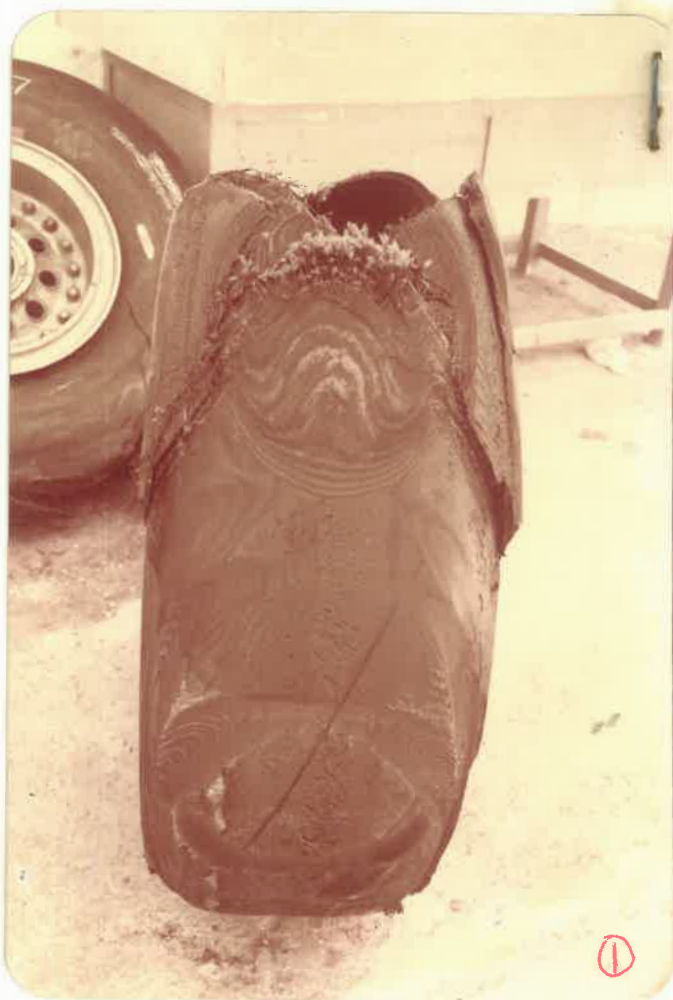
APP 'C1'

- 20.21. Tire of wheel No.6 was found to be without its tread. The pieces of its tread rubber were collected from the middle of runway 25R.
- 20.22. All the tires except No.5 had big flat spots. No.5 wheel tire found chunked which was caused by its friction with the runway surface.

TYRE - WHEEL NO.6 A/C AP-BBM A-300  
(PK-725/290585)

Shows naked chord body with missing tyre tread (crown), flat Spots and bursting of tyre.

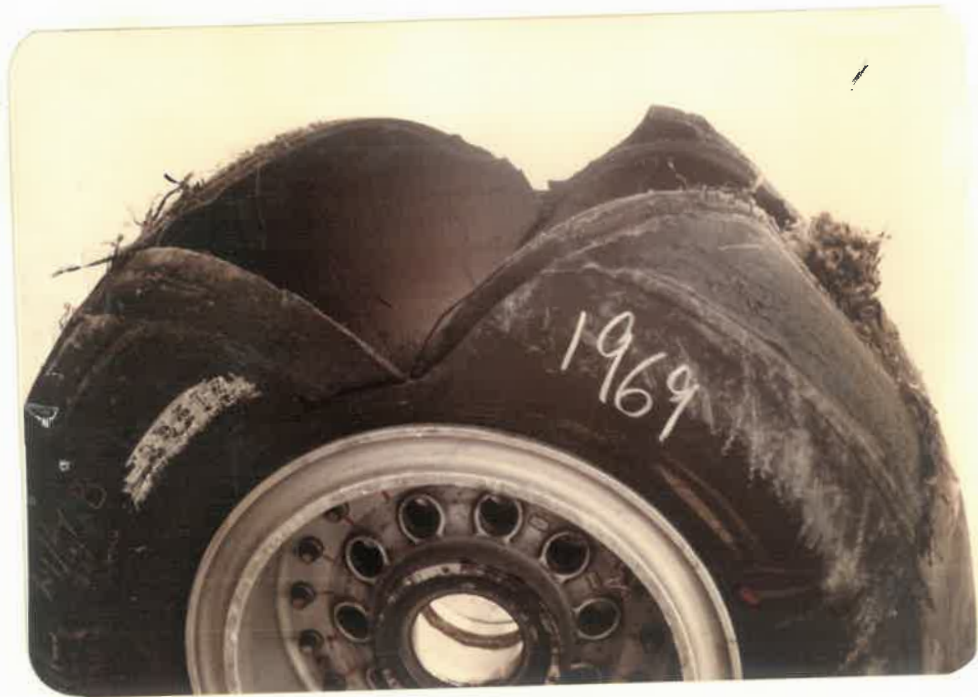
APP. 'c2'

TYRE - WHEEL NO.6 A/C AP-BBM A-300  
(PK-725/290585)

Another view of tire, of wheel No.6.

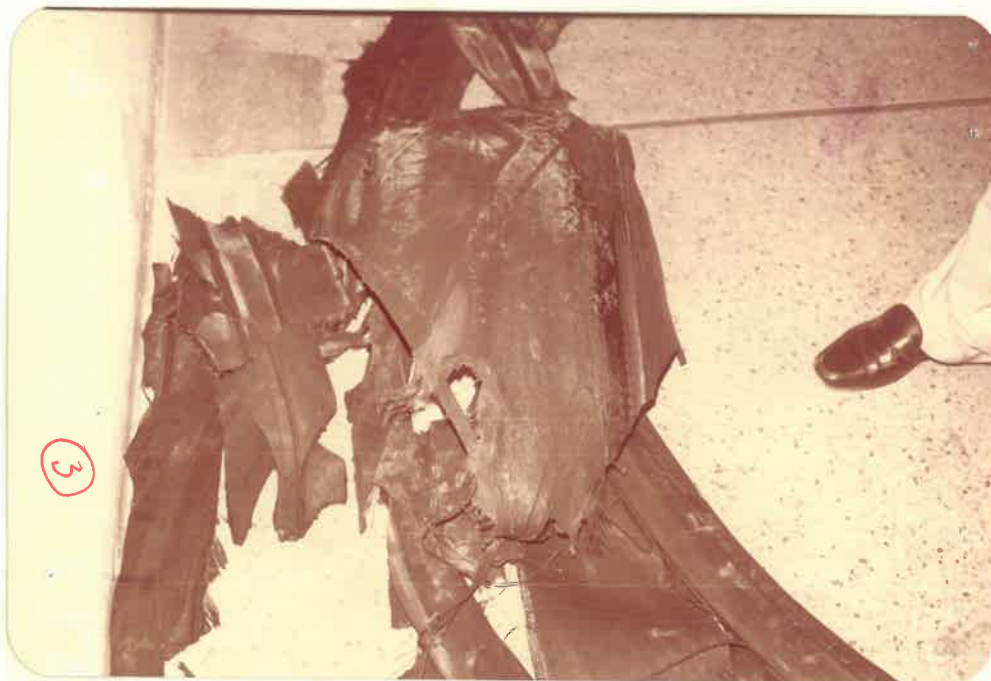
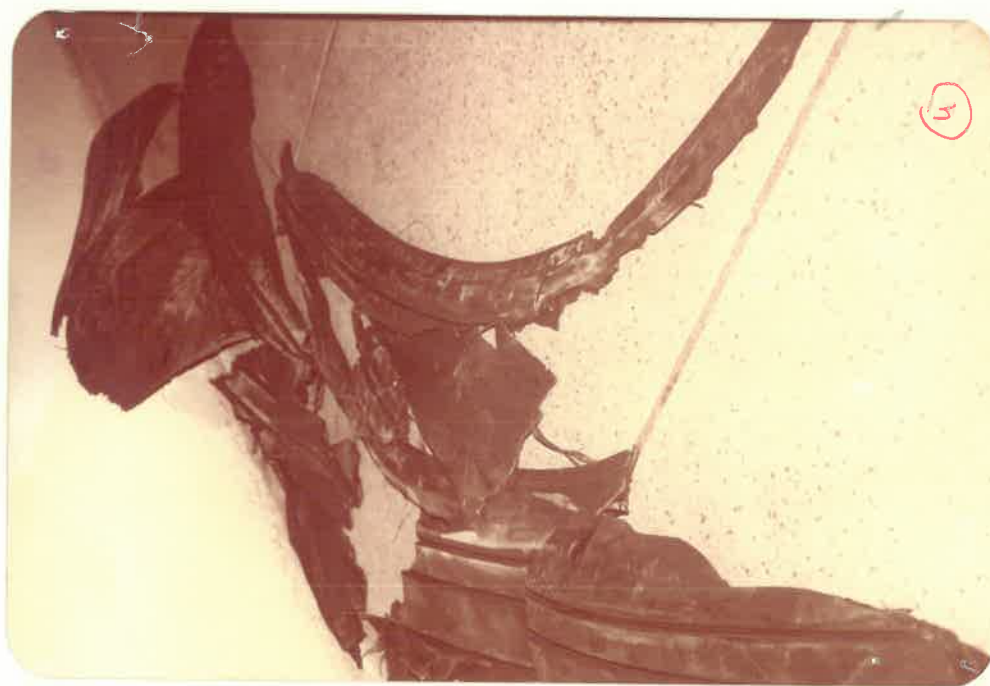
APP. 'C3'

✓ 20.9. Rubber tread separated from the tyre No.6 during take-off roll. The rubber tread after getting separated from tire flunged upward due to the centrifugal force and struck the beam and the harnesses. It caused damage to the flange and broke the two harnesses completely and partially damaging the third one.

TYRE TREAD-WHEEL NO.6 A/C AP-BBM A-300  
(PK-725/290585)

Showing pieces of tyre tread of No. 6 wheel

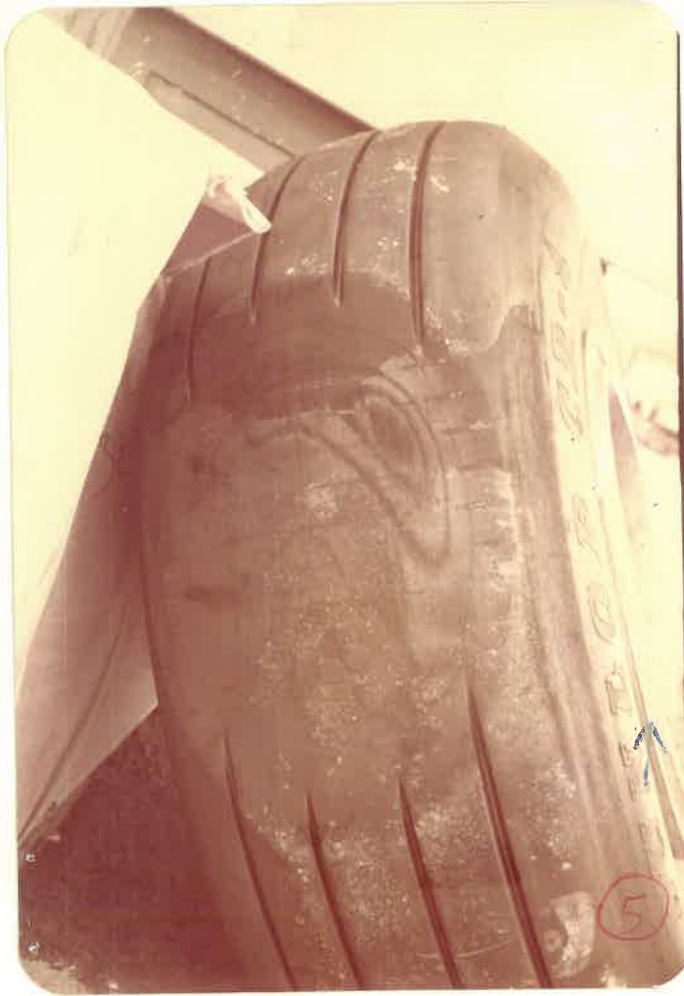
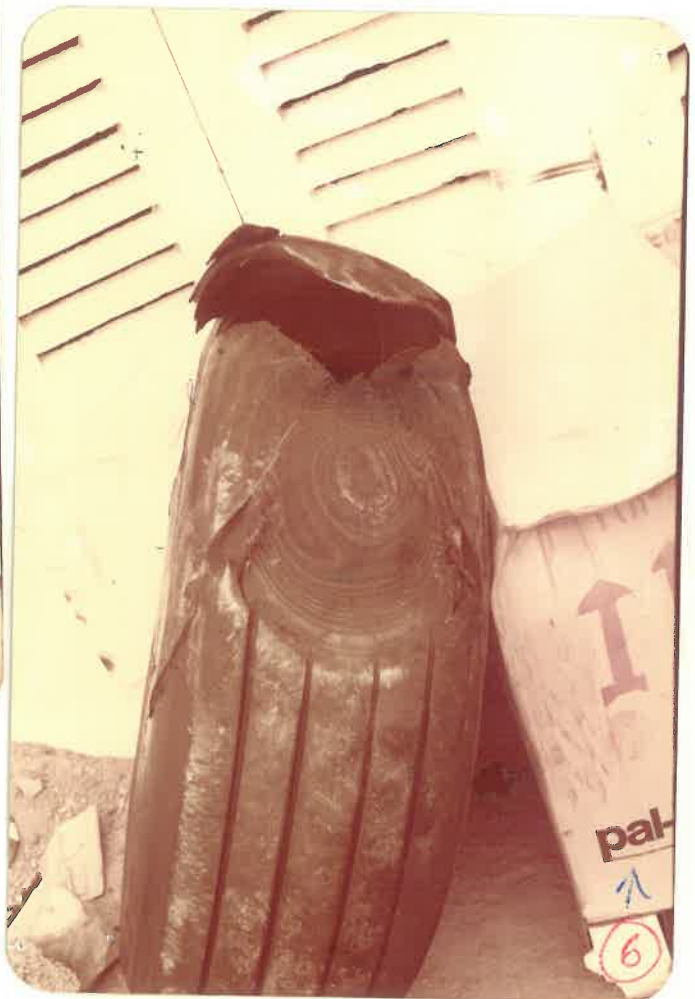
APP. C4

- 20.20. Due to locked wheel condition the wheels failed to rotate or gain a datum velocity on touch down which resulted in heavy flat spots on tires. It caused two tires of wheels 1 & 6 burst on touch down and tires of wheel No.2 deflated due to blown out fuses caused due to brake temperature of No.2 wheel which shot up to 566°C (FDAR refers). The rubber of tire bead was found burnt and melted. Temperature of the remaining brakes stayed in safe range.

TYRE - WHEEL NO.1 A/C AP-BBM A-300  
(PK-725/290585)

Picture Shows - flat spots and bursting of tyre.

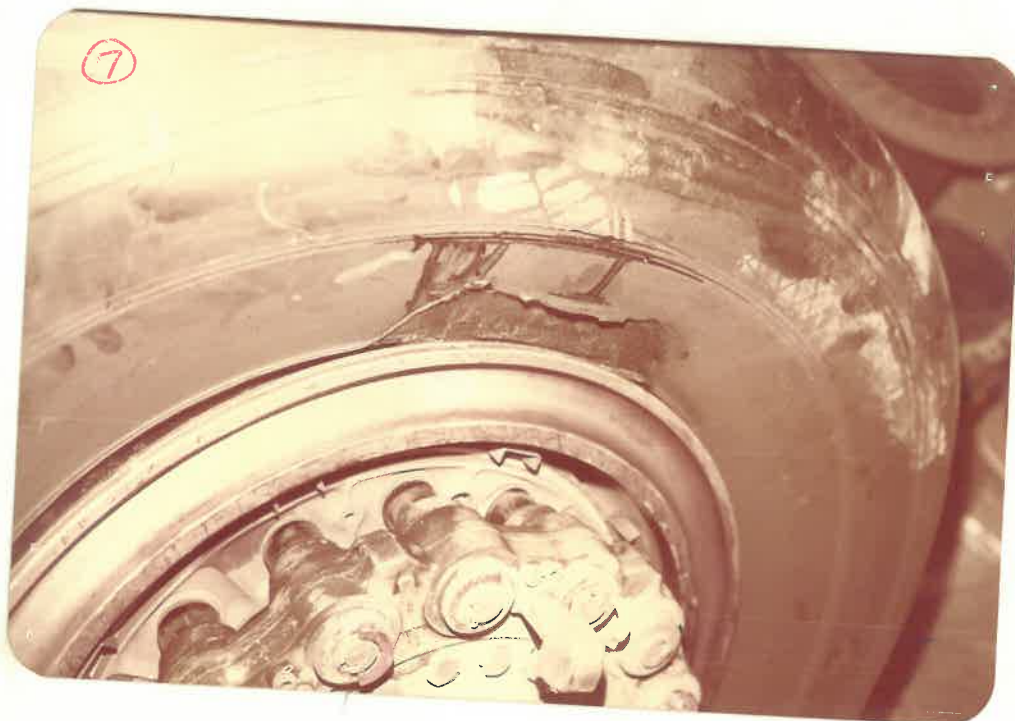
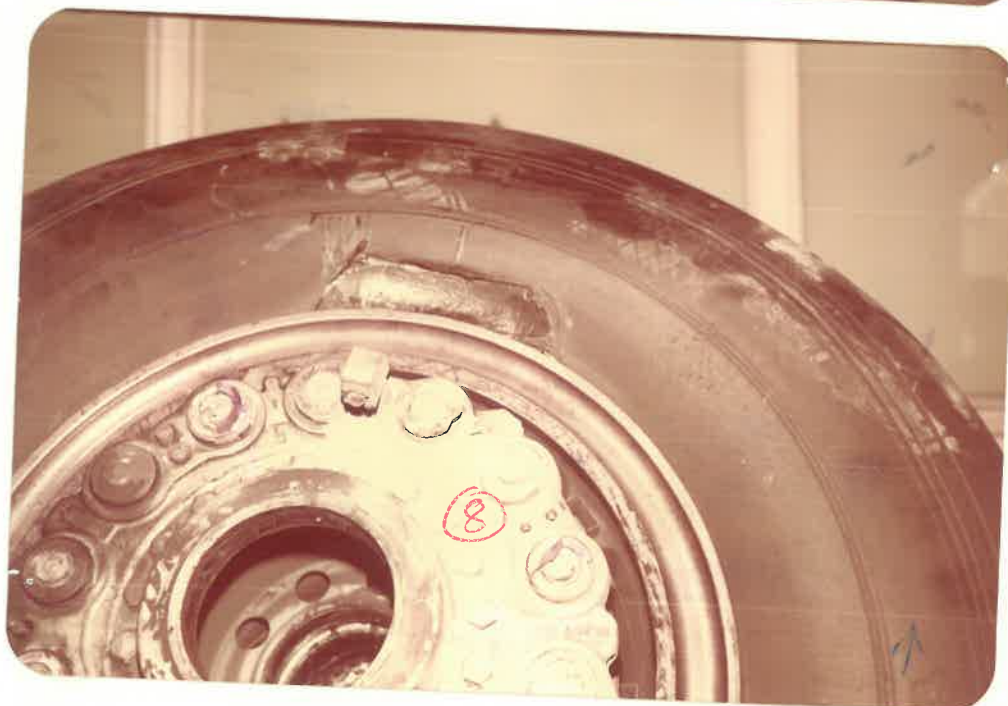
APP. 'C5'

TYRE WHEEL NO.2 & BRAKE ASSEMBLY A/C  
AP-BBM - A-300 (PK-725/290585)

Picture shows deflated tire, rubber melted  
at the rim and ~~overheated~~ <sup>overheated</sup> wheel and brake assembly.

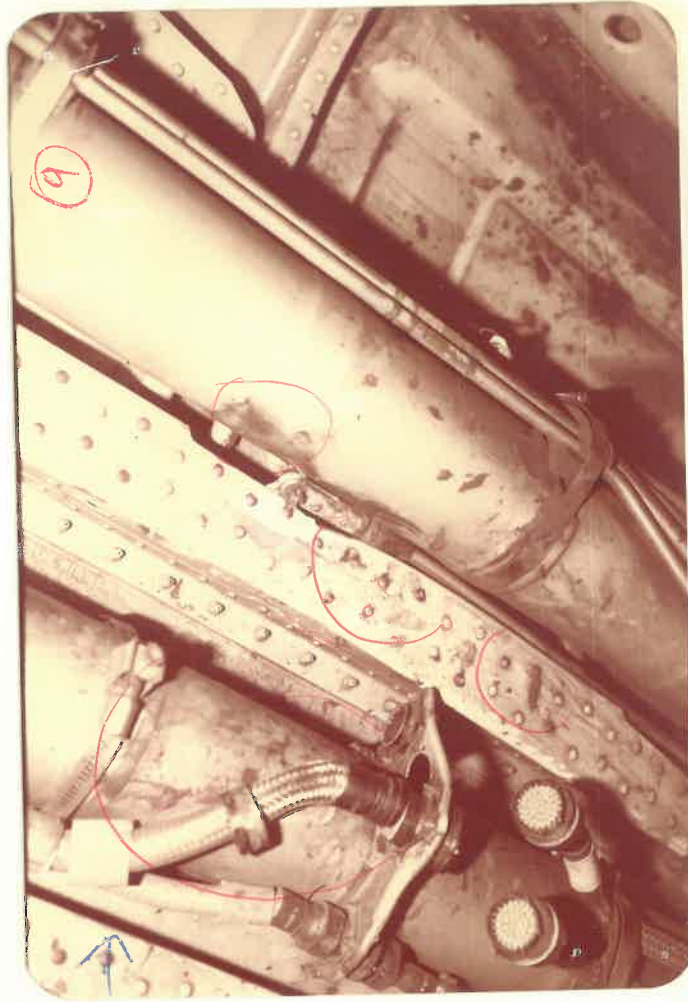
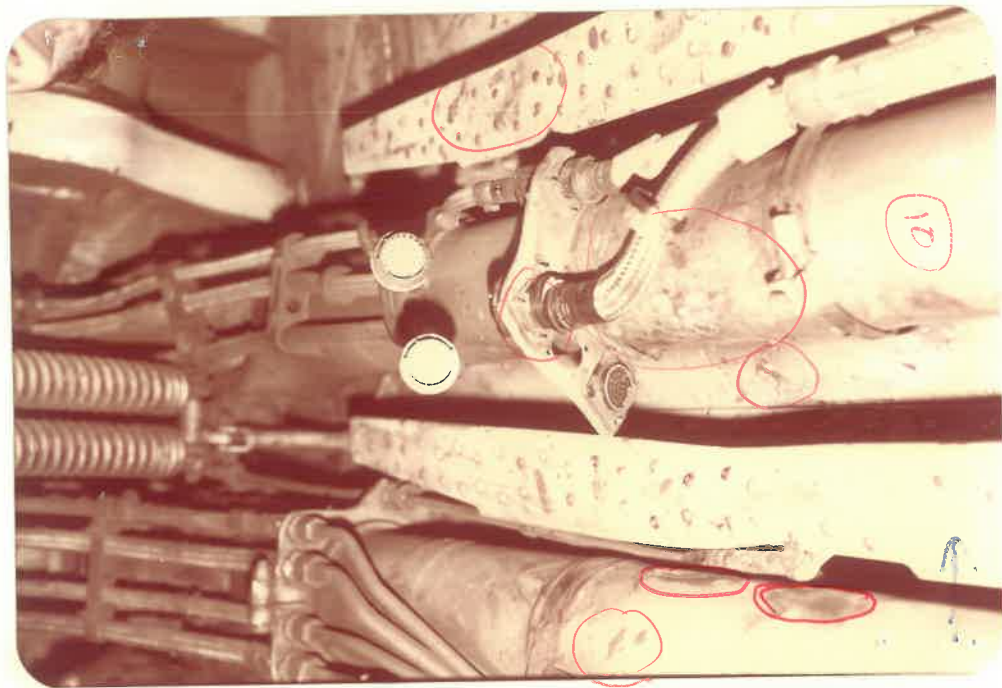
APP. CG

damaged due to the impact of tread rubber pieces. This was evident from the rubber marks present on landing gear bay structure. This occurred on take-off when tread peeled off from No.6 tire.

17.3.6. The re-inforced flange of the landing gear bay structure had sustained damages. These damages had been caused by the impact of tread rubber pieces during take-off roll.

LEFT LANDING GEAR BAY STRUCTURE A/C AP-BBM  
A-300 (PK-725/290585)

Picture showing, tire tread pieces rubber marks and breakage of cable harness at their connectors.

In the above picture, the flange shown damaged and cracked.

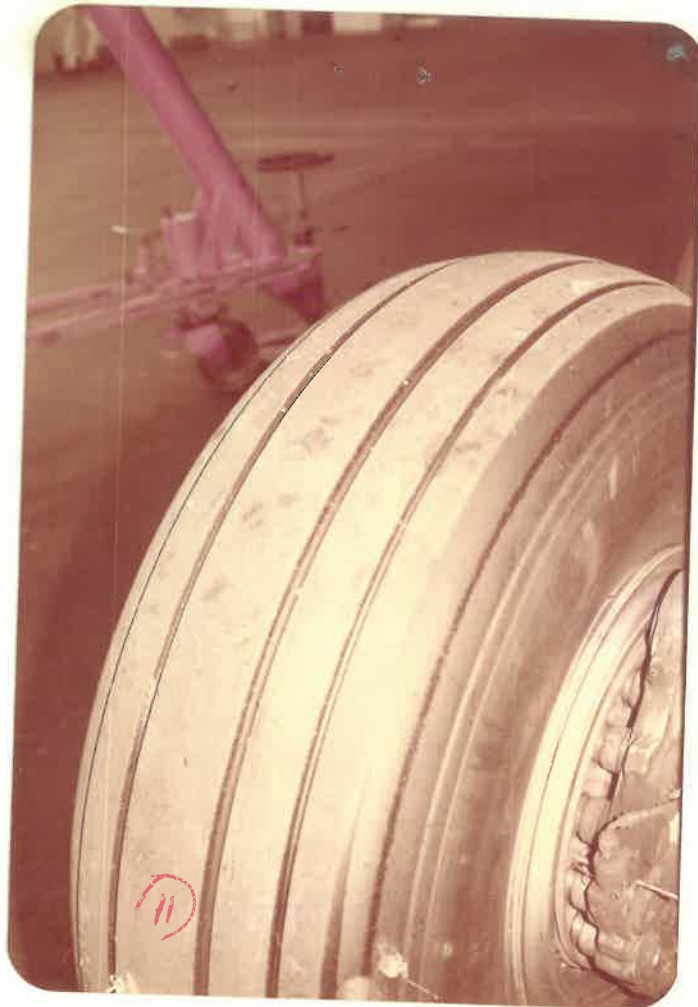
APP. 'C 7

WHEEL NO.5 A/C AP-BBM - A-300 PK-725/290585

Picture shows:- Brake assembly <sup>overheated.</sup> ~~burnt~~ due to excessive braking and tire burn marks.

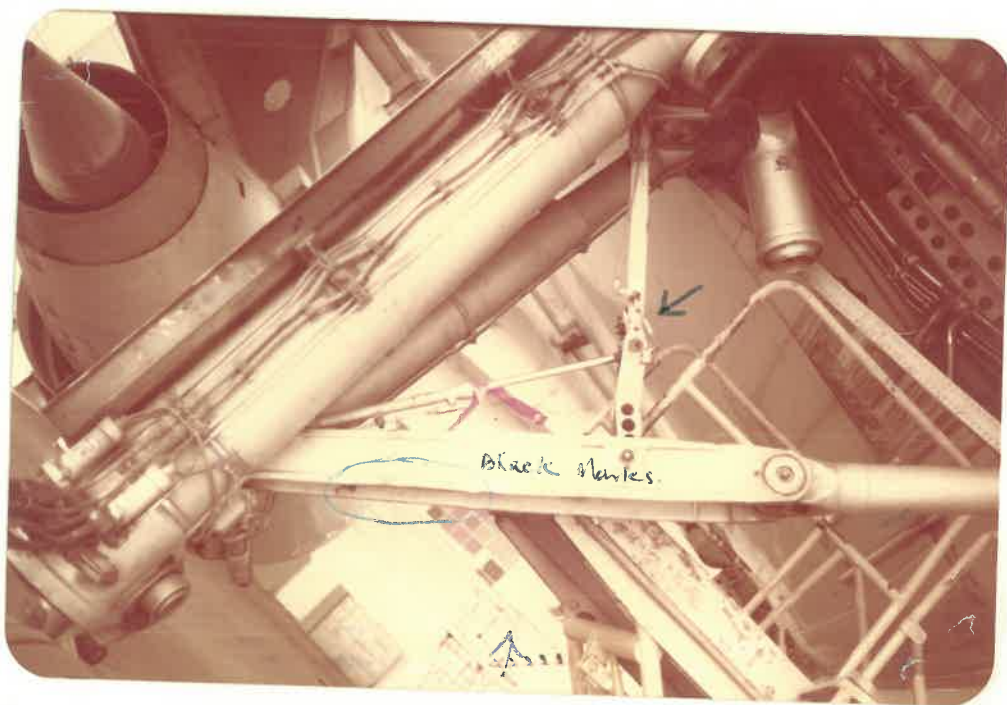
17.3.5. The mechanical linkages connecting mechanical indicator was found broken at the link adjuster position. This was also caused by the impact of separated tread rubber pieces. This occurred during take-off & supported by the indications after take-off.

LEFT LANDING GEAR LOCK STRUT AND MECHANICAL LINKAGE  
CONNECTING THE VISUAL SAFE INDICATOR OF LANDING GEAR

The link was broken at the link adjuster.(Pointed arrow).
